<b>Item</b>	Skate Area				
<b>Supplier</b>	Unknown				
<b>Surface</b>	Wood				
<b>Risk Rating Overall</b>	Very Low	Low	Medium	High	Unacceptable
				13

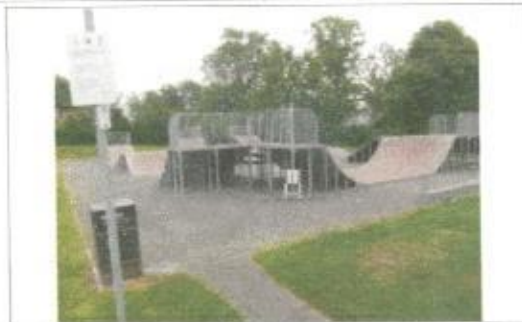
Broken glass evident. <b>Recommendation:</b> Consider removing broken glass and monitor area.	13
 	Transition plates and riding surfaces lifting around whole site. <b>Recommendation:</b> Monitor to repair this condition.	12
 	As above finding. <b>Recommendation:</b> As above Recommendation.	12
 	Half pipe surface unstable. <b>Recommendation:</b> Monitor to repair this condition.	12
