# Level 3 - Individual Tree Assessment

<b>On Behalf of:</b>	Kirbymoorside Town Council
<b>Site Address:</b>	Gilamoor entrance to Manor Vale Woodland
<b>Reason for Assessment:</b>	To assess a mature Oak with suspected decay close to ground level.
<b>Tree Location:</b>	Located on a bank to the east of the public footpath approximately 12m from the entrance gate I have highlighted the position of the tree in yellow on the Google Earth image opposite.
<b>Growing Area:</b>	Based on the relative age of the surrounding trees, this tree is assumed to have developed as an individual, though is becoming included within the woodland.
<b>Altitude:</b>	103m
<b>Exposure:</b>	The tree is sheltered from winds from the north and east. It is relatively exposed to the prevailing winds from the south and west.
<b>Assessor:</b>	Ian Barnes – details in Appendix A.
<b>Date of Assessment:</b>	30/06/2018.
<b>Assessment Method:</b>	Level 3 - None invasive - details in Appendix B

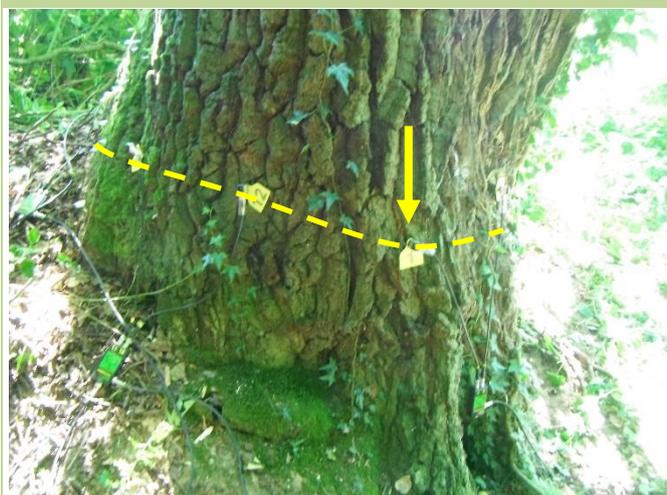
Photograph 1 - SOT at 290mm looking east

- Initial visual assessment of the main stem shows there to be an area of loose bark on the northern and southern stem, this was assumed to be the principal area of suspected decay based upon sounding with a nylon mallet and assessing the resonance of the wood.

- The northern section has partial attached and degraded remnants of fruiting bodies, these were unidentifiable but assumed to be either Ganoderma or Inonothus species, both of which are commonly found as heart rot on Oak.

- I undertook the sonic tomograph assessment of the main stem using 12 measurement points as indicated by the Yellow dashed line on photograph 1 & 2 below; the Yellow arrow shows the position of sensor 1 (northern sensor) on photograph 1 below; and the second arrow shows the position of sensor 7 (southern sensor) on photograph 2 below.

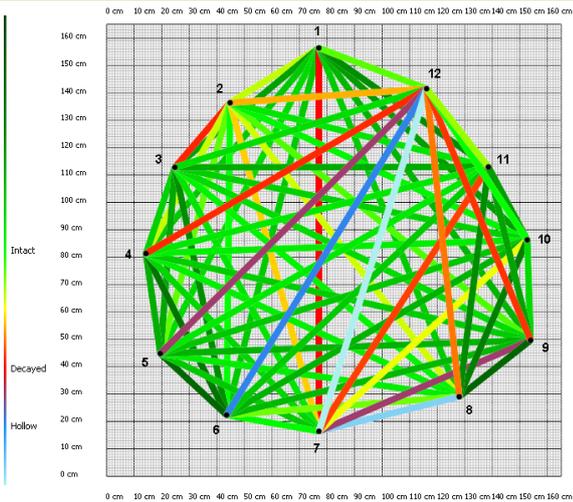
### Sonic Graph

- The sonic graph confirms the central portion of the stem has restricted sound transmission. Based upon the red lines being predominately from east to west the decay is assumed to be central north to south. This image does show a high proportion of green lines on the outer most shell of the stem, particularly north to south, indicating only a reasonably thick shell wall is retained.

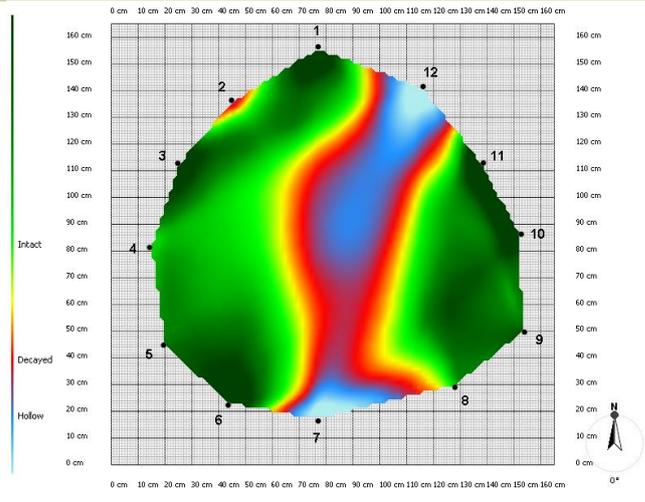
### Sonic Tomogram (SOT)

- The SOT (Sonic Tomogram) shown above, indicates that the stem has undergone significant decay from roughly northeast to south indicated by the blue area. The eastern and western buttress still has reasonably uniform high sound transfer abilities shown in green.

- Based upon this assessment the decayed element is within the typical safe limits of decay in trees of this size.
- The software detected a 40cm deep crack between sensor 7 & 8 which may well be exacerbating the extent of decay displayed in the southern portion of the stem. Such a crack may enable increased stem colonisation by the decay fungi and ideally this should be assessed periodically.

- Ongoing tree assessment will be required periodically and ideally the buttress should be assessed by sonic tomography in the summer of 2020.

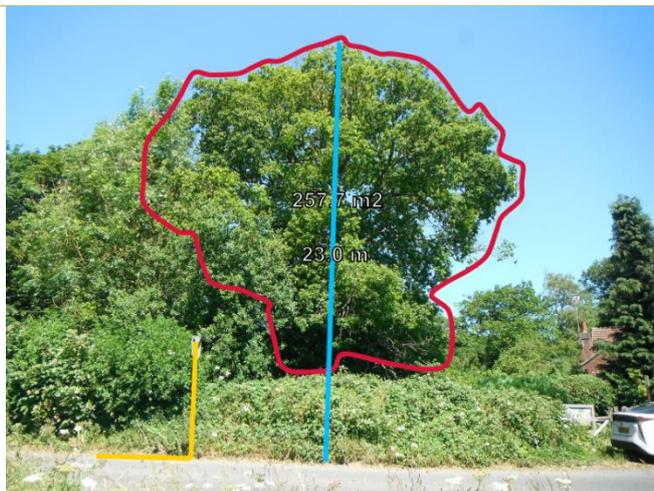
### Photograph 3 – looking NE

- A visual assessment of the remaining tree shows that Ivy is beginning to develop on the main stem and within the lower canopy and may obscure defects, ideally this should be controlled or removed.

- The canopy does contain several dead branches and ideally this needs to be kept within safe limits.
- The tree has been harshly lopped historically and excessively thinned. Some of this work has involved the removal of large limbs both close to the main stem and within the main canopy network. This work has been undertaken to a poor standard and left poorly made final cuts which are now sites of dysfunction and possibly decay.

- The response of the tree to the harsh work has been to continue to develop and to try to outgrow the problem which has created the current canopy which contains a range of elongated limbs with limited secondary branching, suggesting the tree will struggle to dampen wind loads and may be predisposed to branch failure and the tree will require formative pruning to manage this issue.

- The tree canopy being approximately 257m<sup>2</sup> as shown above in photograph 3.
- Comparison of the bearing capacity with the expected loading resulting from the canopy areas suggests that the tree has enough basic safety, as such the tree is assumed to offer a low risk of stem failure assuming a wind speed of up to 33m/s (118.8 km/h or 73.8 mph or Beaufort Force 12) which are likely to be experienced on site annually based upon published data.

- If retention of the tree is required, then I suggest that the canopy needs to be cleared of immediately defective material, ideally deadwood greater than 100mm should be removed.

- The Ivy growing on the trees stem and within the canopy should be treated to prevent regrowth and ideally removed in the current growing season.
- To counter the moderate risk of branch failure the elongated branches within the canopy should be reduced, by a process known as retrenchment in the current growing season. This pruning method gradually reduces the canopy volume, reducing the mechanical and wind loading on the canopy, though maintains the canopies characteristic shape. I have indicated the likely level of reduction in red on the photograph below. This will have the additional benefit of limiting wind loading and reduce the potential for torsional movement in the main stem.

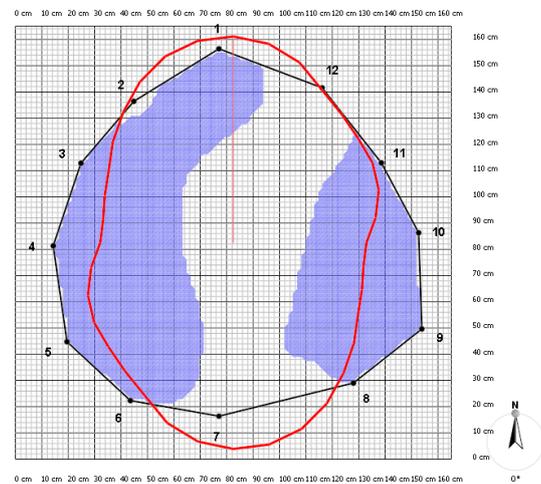
### Biomechanics Layer Map

- The bearing strength of the trees stem at the level of assessment is currently sufficient to offer support, based upon calculations which compare the greenwood strength of the retained wood and the estimated load based upon the tree canopied surface area, wind resistance and the mechanical advantage offered by the height of the tree. The assumed supportive element of the stem at the assessment height is shown as blue shading on the Biomechanics Layer Map above.

- The thickened area of blue in the south west area of the stem is around sensor 4, 5 & 6 suggests there has been a response by the tree to mechanical loading and adaptive wood has been produced. Based upon this information the tree has reduced strength against winds from the north and south, indicated by the red lines outside the stem on the Biomechanics Layer Map. However, significant winds from these directions are not expected and this is not considered as issue.
