Annual inspection report

Kirkbymoorside Town Council play areas at

Old Road, Kirkbymoorside, York, YO62 6LT &

Ryedale View, Kirkbymoorside, York, YO62 6EH

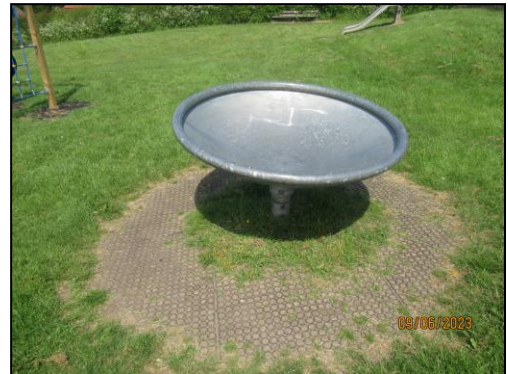
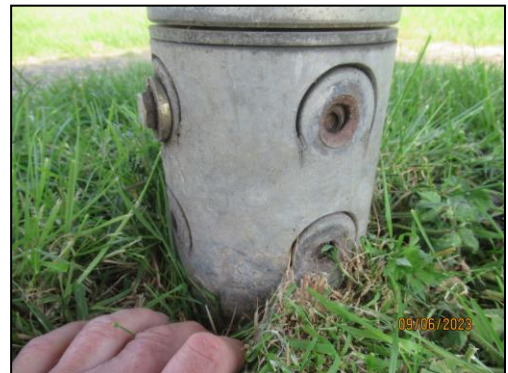
2. Sutcliffe Large Spinning Bowl

Condition: Replace three broken studs on ground fixing

(Broken studs at ground fixing)

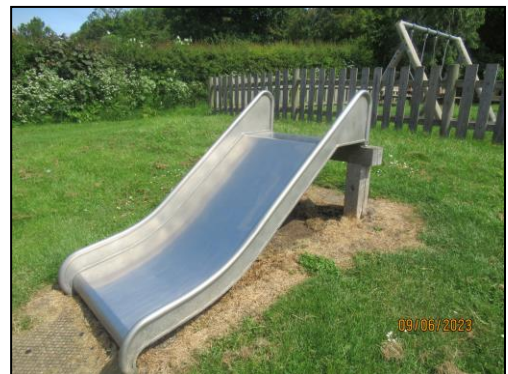
3. Richter Embankment Slide

Condition: Supports showing signs of rotting – monitor

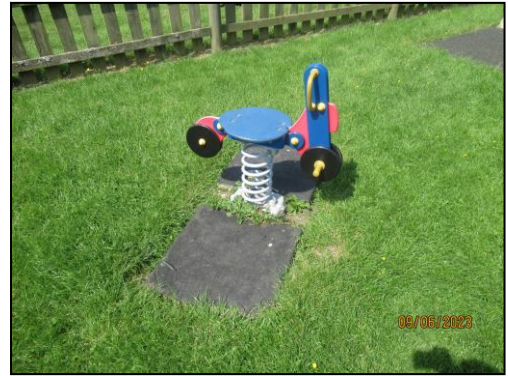
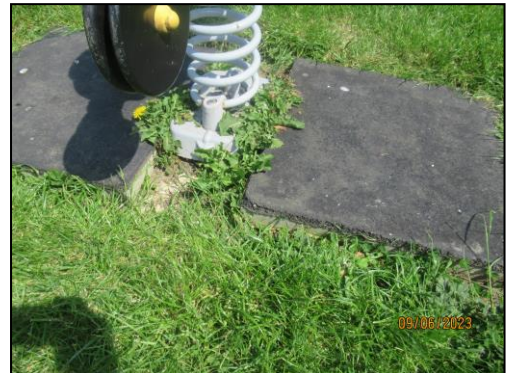
4. Ledon Spring Bike

Compliance: BS EN 1176-6, Sec. 4.6, foot rests fail gauge test

Surface Condition: Potential trip hazards at edges of tiles – requires attention (Medium Risk)

(Potential trip hazards at edges of tiles)

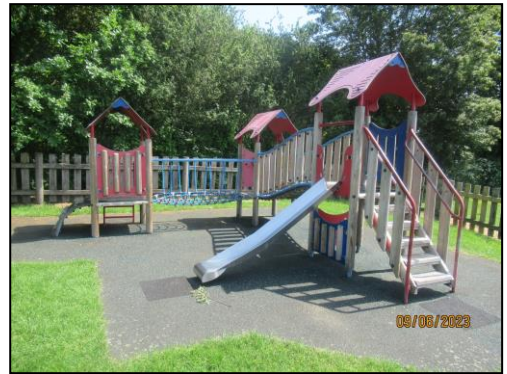
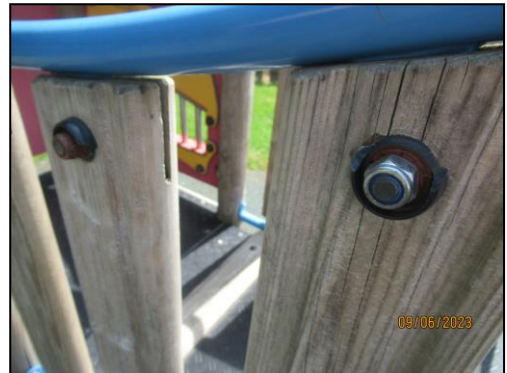
6. Playdale Toddler Multi Unit

Condition: Replace several broken bolt cover caps

(Broken bolt cover caps)

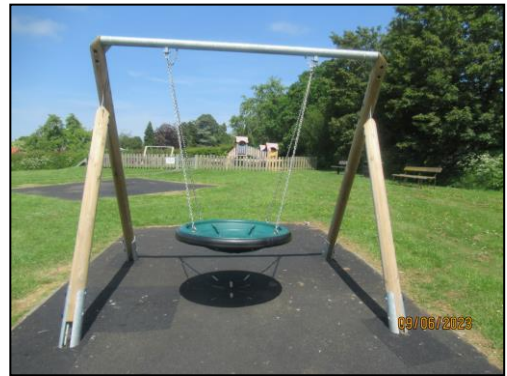
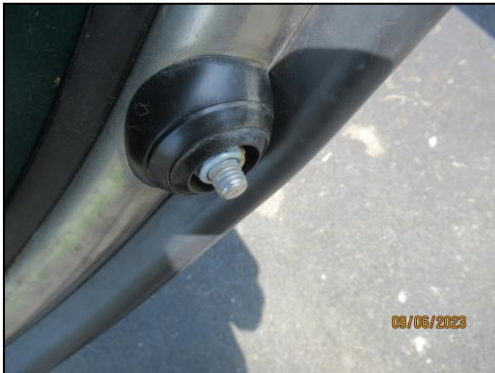
8. Playdale Group Swing

Condition: Replace three missing bolt cover caps beneath seat

Compliance: BS EN 1176-1, Sec. 4.2.5, excess bolt thread present at missing bolt cover caps beneath seat

(Missing bolt cover caps beneath seat)

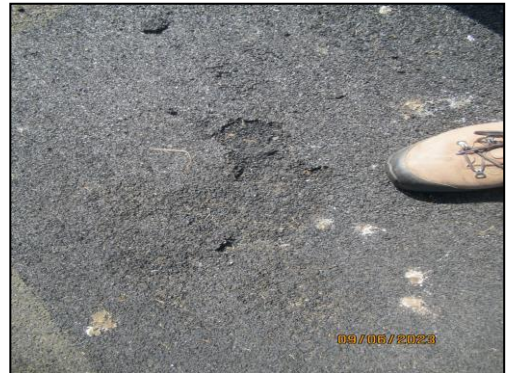
Surface Condition: Repair 200mm x 100mm x 10mm deep

(Damaged wet pour)

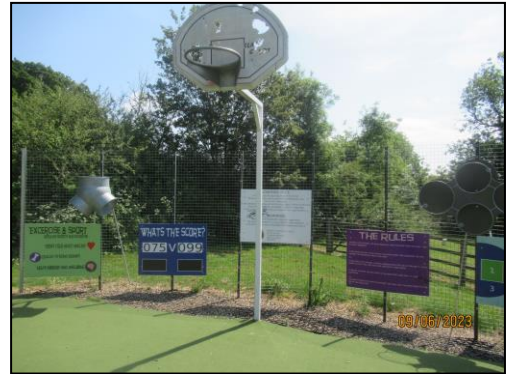
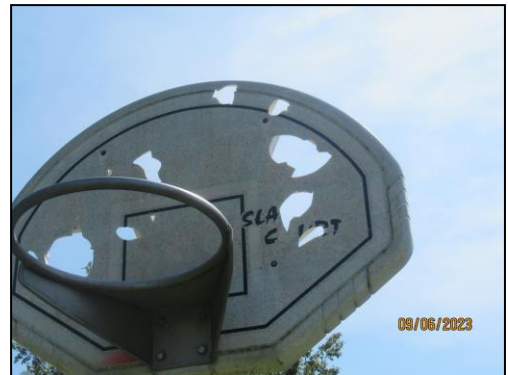
11. Sure Shot Basketball

Condition: Replace damaged back board

(Damaged back board)

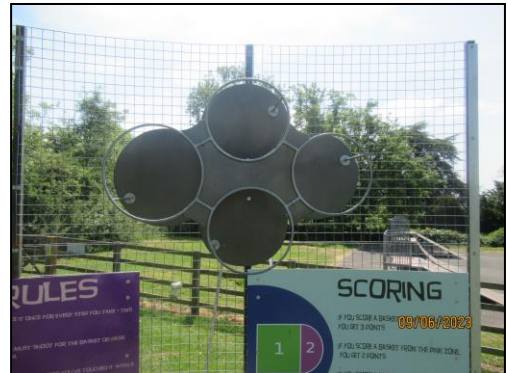
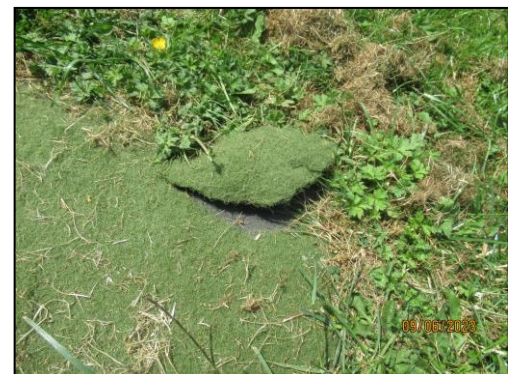
12. Unknown Make Target Panel

Surface Condition: Repair 200mm²

(Damaged artificial turf)

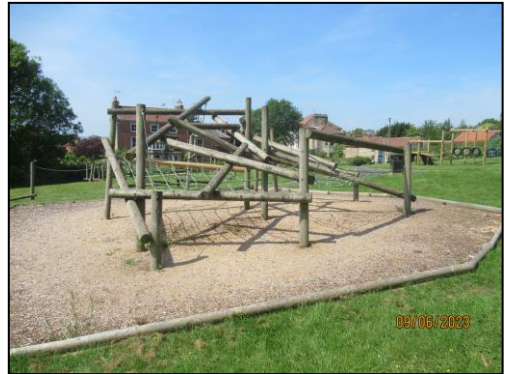
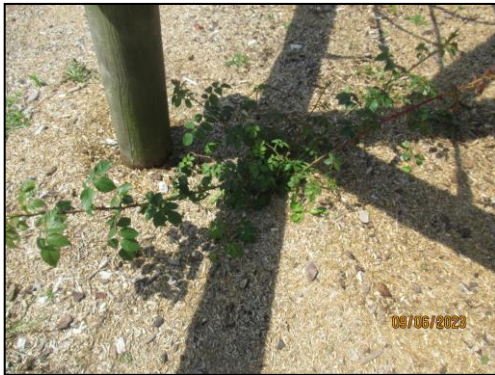
13. Playdale Log & Net Climber

Condition: Remove thorny shrub

(Thorny shrub)

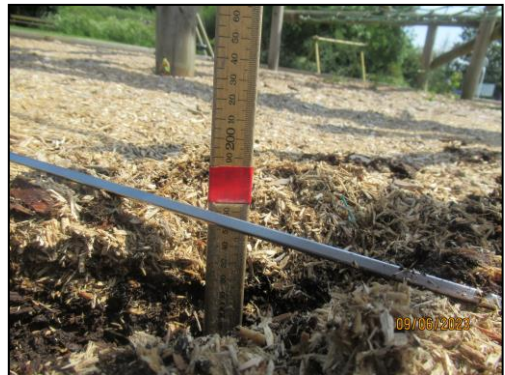
Surface Condition: Require top up (actually 170mm deep, should be at least 300mm)

(Wood chippings 170mm deep)

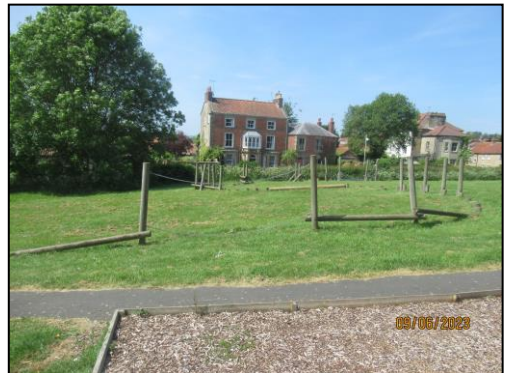
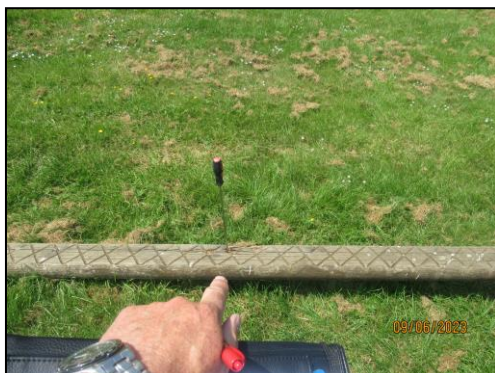
14. Playdale Trim Trail

Condition: Replace rotten incline balance beam

(Rotten incline balance beam)

Comments: Given age of items suspect rotten supports will occur on future annual inspections – consideration should be given to replaciung whole trim trail

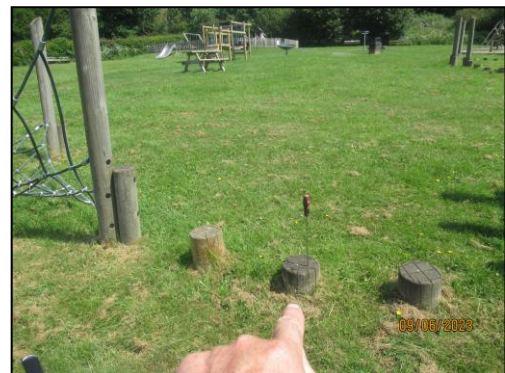
Replace one rotten step post

(Rotten step post)

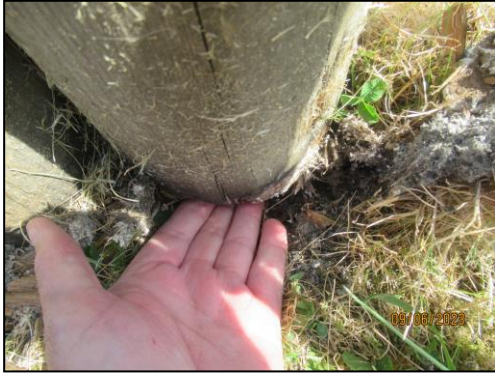
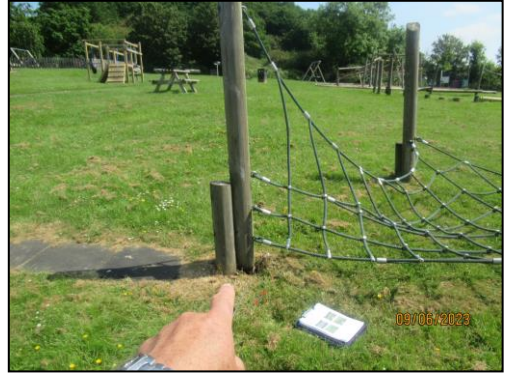
14. Playdale Trim Trail (continued)

Replace one rotten post on net climber

(Rotten post on net climber)

(Location of rotten post on net climber)

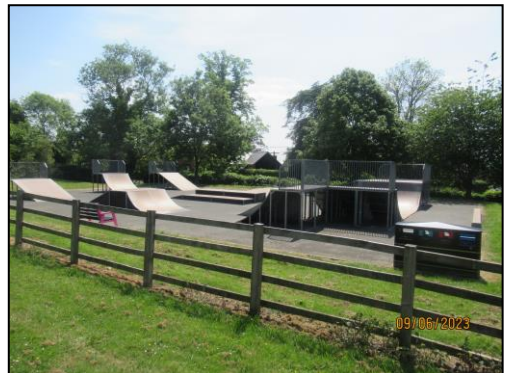
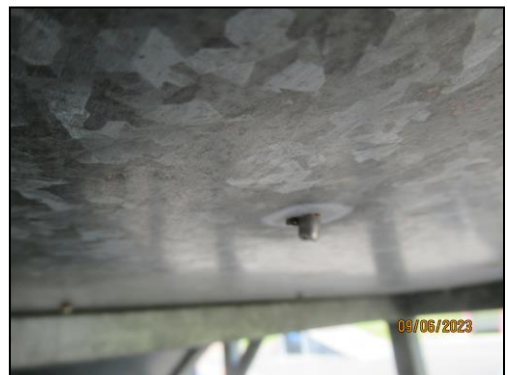
15. Eight-item Skate Park

Compliance: BS EN 14974, Sec. 6.1.7, rivets protruding beneath platforms & ramps at various locations – requires attention

(Protruding rivets)

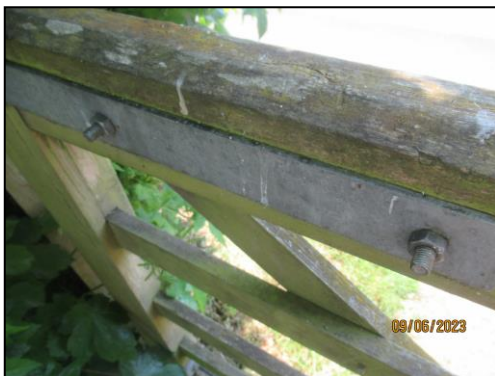
Fence (around skate park) c/w 4 pedestrian gates – potential head trap between top two rails on fence & gates. **Clearance of between 60mm & 110mm should be maintained at bottom of gates. Replace one missing gate stop. Re-set gates (catches missing stoppers at two gates (Low Risk) Remove excess bolt thread. Replace one missing nut on bolt (Medium Risk)**

(Excess bolt thread at gate at skate park)

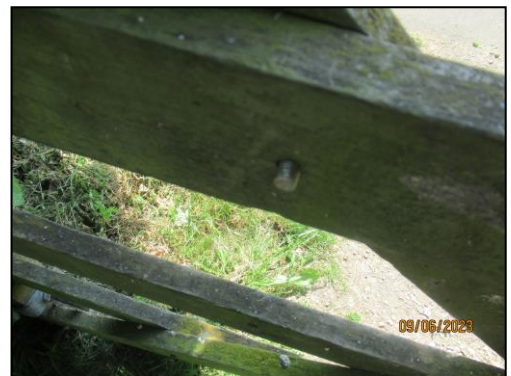
(Missing nut on bolt at gate at skate park)

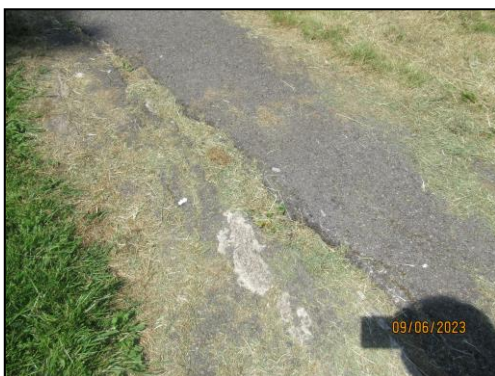
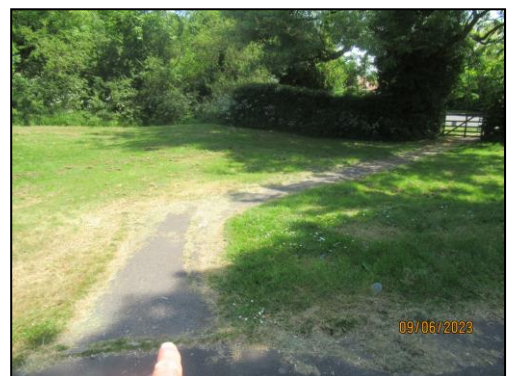
Path – **poor condition – requires attention (Low Risk)**

(Poor condition path)

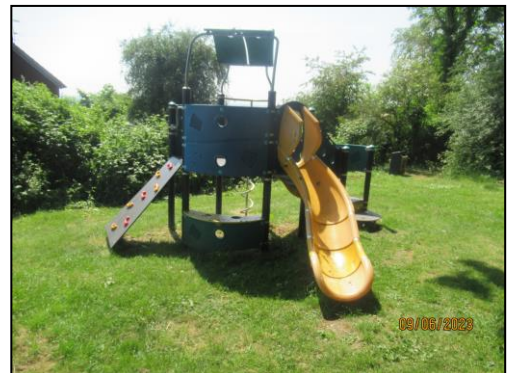
1. Kompan Junior Multi Unit

Condition: Slide requires cleaning due to bird fouling

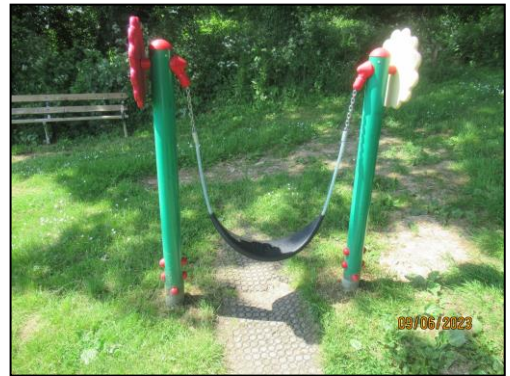
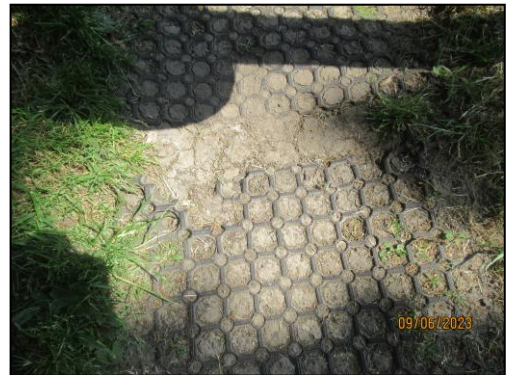
2. Kompan Daisy Swing

Surface Condition: Repair/replace one damaged mat

(Damaged grass mat)

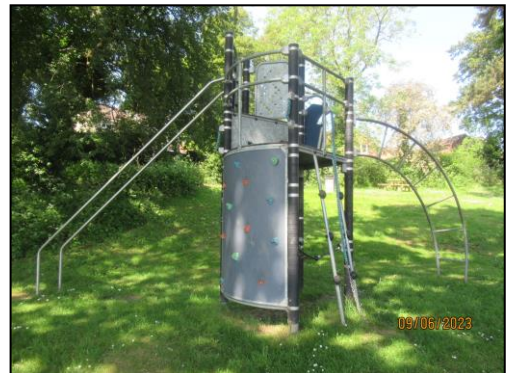
3. Kompan Multi Climbing Frame

Compliance: BS EN 1176-1, Sec. 4.2.7.6, potential finger trap between top of climbing wall & platform

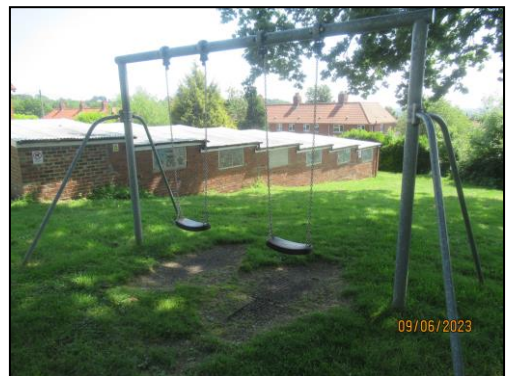
6. Kompan 2.4m 1 Bay Swing with 2 Flat Seats

Surface Condition: Grass worn (this may affect the impact attenuating properties of the mats)

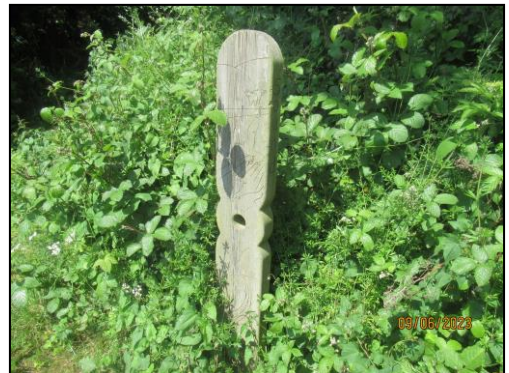
a) Post

Condition: Not ideally positioned beneath tree

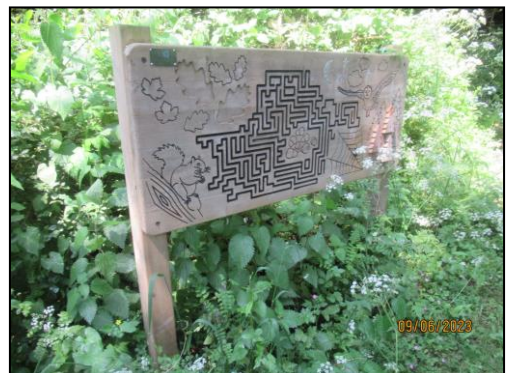
b) Information Panel

Condition: Not ideally positioned beneath tree

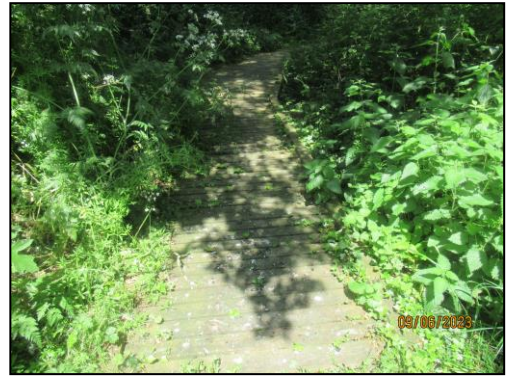
c) Board Walk

Condition: Not ideally positioned beneath tree
