## **TREE SAFETY SURVEY & REPORT**

### **4 SITES FOR KIRKBYMOORSIDE TOWN COUNCIL**

*Tree Safety Report with recommendations for all trees on 4 Sites - 2023*

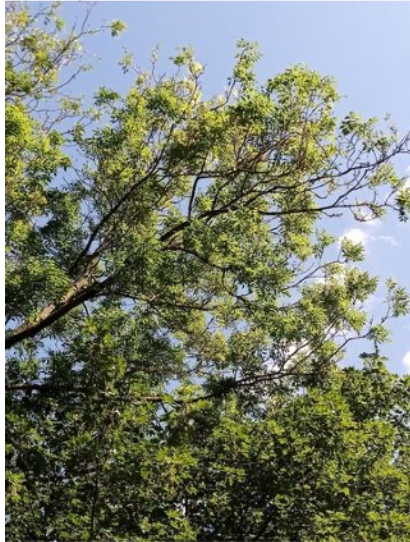
T001

Showing canopy health

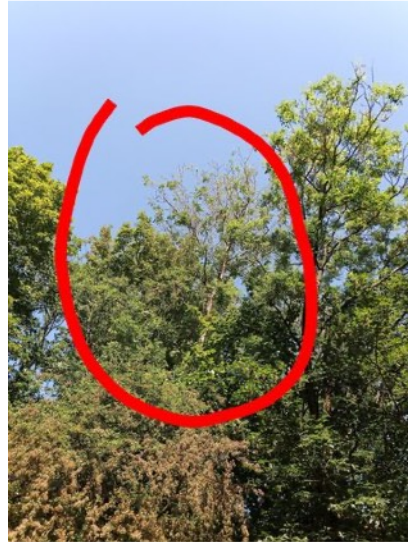
T002

Showing tree location

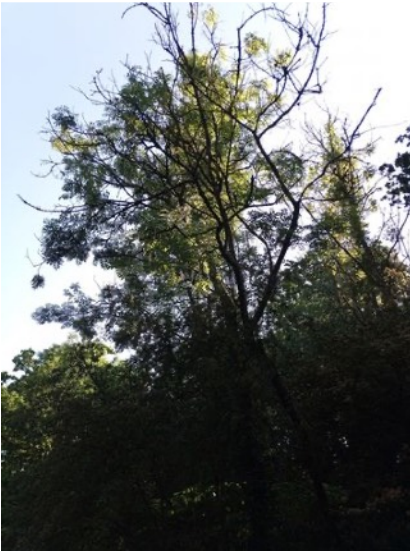
T013

Showing canopy and lower dead limb

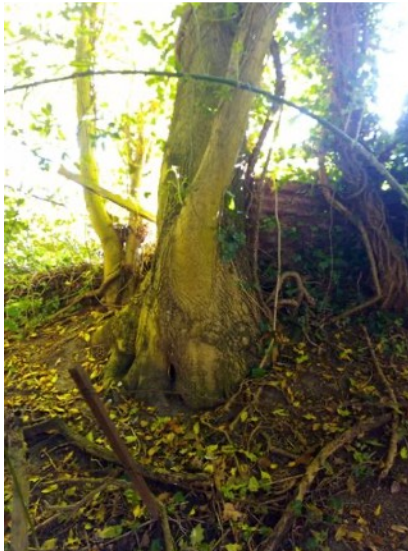
T026

Showing main stem location

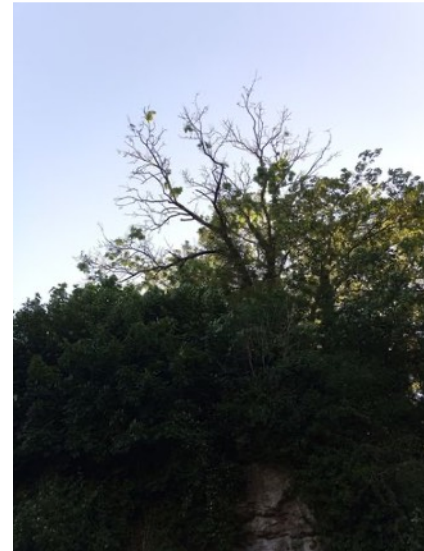
Ref.	Species	Description	Measurements	Survey Notes	Physio' Condition	Structural Condition	Overall Condition	Recommendations
T028	Common Ash (Fraxinus excelsior)	Growing in small group with other mature Ash and Sycamore on top of cliff face over car park. Ownership undetermined.	Height (m): 18 Crown Radius (m): 7 Life Stage: Mature Life Exp.: <10 years	Severe ADB symptoms. Only small internal canopy left. Access difficult due to cliff face and thick undergrowth. No pathway. Some large snapped out branches noted.  Pests and Diseases: Ash Dieback Infection Level 4: 75% to 100%	Poor	Poor	Poor	Fell tree. Timescale: 14-Jun-2024 (1 Year)

Showing weak canopy and location

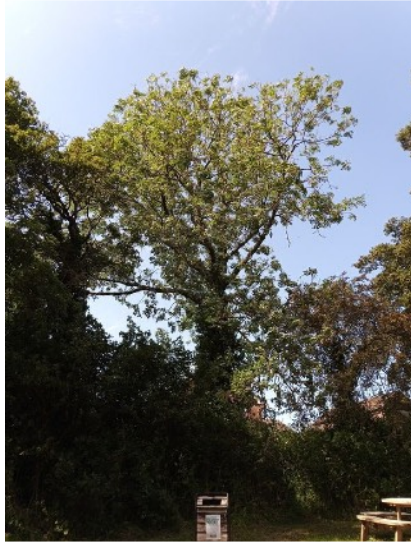
Ryedale View - T001

Showing canopy condition

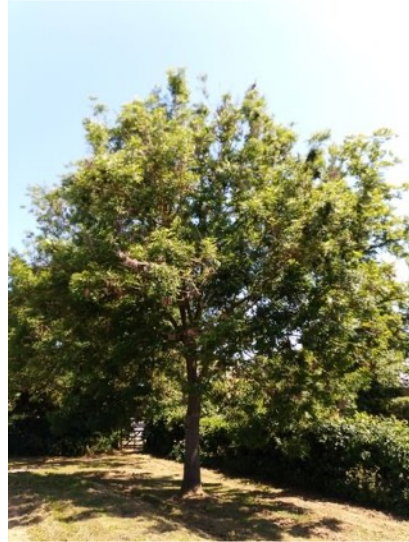
Old Road - T002

Showing canopy condition

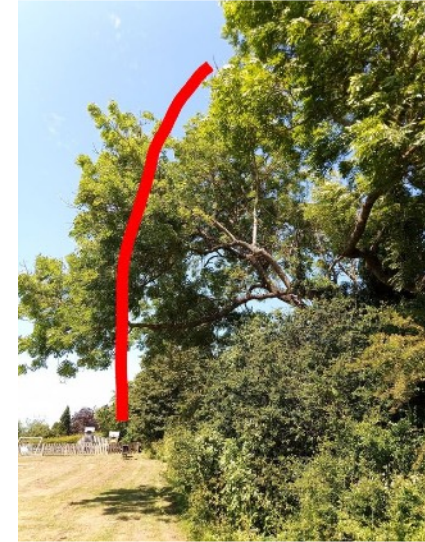
Old Road - T004

Showing lower limb to be reduced

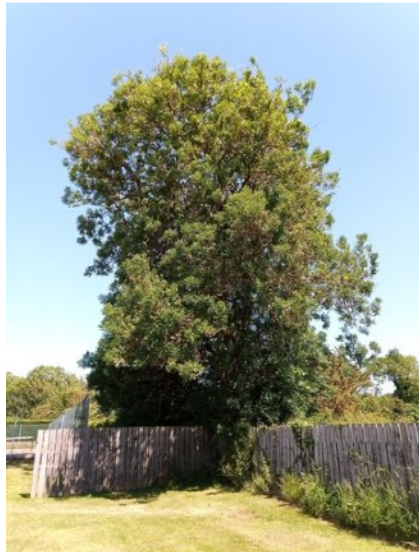
Kirkby' Sports Field - T001

Ref.	Species	Description	Measurements	Survey Notes	Physio' Condition	Structural Condition	Overall Condition	Recommendations
T001	Common Ash (Fraxinus excelsior)	Boundary tree behind conifer hedge, near corner of tennis court. Access difficult	Height (m): 18 Crown Radius (m): 6 DBH (cm): 85 Stems: 2 Life Stage: Mature Life Exp.: <10 years	Healthy canopy. Some slight deadwood and weakening at the top. Previously ivy clad but has been severed. Significant fruiting. Multi stemmed from 2m. Tight union.  Pests and Diseases: Ash Dieback - not currently showing symptoms	Good	Good	Good	Monitor Ash dieback level. Timescale: 14-Jun-2026 (3 Years)
T002	Common Ash (Fraxinus excelsior)	Boundary tree with canopy over playing field	Height (m): 21 Crown Radius (m): 10 DBH (cm): 120 Life Stage: Mature Life Exp.: 10+ Years	Large base with buttress roots. Small historic wound a 1m sealing well. Healthy canopy. Very broad spread canopy. Slightly weakening at top. Previously ivy clad but severed.  Some substantial deadwood noted but mainly field side. One major limb is over heavy and has lions tailed away from main canopy but potential failure would be field side so low risk.  Lots of nests noted.  Pests and Diseases: Ash Dieback. No clear symptoms.	Good	Fair	Good	Monitor Ash dieback level Timescale: 14-Jun-2026 (3 Years)

Showing canopy health

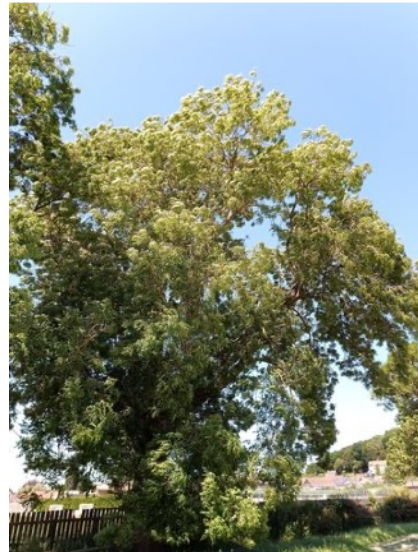
Kirkby' Sports Field - T002

Showing canopy health

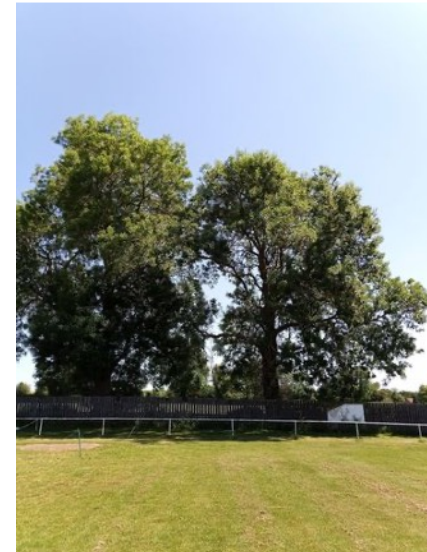
Kirkby' Sports Field - T003

T003	Common Ash (Fraxinus excelsior)	Boundary tree with canopy over playing field	Height (m): 21 Crown Radius (m): 6 DBH (cm): 75 Life Stage: Mature Life Exp.: <10 years	Previously ivy clad but has been recently severed. Previously crown lifted leaving large historic wounds. Not sealing. Canopy vitality is low, sparse in areas with some dieback  Pests and Diseases: Ash Dieback Infection Level 1: 0% to 25%	Fair	Good	Fair	Recommendations 1: Remove deadwood - greater than 25 mm to be able to monitor rate of dieback. Timescale: 14-Jun-2024 (1 Year)  Recommendations 2: Monitor Ash dieback level Timescale: 14-Jun-2026 (3 Years)

Showing T003 on right of image with slightly sparser canopy.

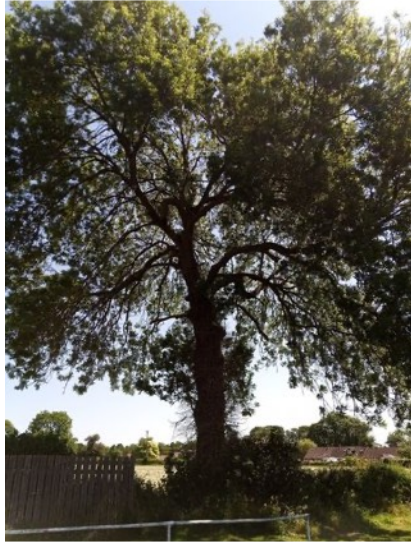
**Kirkby' Sports Field - T004**

T004	Common Ash (Fraxinus excelsior)	Boundary tree with canopy over playing field	Height (m): 21 Crown Radius (m): 7 DBH (cm): 60 Life Stage: Mature Life Exp.: 10+ Years	Ivy clad but previously severed. Some epicomic growth which is recent. Canopy definitely weaker. Somewhat sparse. Multiple examples of small to substantial Deadwood. Three sites of recent branch drop with one large piece of Deadwood remaining in tree..  Canopy shape is broad with some long horizontal limbs.  One snapped hanging branch field side.  Pests and Diseases: Ash Dieback Infection Level 2: 25% to 50%	Fair	Fair	Fair	Recommendations 1: Remove deadwood - greater than 25 mm. Remove snapped and hanging branches. Timescale: 14-Jun-2024 (1 Year)  Recommendations 2: Monitor Ash dieback level Timescale: 14-Jun-2026 (3 Years)
T005	Black Poplar (Populus nigra)	Boundary tree with canopy over playing field.	Height (m): 25 Crown Radius (m): 7 DBH (cm): 90 Life Stage: Mature Life Exp.: 30+ Years	Healthy canopy and form. Has no signs of pathogen infection or destabilisation after removal of neighbouring tree.	Good	Good	Good

Showing canopy condition

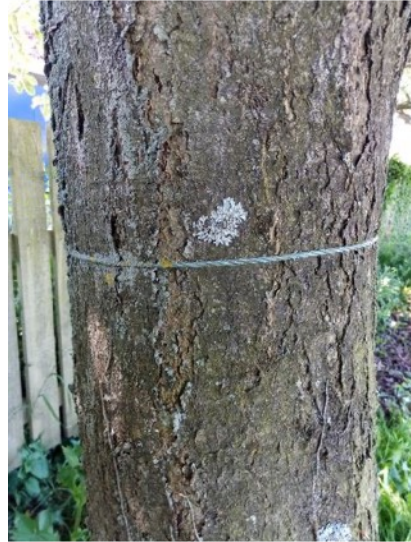
**Kirkby' Sports Field - T007**

Showing example of rope and inclusion

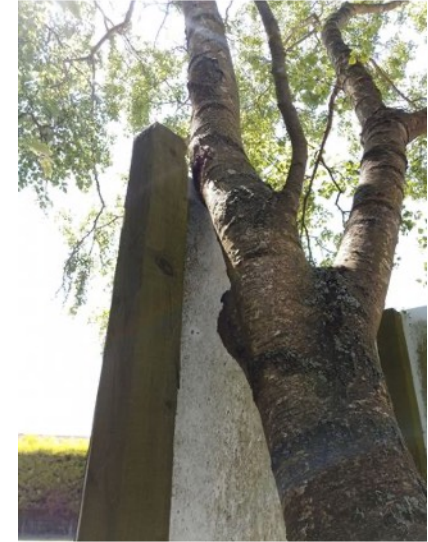
**Kirkby' Sports Field - T009**

Showing proximity to signage
