TREE SAFETY SURVEY & REPORT

SINGLE SITES FOR KIRKBYMOORSIDE TOWN COUNCIL

Tree Safety Report with recommendations for trees with potential to impact 17 Kirkdale Court, Kirkbymoorside - 2023

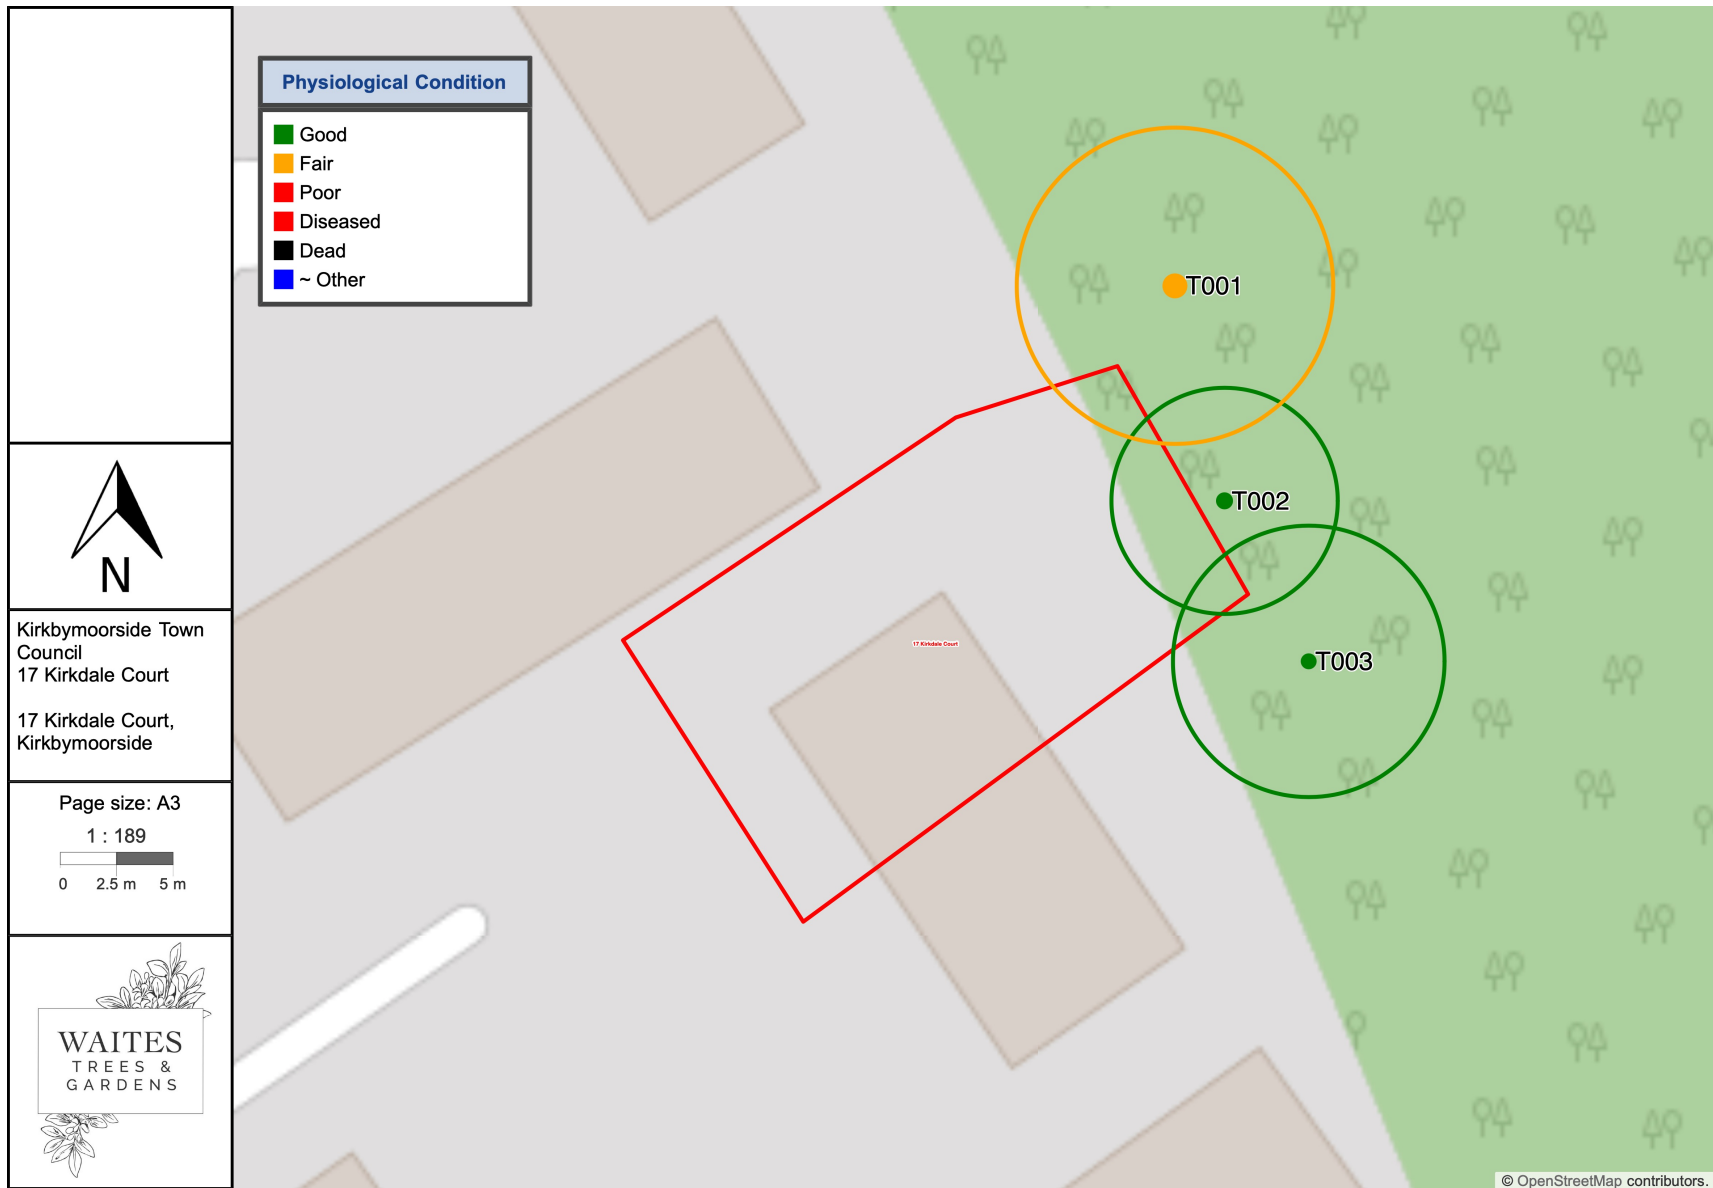
APPENDIX 1 - MAP - TREE LOCATIONS AND CONDITION

Ref.	What 3 Words	Species	Description	Measurements	Risk Category	Physio' Condition	Structural Condition	Overall Condition	Public Amenity Value	Wildlife Value	Survey Notes	Recommendations
T001	/// tides.thin. ballooned	Pedunculate oak (Quercus robur)	Set back from boundary. Bottom of neighbouring garden.	Height (m): 18.0 Crown Radius (m): 7.0 DBH (cm): 110 Life Stage: Mature Life Exp.: 30+ Years	Low	Fair	Fair	Fair	High	Good	Holly growing at base. Unusual twisted form higher in canopy. Historic snap out and branch failure over neighbouring property, wounds sealing well. Central upper branch has died and failed at buckle point, is hung up in upper canopy. One other large dead branch in upper canopy noted. All with potential to impact property below.	Remove dead main stem and dead branch Timescale: 01-Dec-2024 (1 Year)

Ref.	What 3 Words	Species	Description	Measurements	Risk Category	Physio' Condition	Structural Condition	Overall Condition	Public Amenity Value	Wildlife Value	Survey Notes	Recommendations
T002	/// downs.sle eps.debit	Pedunculate oak (Quercus robur)	Below garden area lower on bank. Proximity to building-12m	Height (m): 20.0 Crown Radius (m): 5.0 DBH (cm): 75 Life Stage: Mature Life Exp.: 30+ Years	Medium	Good	Good	Good	High	Good	Some epicormic growth on main stem. Tall upright form, even canopy. Exposed with only small trees to E, down bank side. Squirrel drey noted. Little internal foliage. From bud formation canopy appears to be weakening in top but currently showing moderate vitality.	Monitor canopy vitality, and assess upper canopy dieback. Timescale: 01-Dec-2026 (3 Year)
T003	/// stage.affor ds.tint	Pedunculate oak (Quercus robur)	Set down bank from neighbouring property.	Height (m): 19.0 Crown Radius (m): 6.0 DBH (cm): 70 Life Stage: Mature Life Exp.: 30+ Years	Medium	Good	Good	Good	High	Good	Strong upright form. Mild buttress roots, no cavities evident. Late to drop leaf. Full and even canopy. Exposed to E due to lack of tall trees. Lower limb with hazard beam failure in valley side, no potential impact to neighbouring property.
