Annual inspection report

Kirkbymoorside Town Council play areas at

Old Road, Kirkbymoorside, York, YO62 6LT &

Ryedale View, Kirkbymoorside, York, YO62 6EH

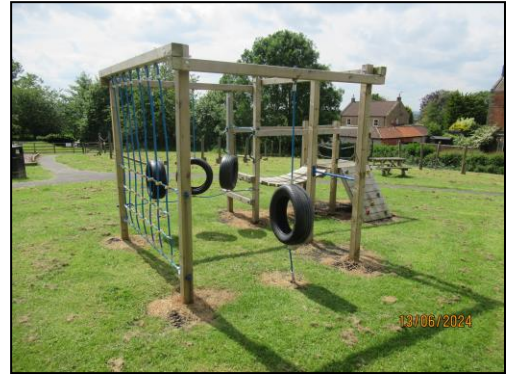
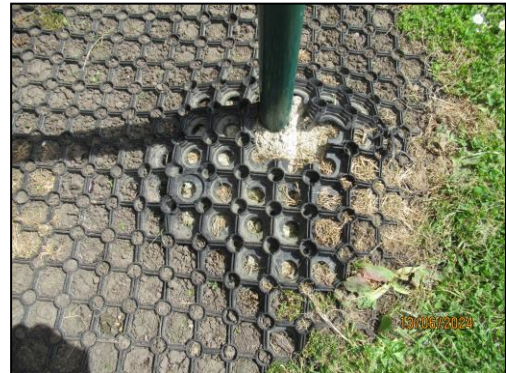
1. Sovereign Multi Climbing Frame

Surface Compliance: BS EN 1176-1, Sec. 4.2.14, exposed foundations at sliding pole – requires attention

(Exposed foundations at sliding pole)

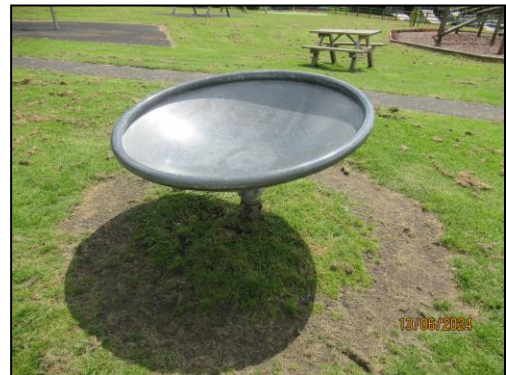
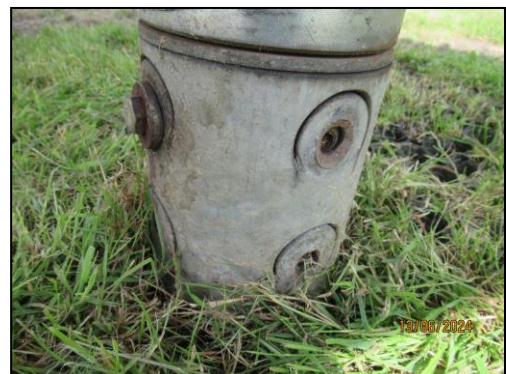
2. Sutcliffe Large Spinning Bowl

(Broken studs at ground fixing)

Condition: Replace three broken studs on ground fixing

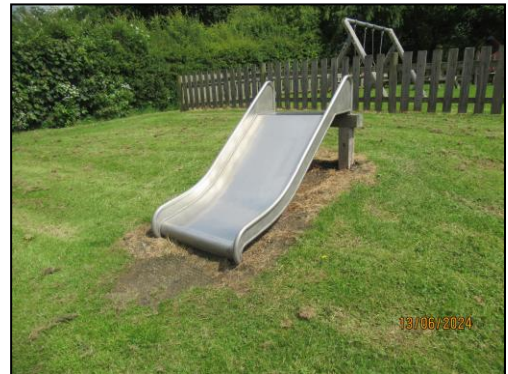
3. Richter Embankment Slide

Condition: Supports showing signs of rotting – monitor

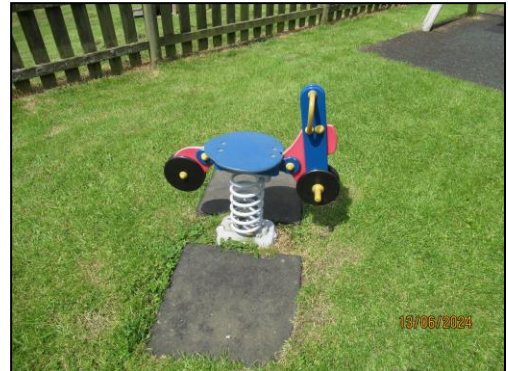
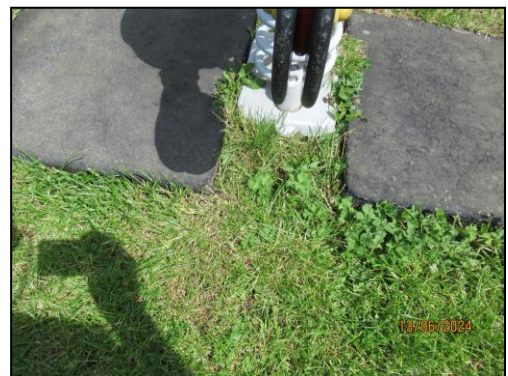
4. Ledon Spring Bike

Compliance: BS EN 1176-6, Sec. 4.6, foot rests fail gauge test

Surface Condition: Potential trip hazards at edges of tiles – requires attention (Medium Risk)

(Potential trip hazards at edges of tiles)

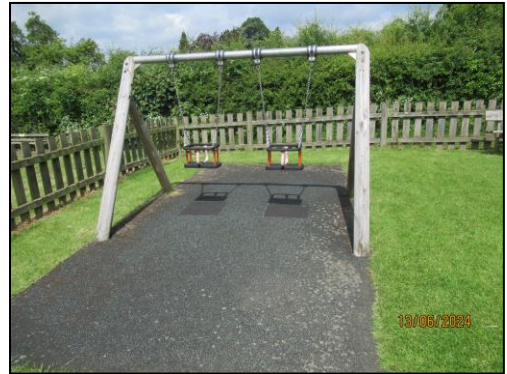
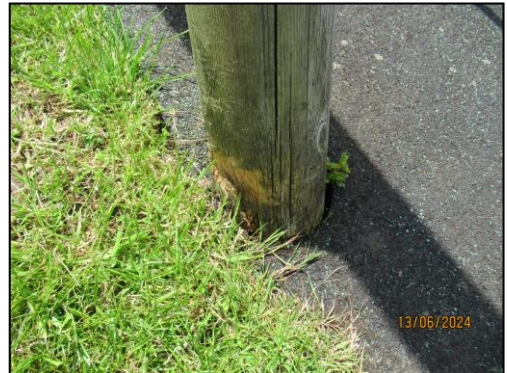
5. Playdale 1.75m 1 Bay Swing with 2 Cradle Seats

Condition: One support showing signs of rotting – monitor

(Rotting support)

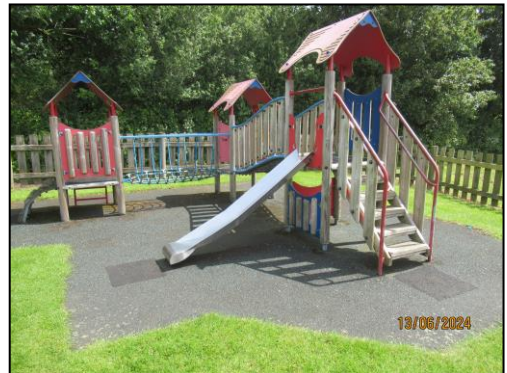
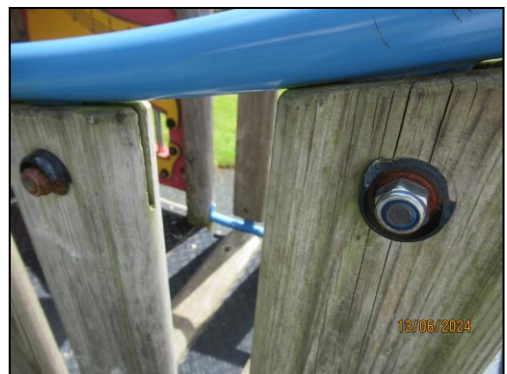
6. Playdale Toddler Multi Unit

(Broken bolt cover caps)

Condition: Replace several broken bolt cover caps

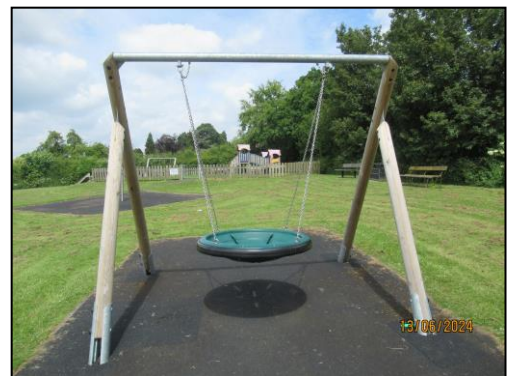
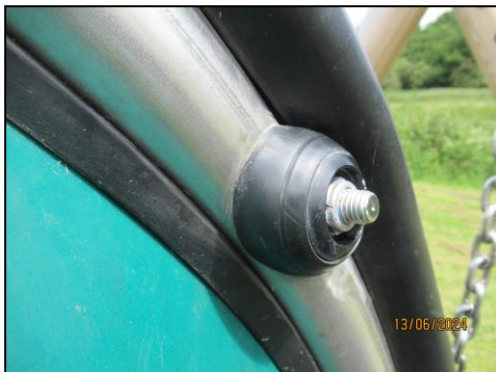
8. Playdale Group Swing

Compliance: BS EN 1176-1, Sec. 4.2.5, excess bolt thread present at missing bolt cover caps beneath seat

(Missing bolt cover caps beneath seat)

Condition: Replace three missing bolt cover caps beneath seat

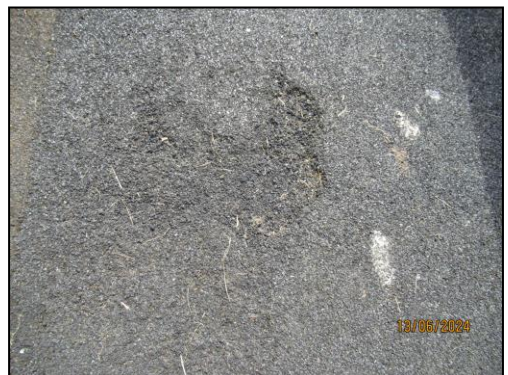
(Damaged wet pour)

Surface Condition: Repair 200mm x 100mm x 10mm deep

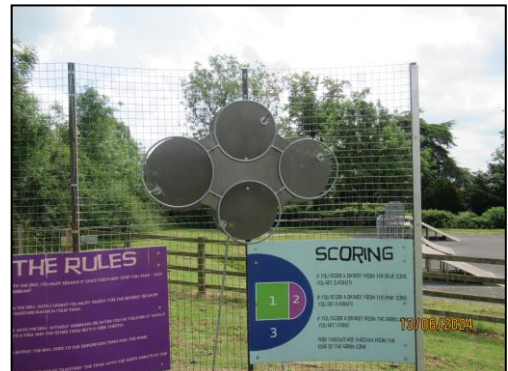
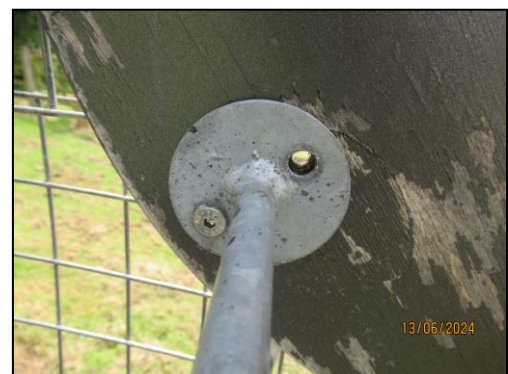
12. Unknown Make Target Panel

(Missing bolts on back board)

Condition: Replace four missing bolts on back board

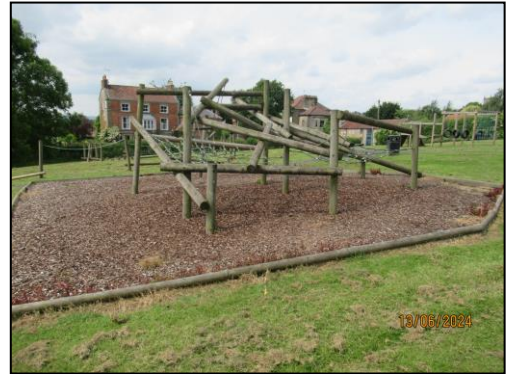
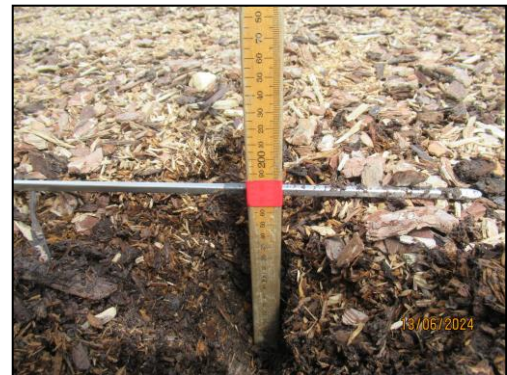
13. Playdale Log & Net Climber

Surface Condition: Require top up (actually 180mm deep, should be at least 300mm)

(Wood chippings 180mm deep)

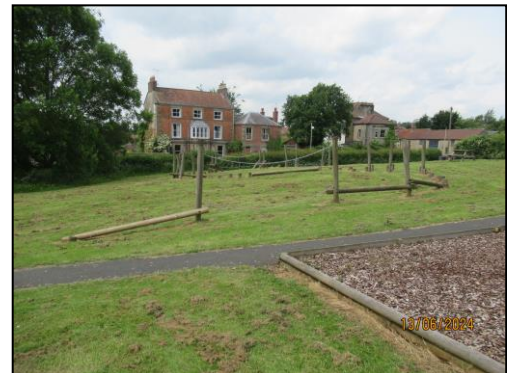
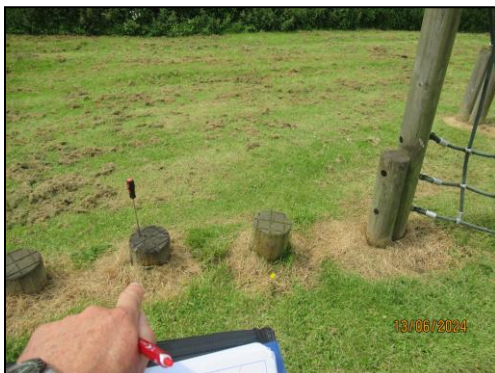
Comments: Given age of items suspect rotten supports will occur on future annual inspections – consideration should be given to replacing whole trim trail

(Rotten step post)

Condition: Replace one rotten step post

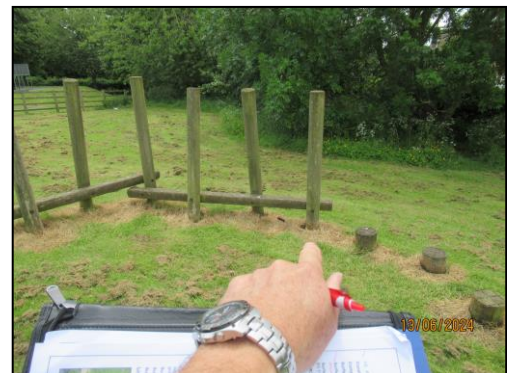
(Rotten post on weave beam)

Replace one rotten post on weave beam

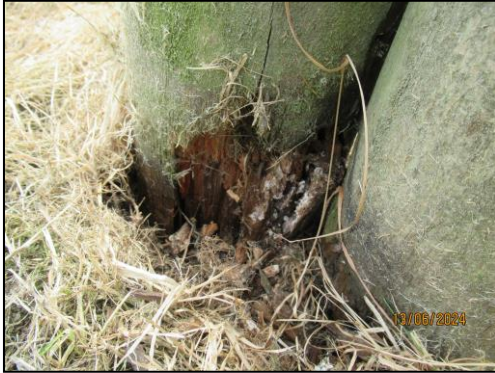
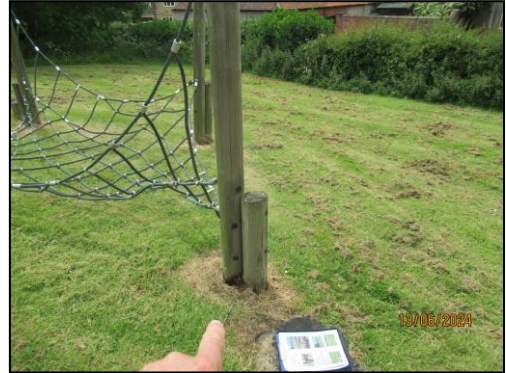
(Rotten post on net climber)

(Location of rotten post on net climber)

Replace one rotten post on net climber

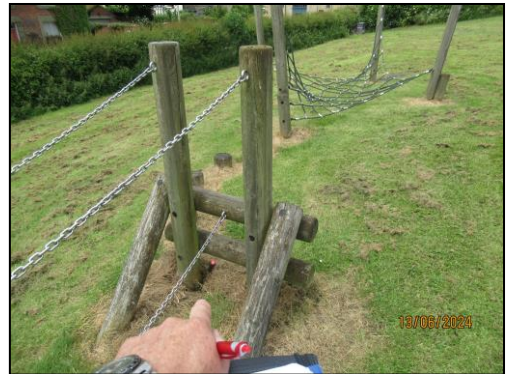
(Rotten post on Burma bridge)

Replace all rotten posts on Burma bridge

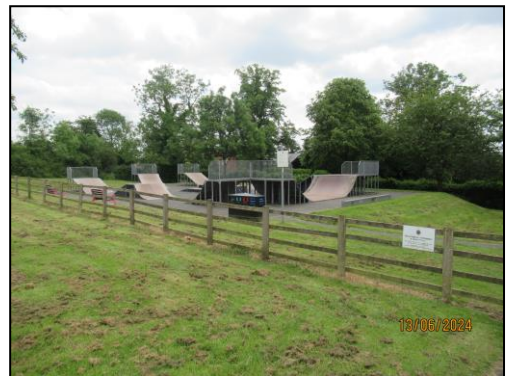
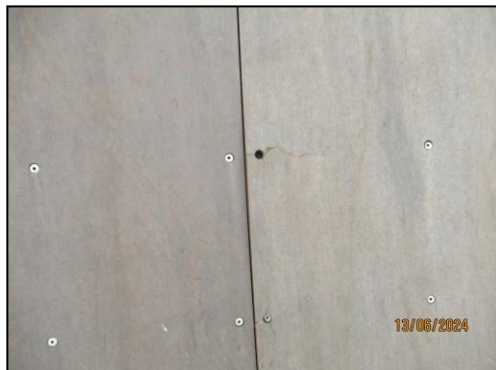
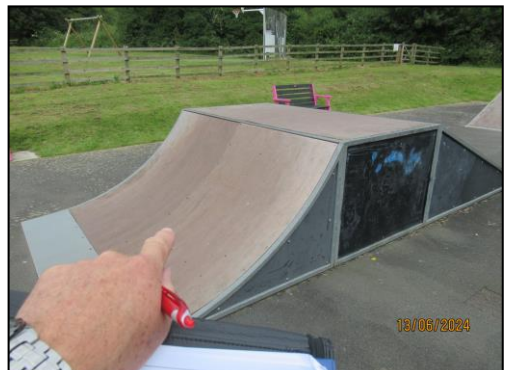
(Loose liner on driveway)

(Location of loose liner on driveway)

Resecure one liner on driveway

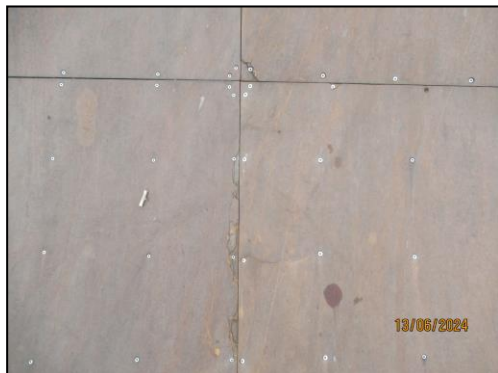
Condition: Slight damage to three liners on half pipe combi unit – monitor

(Slight damage to liner on half pipe combi unit)

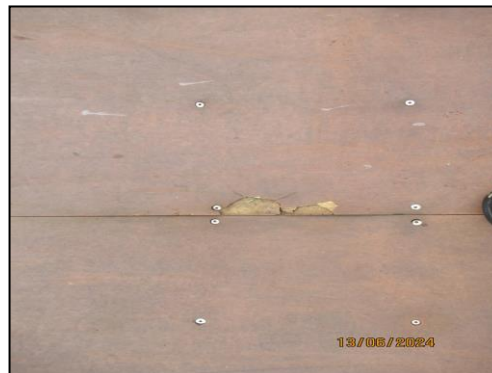
(Damaged liner on half pipe combi unit)

Repair/replace one damaged liner on half pipe combi unit

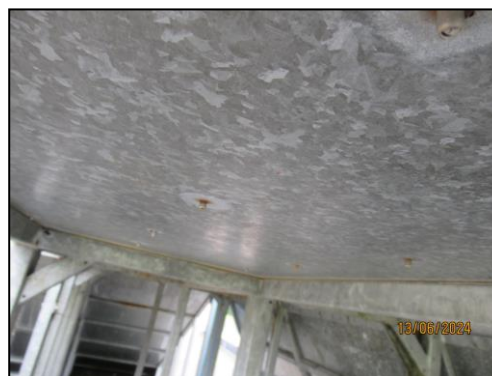
Compliance: BS EN 14974, Sec. 6.1.7, rivets protruding beneath platforms & ramps at various locations – requires attention

(Protruding rivets)

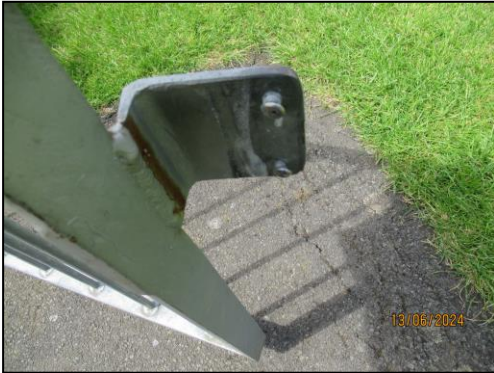
Fence (around items 4-6) c/w one pedestrian gate – potential neck trap between slats. Posts showing signs of rotting – **monitor. Replace missing buffer on gate (Low Risk)**

(Missing buffer at gate to play area)

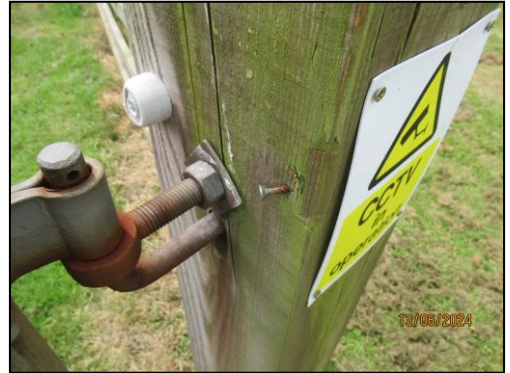
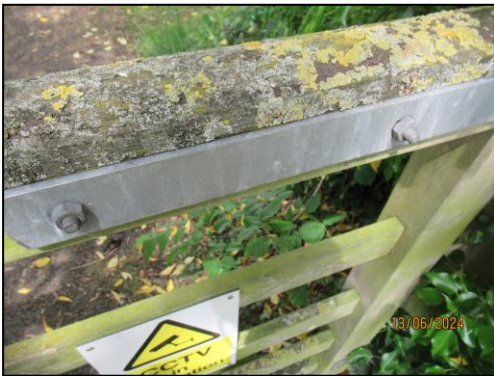
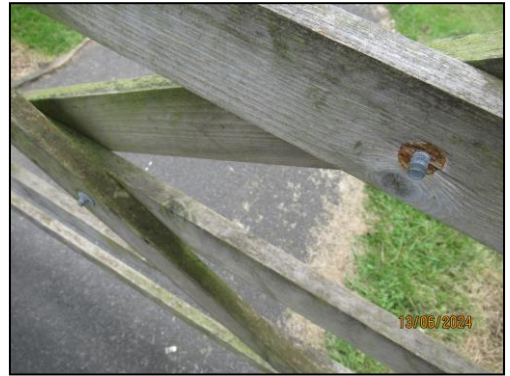
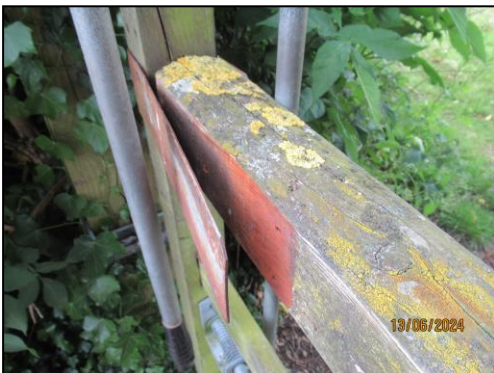
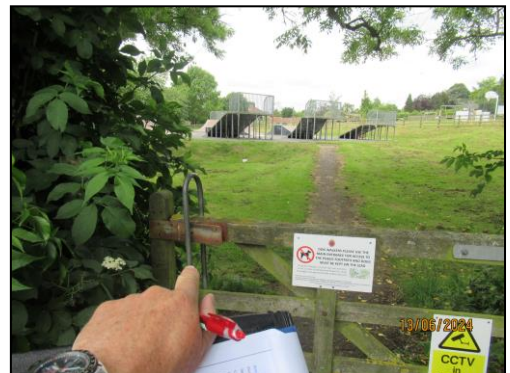
Fence (around skate park) c/w 4 pedestrian gates – potential head trap between top two rails on fence & gates. **Clearance of between 60mm & 110mm should be maintained at bottom of gates. Replace one missing gate stop. Re-set gates (catches missing stoppers at two gates. Resecure one bracket on gate (Low Risk) Remove excess bolt thread. Replace two missing nuts on bolts (Medium Risk)**

(Missing gate stop at gate to play area)

(Excess bolt thread at gate to skate park)

(Missing nut on bolt at gate to skate park)

(Loose bracket at gate to skate park)

(Location of loose bracket at gate to skate park)

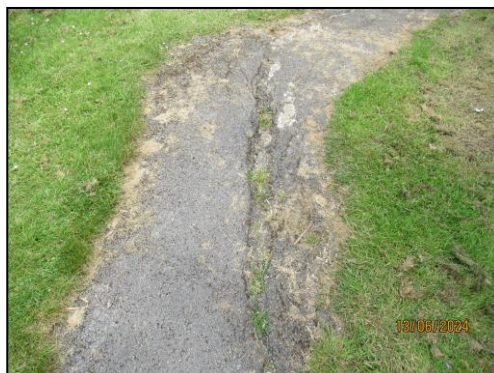
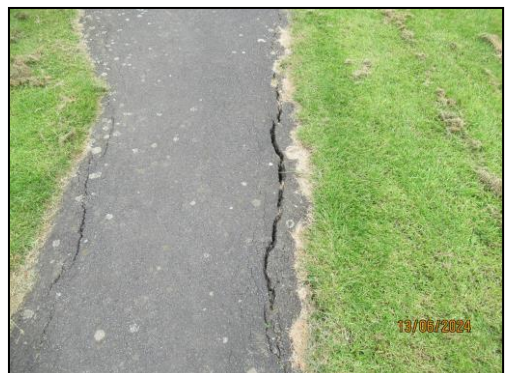
Path – **poor condition – requires attention (Low Risk)**

(Poor condition path)

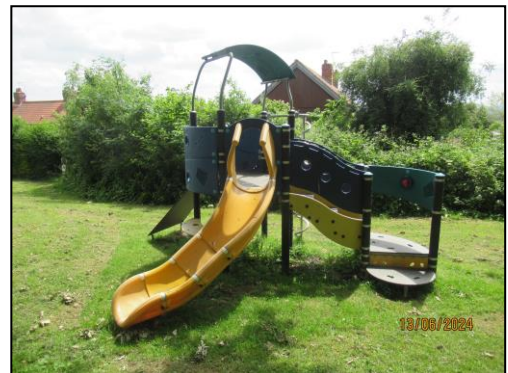
1. Kompan Junior Multi Unit

Condition: Slide requires cleaning due to bird fouling

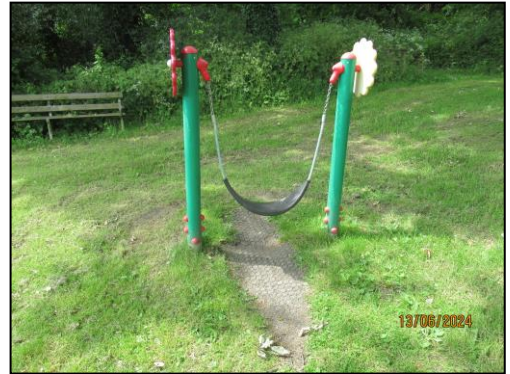
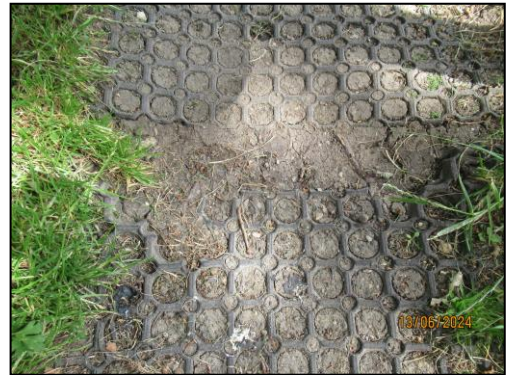
2. Kompan Daisy Swing

(Damaged grass mat)

Surface Condition: Repair/replace one damaged mat

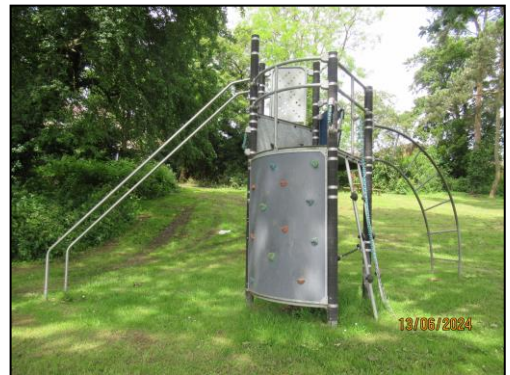
3. Kompan Multi Climbing Frame

Compliance: BS EN 1176-1, Sec. 4.2.7.6, potential finger trap between top of climbing wall & platform

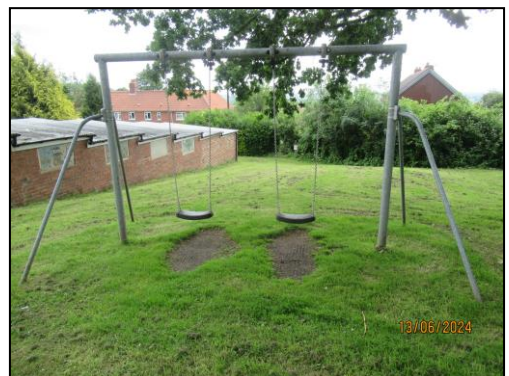
6. Kompan 2.4m 1 Bay Swing with 2 Flat Seats

Surface Condition: Grass worn (this may affect the impact attenuating properties of the mats)

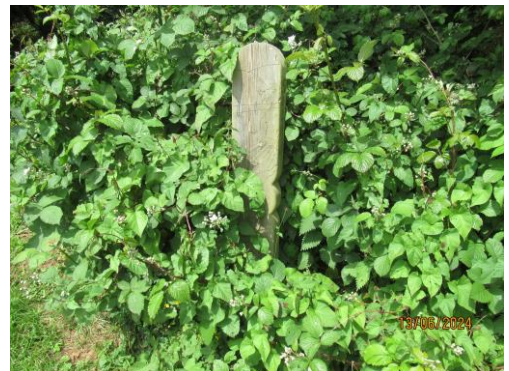
a) Post

Condition: Not ideally positioned beneath tree
Cut back shrubs (Low Risk)

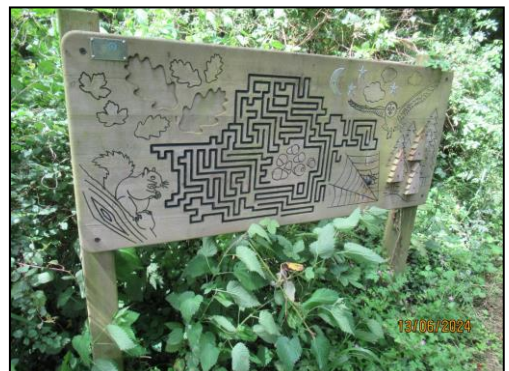
b) Information Panel

Condition: Not ideally positioned beneath tree

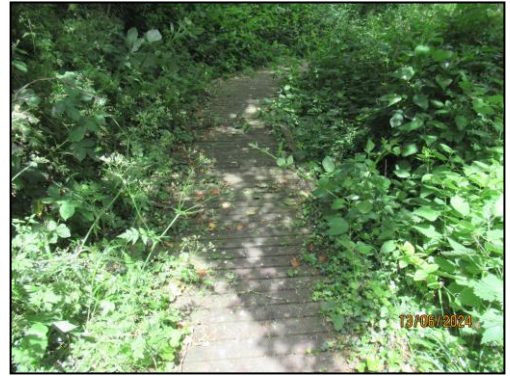
c) Board Walk

Condition: Not ideally positioned beneath tree
Cut back brambles (Low Risk)

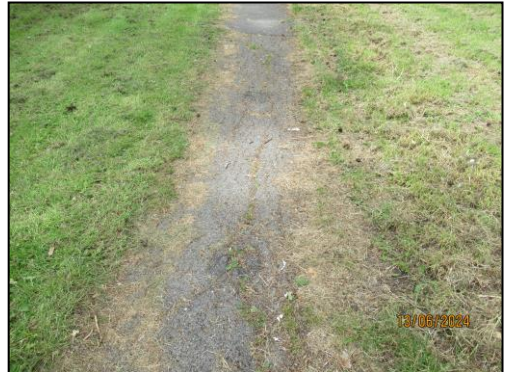
Path – **poor condition (possibly due to tree roots) – requires attention (Low Risk)**

(Poor condition path)
