Annual inspection report

Kirkbymoorside Town Council play areas at

Old Road, Kirkbymoorside, York, YO62 6LT &

Ryedale View, Kirkbymoorside, York, YO62 6EH

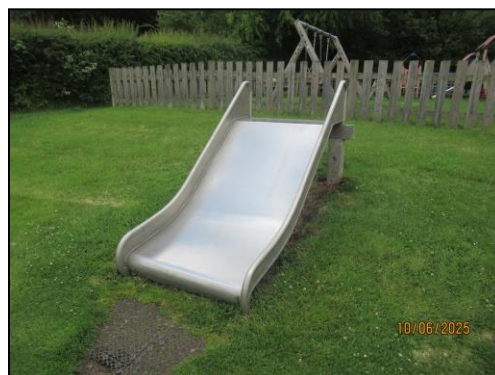
3. Richter Embankment Slide

Condition: Supports showing signs of rotting – monitor

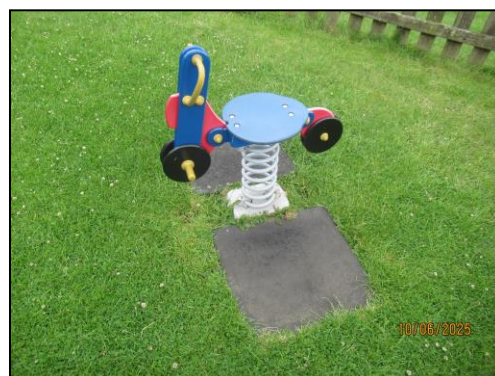
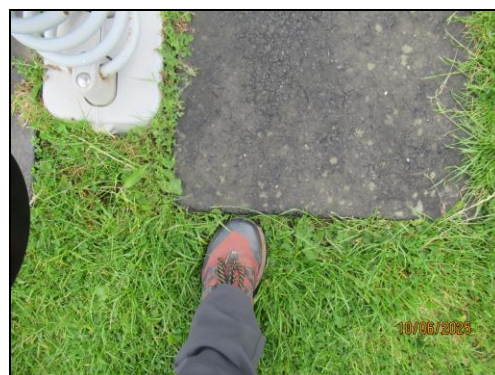
(Potential trip hazards at edges of tiles)

Compliance: BS EN 1176-6, Sec. 4.6, foot rests fail gauge test

Surface Condition: Potential trip hazards at edges of tiles – requires attention (Medium Risk)

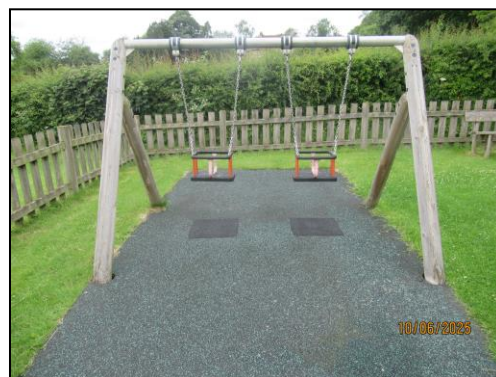
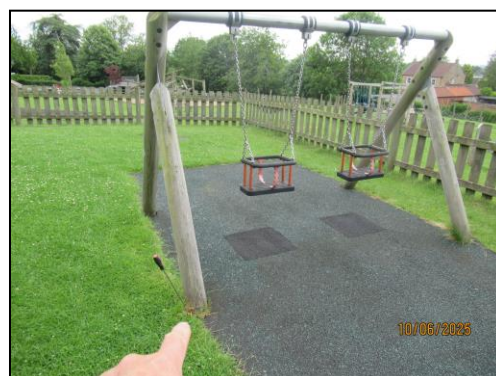
(Location of rotting support)

Condition: One support showing signs of rotting – monitor

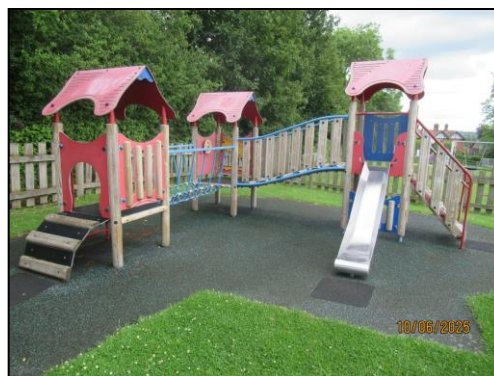
6. Playdale Toddler Multi Unit

Condition: Replace several broken bolt cover caps

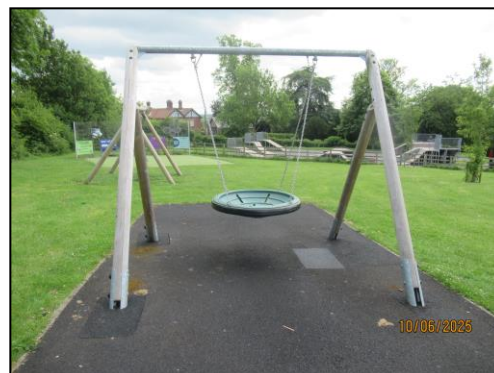
8. Playdale Group Swing

Condition: Replace four missing bolt cover caps beneath seat

Compliance: BS EN 1176-1, Sec. 4.2.5, excess bolt thread present at missing bolt cover caps beneath seat

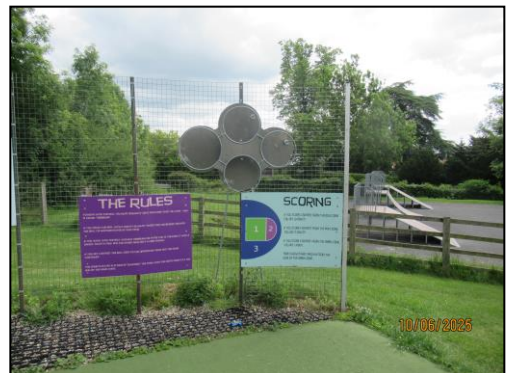
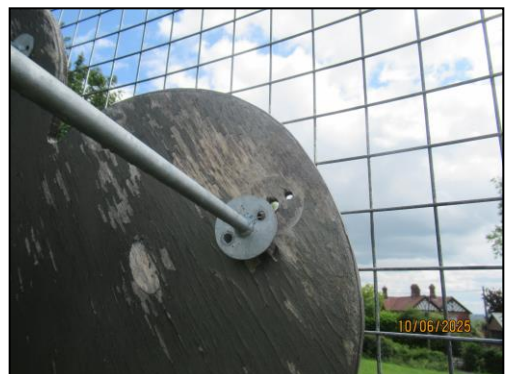
(Missing bolts on back board)

Condition: Replace six missing bolts on back board

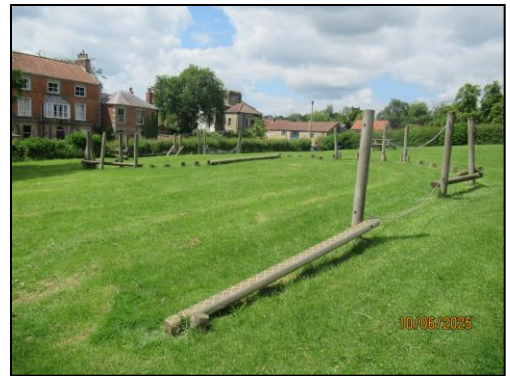
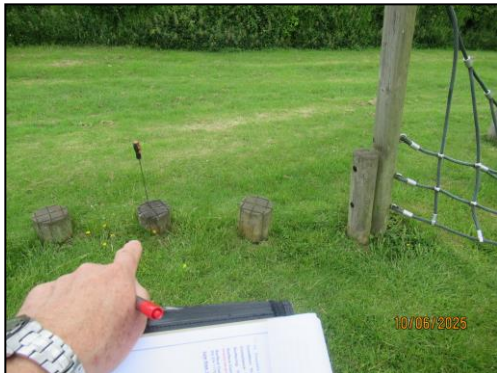
(Rotten step post)

Condition: Replace one rotten step post

Comments: Given age of items suspect rotten supports will occur on future annual inspections – consideration should be given to replacing whole trim trail

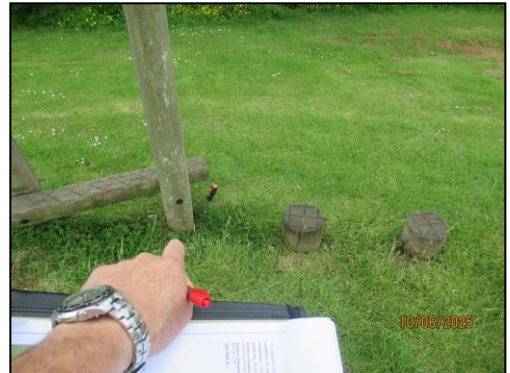
(Rotten post on weave beam)

Replace one rotten post on weave beam

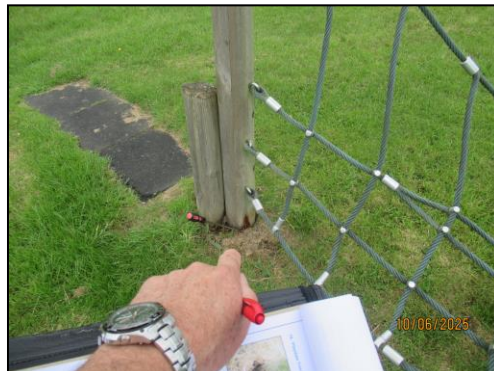
(Location of rotten post on net climber)

Replace one rotten post on net climber

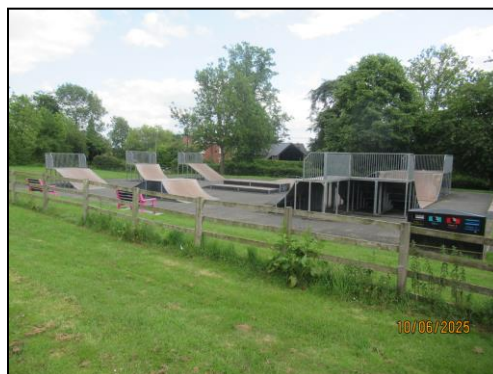
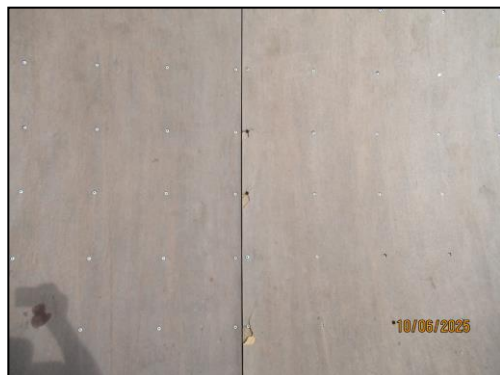
(Loose liner on driveway)

Slight damage to one liner on driveway – monitor

Compliance: BS EN 14974, Sec. 6.1.7, rivets protruding beneath platforms & ramps at various locations – requires attention

Resecure one liner on driveway

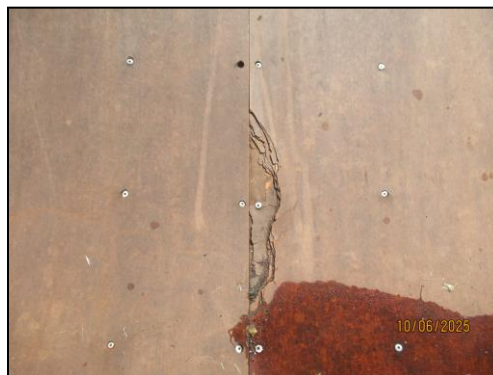
(Damaged liner on half pipe combi unit)

Condition: Slight damage to three liners on half pipe combi unit – monitor

Repair/replace one damaged liner on half pipe combi unit

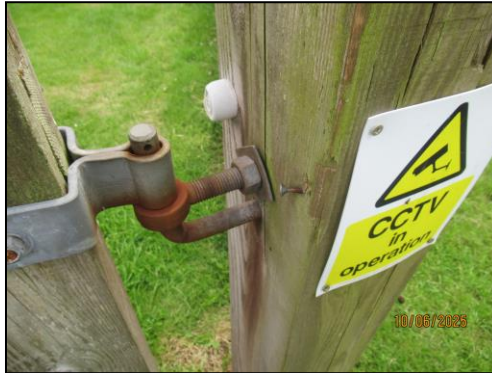
(Missing gate stop at gate to play area)

Fence (around skate park) c/w 4 pedestrian gates – potential head trap between top two rails on fence & gates. **Clearance of between 60mm & 110mm should be maintained at bottom of gates. Replace one missing gate stop. Re-set gates (catches missing stoppers at two gates. (Low Risk) Remove excess bolt thread. Replace two missing nuts on bolts (Medium Risk)**

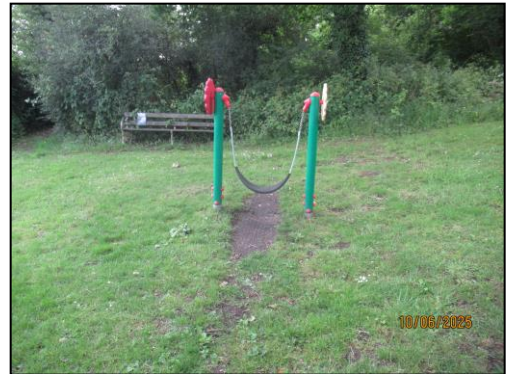
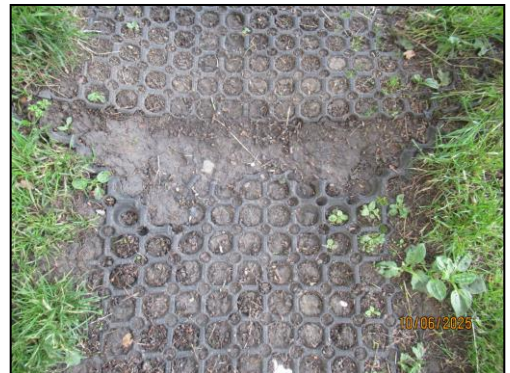
(Damaged grass mat)

Surface Condition: Repair/replace one damaged mat

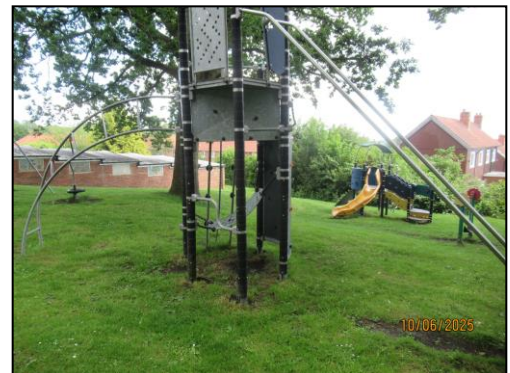
3. Kompan Multi Climbing Frame

Compliance: BS EN 1176-1, Sec. 4.2.7.6, potential finger trap between top of climbing wall & platform

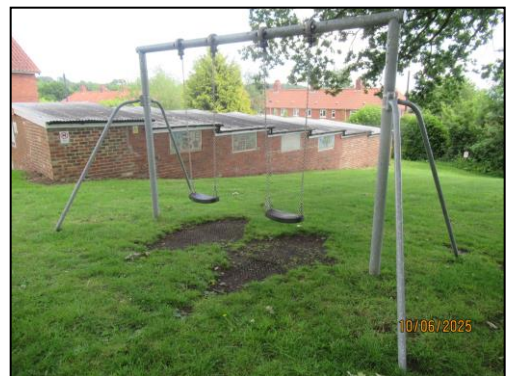
6. Kompan 2.4m 1 Bay Swing with 2 Flat Seats

Surface Condition: Grass worn (this may affect the impact attenuating properties of the mats)

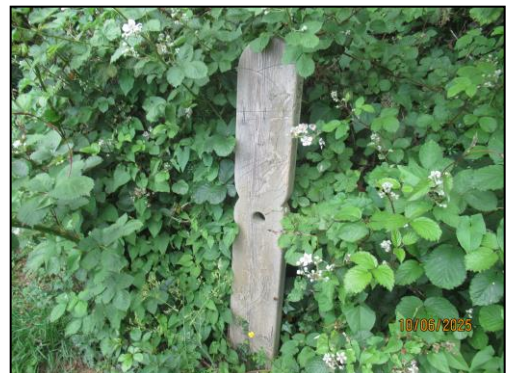
a) Post

Condition: Not ideally positioned beneath tree

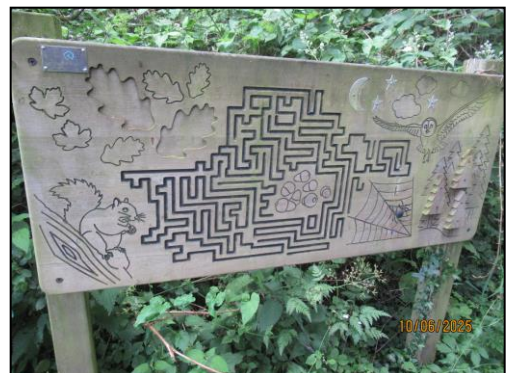
b) Information Panel

Condition: Not ideally positioned beneath tree
