## Inspection Report For:

SOVEREIGN DESIGN PLAY SYSTEMS LIMITED

## Activity Tower

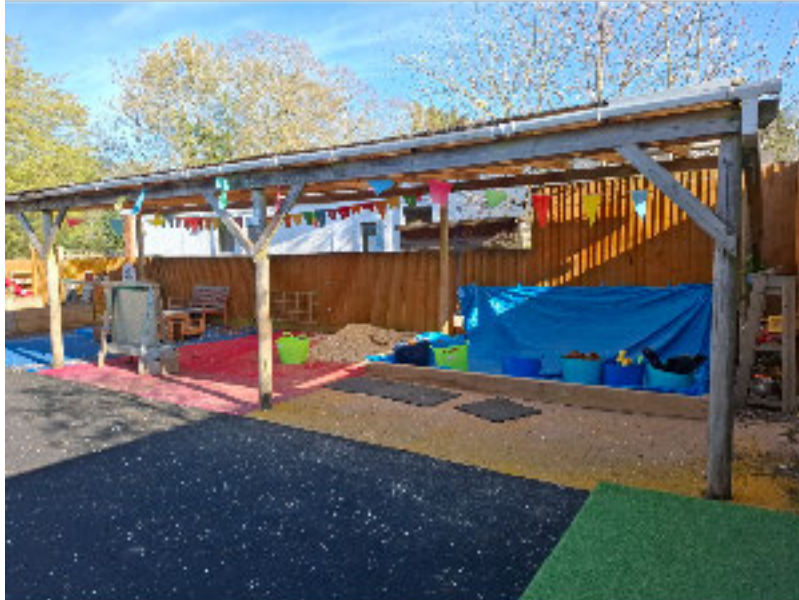
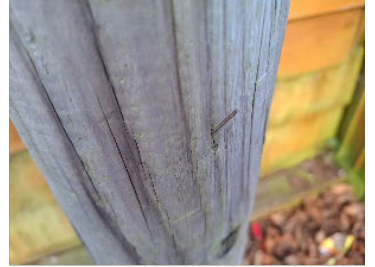
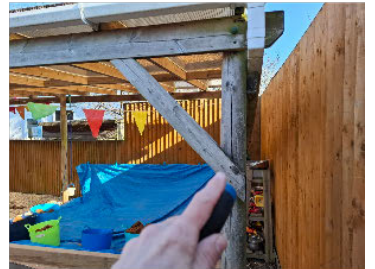
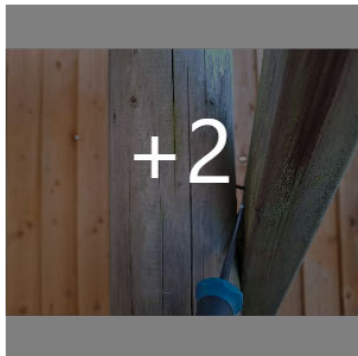
## Shelter

| <b>Finding One:</b> | The item is in moderate overall condition |
| <b>Finding Two:</b> | Staples/unused fixings were found in the timbers |
| <b>Finding Three:</b> | Some of the timbers require replacing due to fatigue. |
| <b>Finding Four:</b> | A timber is showing signs of movement. The fixing is pulling away from the connecting post. |

Guttering is showing signs of algae growth

| <b>Action(s):</b> | Please remove staples unneeded fixings, as these can result in injuries |
| <b>Action(s):</b> | The affected timbers require replacing |
| <b>Action(s):</b> | Recommend adding a new fixing., Recommend the site maintenance team rectify this finding |

Clean and treat appropriately

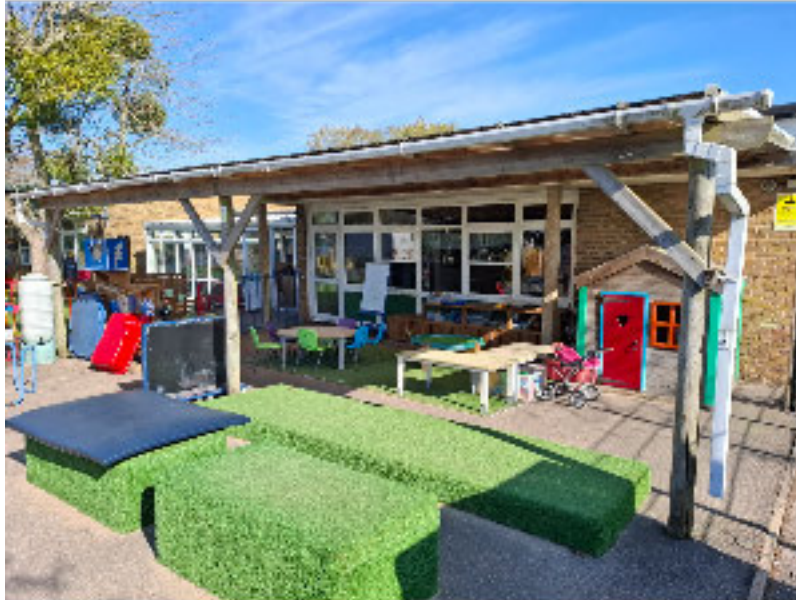
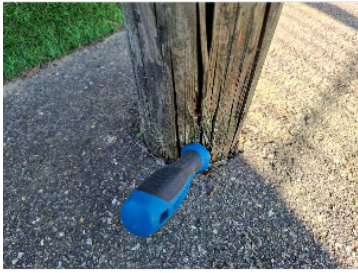
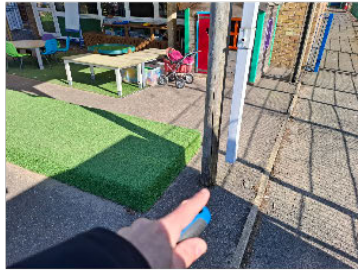
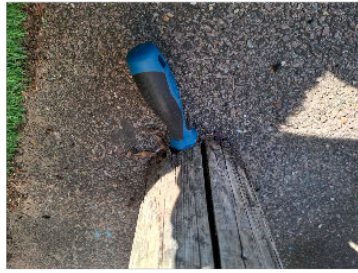
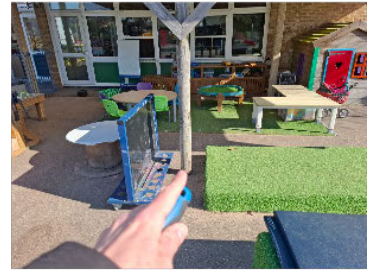
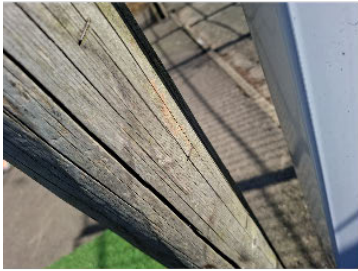
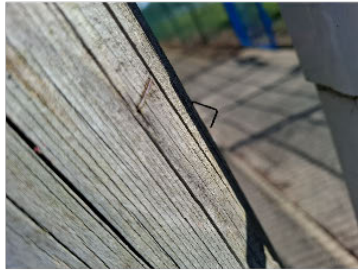
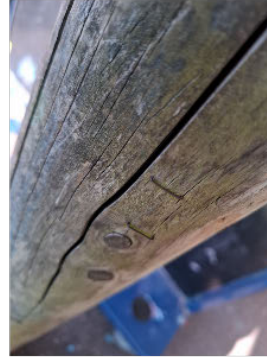
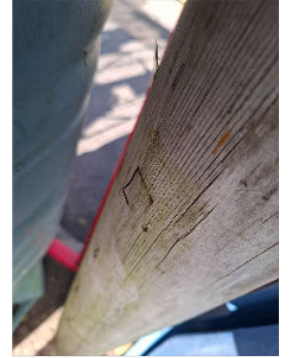
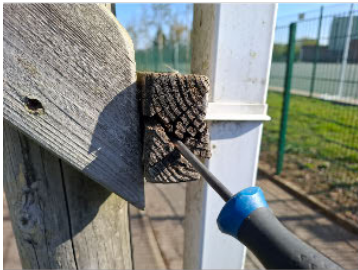
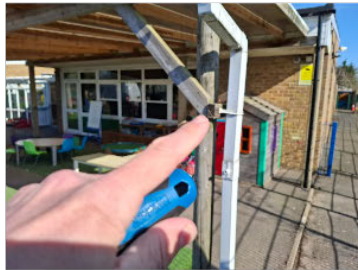
## Shelter

| Finding One: | The item is in moderate overall condition |

| Finding Two: | Some of the timbers require replacing due to fatigue |

| Finding Three: | Staples/unused fixings were found in the timbers. |

| Finding Four: | The timber Infill holding the gutter pipe in place is showing signs of fatigue |

| Action(s): | The affected timbers require replacing |

| Action(s): | Please remove staples unneeded fixings, as these can result in injuries |

| Action(s): | Repair/replace as required |

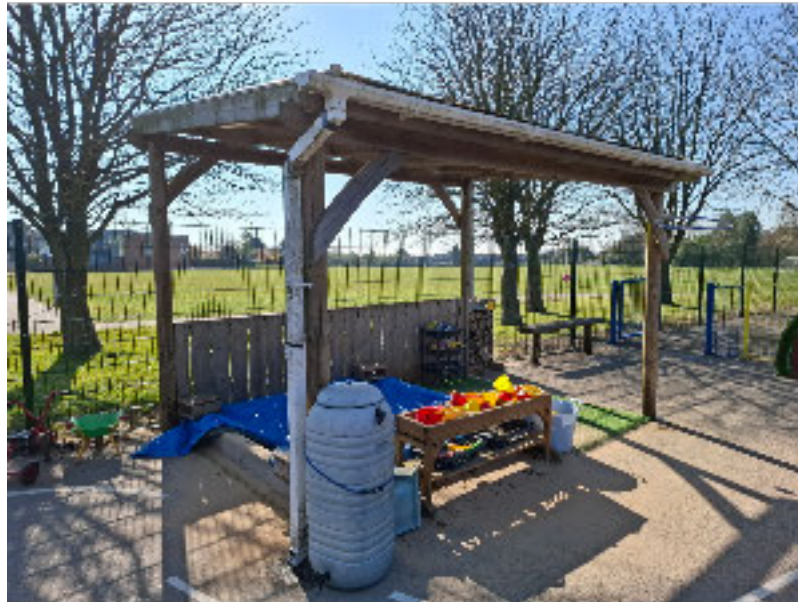
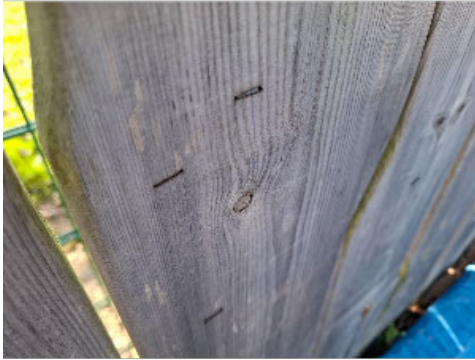
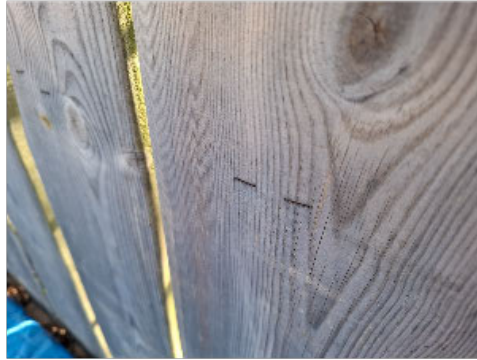
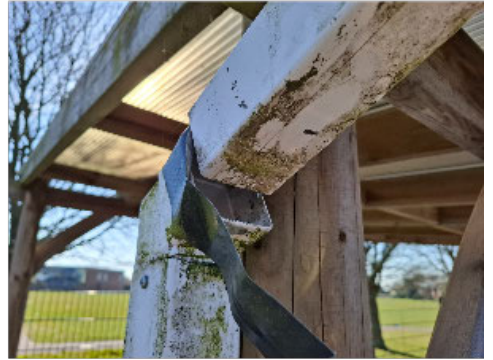
## Shelter

| <b>Finding One:</b> | The item is in moderate overall condition |
| <b>Finding Two:</b> | Staples/unused fixings were found in the timbers |
| <b>Finding Three:</b> | Gutter pipe is taped. |

| <b>Action(s):</b> | Please remove staples unneeded fixings, as these can result in injuries |
| <b>Action(s):</b> | Recommend fixing guttering in place, Recommend the site maintenance team rectify this finding |

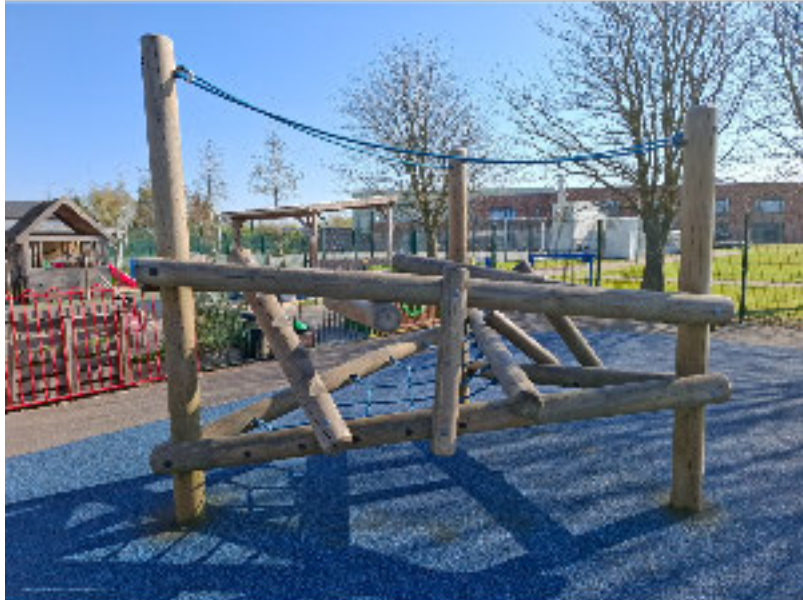
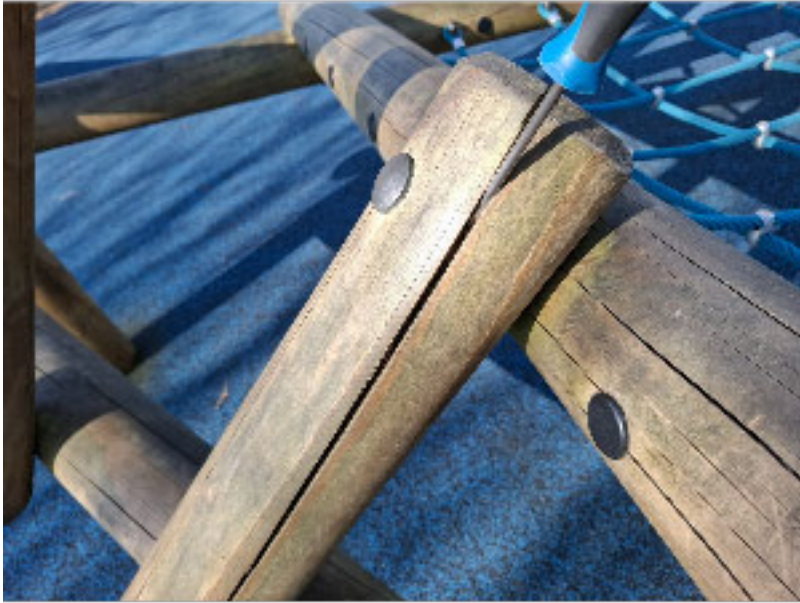
## Log Climber

| <b>Finding Two:</b> | Some of the timbers were showing air cracks (referred to as timber shakes) |

| <b>Action(s):</b> | This is a low risk finding and no remedial action is required at this time - monitor use |

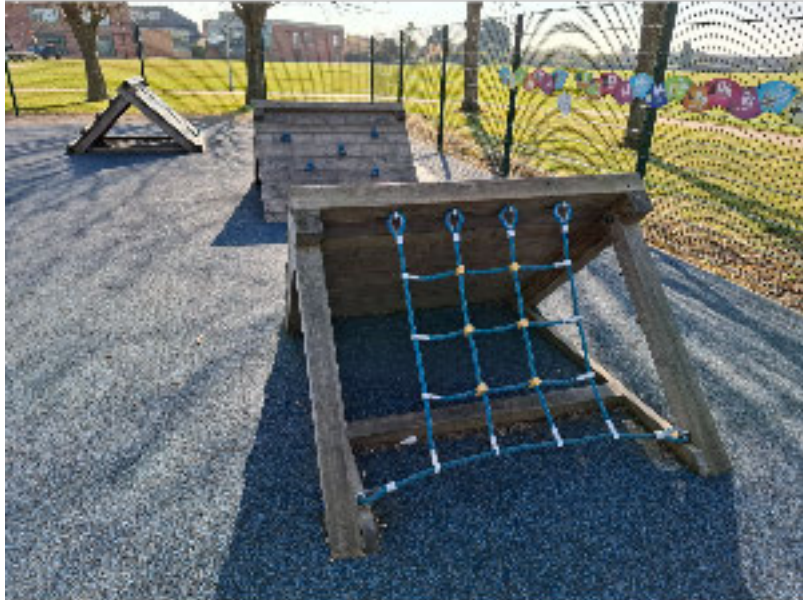
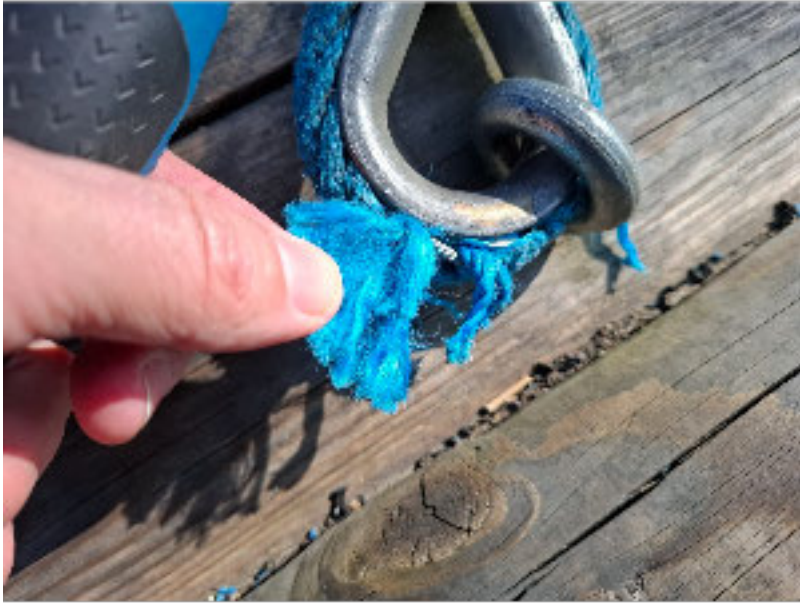
## Scramble Net Climbers

| <b>Finding Two:</b> | The rope was showing signs of wear |

| <b>Action(s):</b> | This is a low risk finding and no remedial action is required at this time - monitor use |

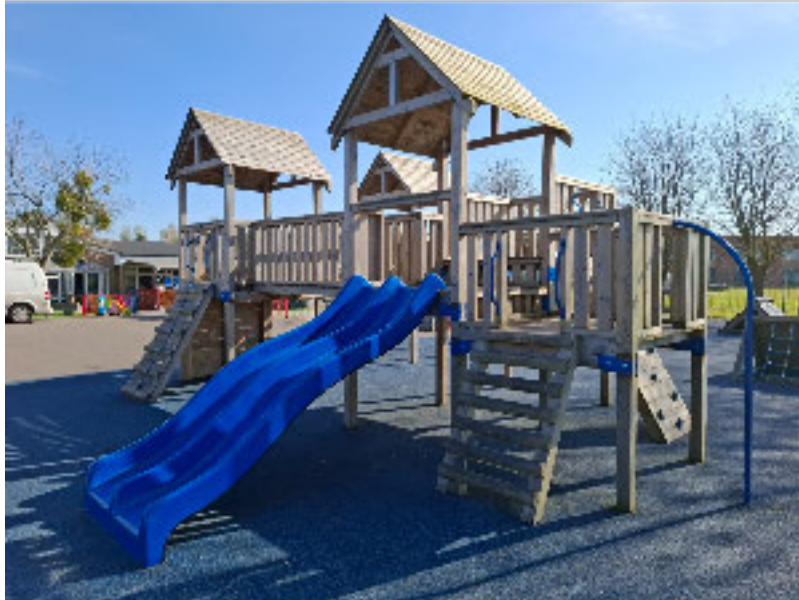
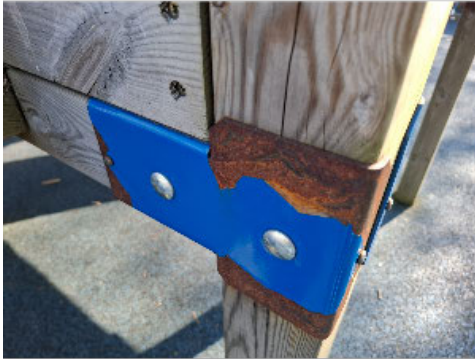
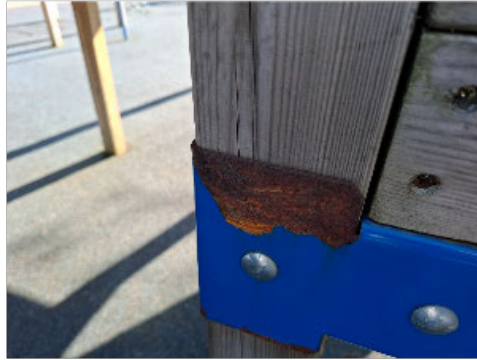
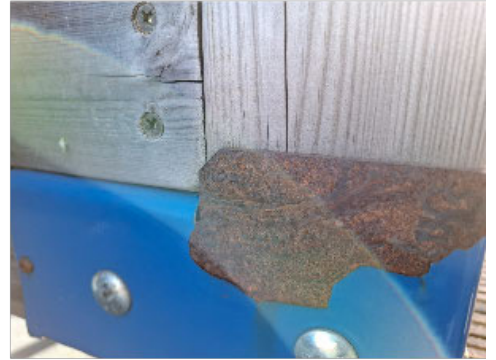
## Activity Tower

| <b>Finding Two:</b> | Paintwork is showing signs of wear and corrosion. |

| <b>Action(s):</b> | This is a low risk finding and no remedial action is required at this time - monitor use |

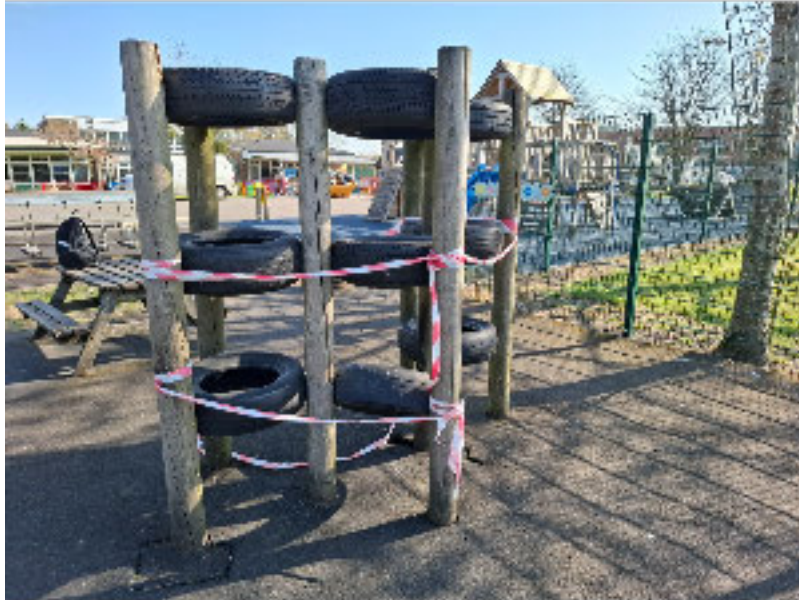
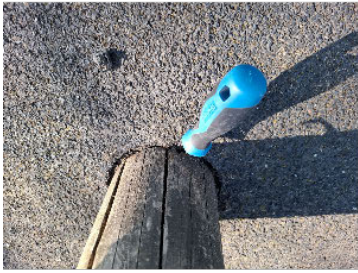
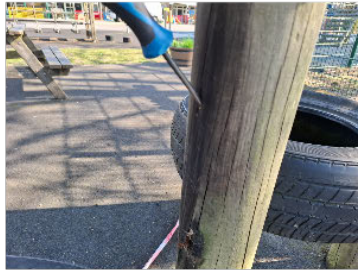
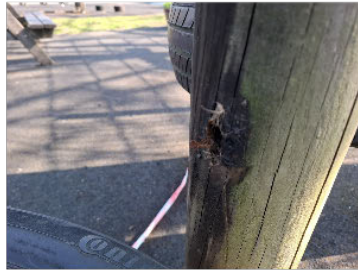
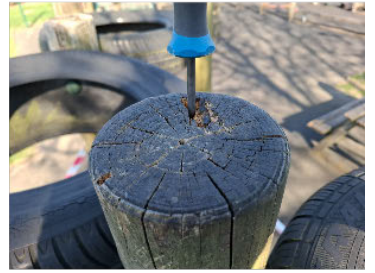
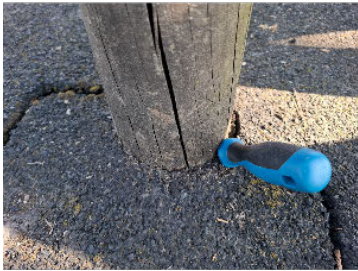
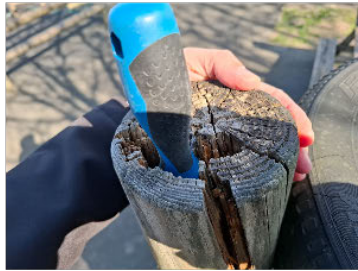
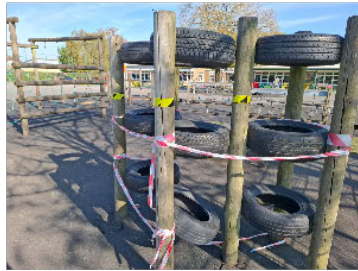
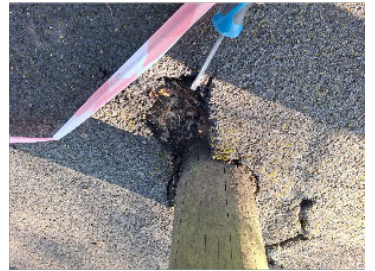
## Tyre Climber

| <b>Finding One:</b> | The item is in moderate overall condition |
| <b>Finding Two:</b> | Some of the timbers require replacing due to fatigue |
| <b>Finding Three:</b> | The surface is showing signs of damage. |

| <b>Action(s):</b> | The affected timbers require replacing |
| <b>Action(s):</b> | Repair/replace as required |

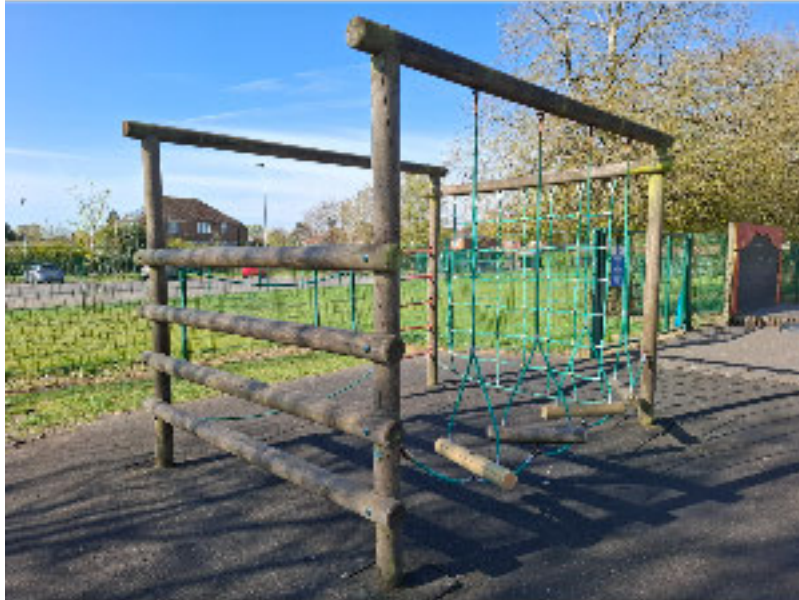
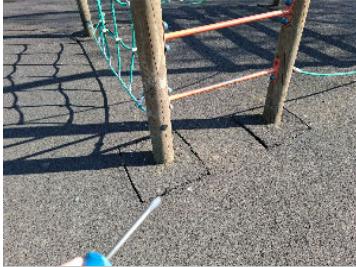
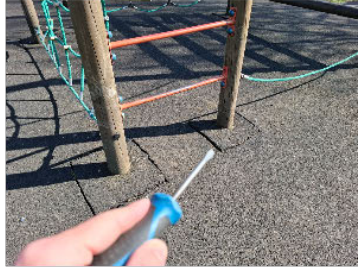
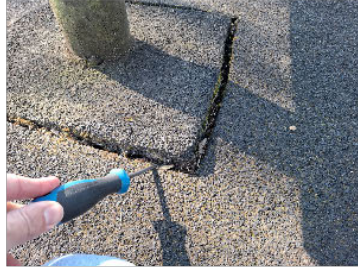
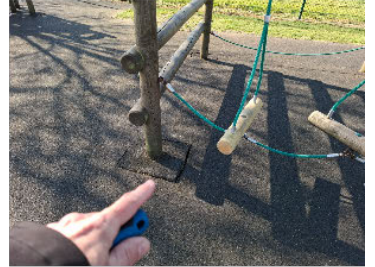
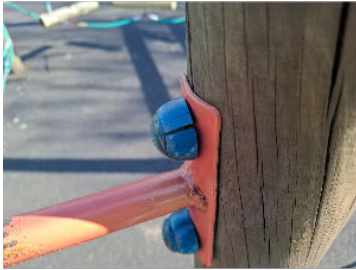
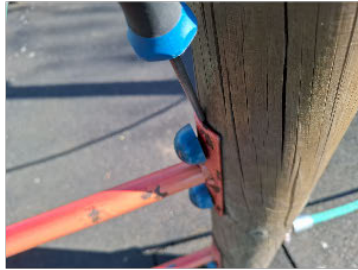
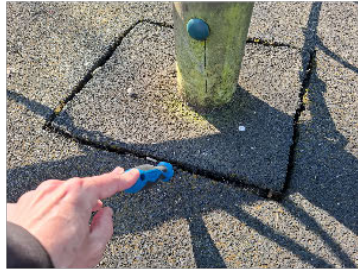
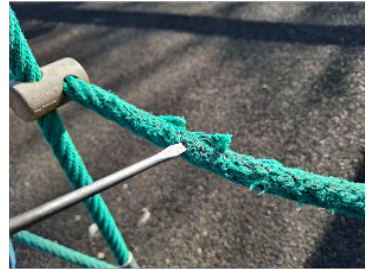
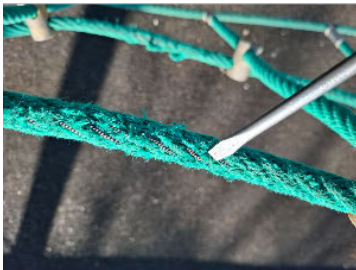
## Activity Frame

| <b>Finding Two:</b> | The overall structure is showing early signs of movement. It is possibly due to the foundations becoming loose in the ground. |

| <b>Finding Three:</b> | The rope is showing signs of wear |

| <b>Finding Four:</b> | The equipment is showing signs of loose fixings. |

There are gaps opening between the surfacing and the edging surround or between the joints in the surfacing.

| <b>Action(s):</b> | Monitor use |

| <b>Action(s):</b> | Recommend the site maintenance team rectify this finding |

Monitor for any further deterioration and repair as required

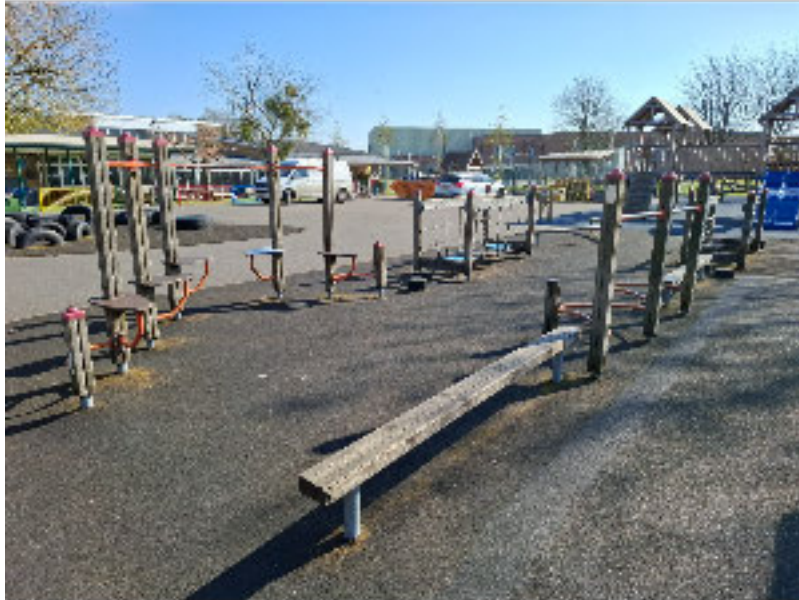
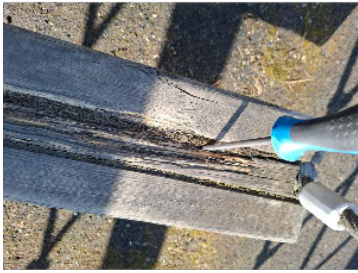
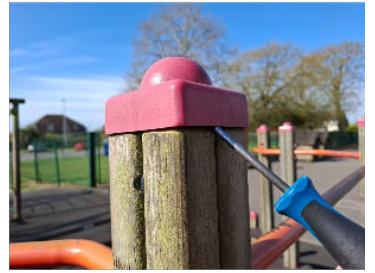
## Activity Trail

| <b>Finding Two:</b> | Some of the timbers were showing early signs of fatigue |

| <b>Finding Three:</b> | Plastic post caps are showing signs of movement. |

| <b>Action(s):</b> | This is a low risk finding and no remedial action is required at this time - monitor use |

| <b>Action(s):</b> | This is a low risk finding and no remedial action is required at this time - monitor use |

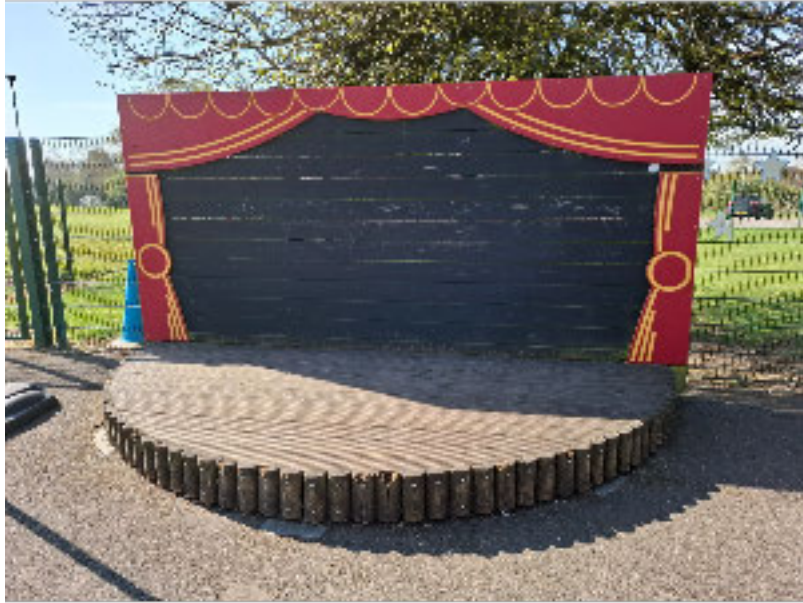
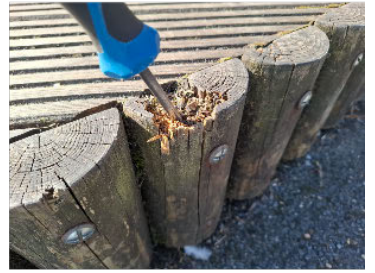
## Stage Area

| <b>Finding Two:</b> | Some of the timbers require replacing due to fatigue |

| <b>Action(s):</b> | The affected timbers require replacing |

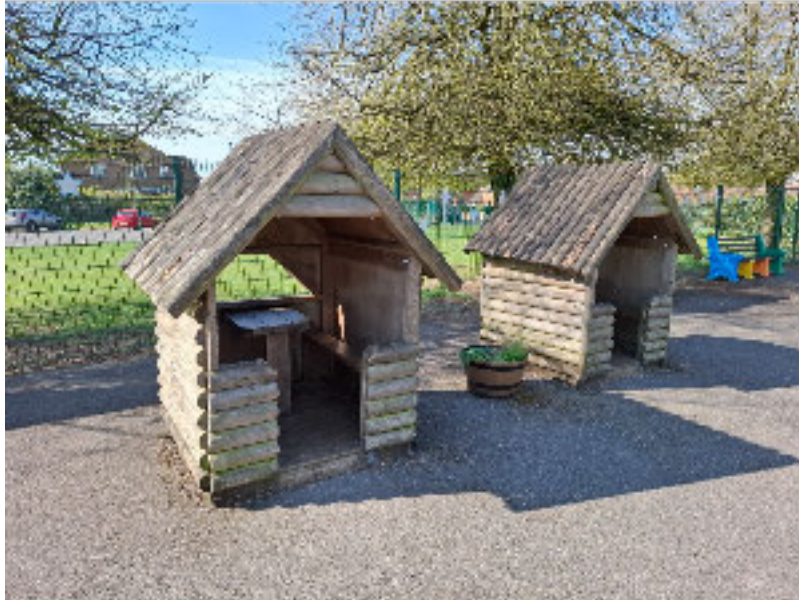
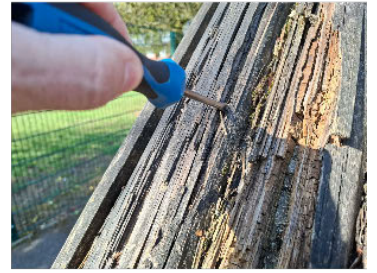
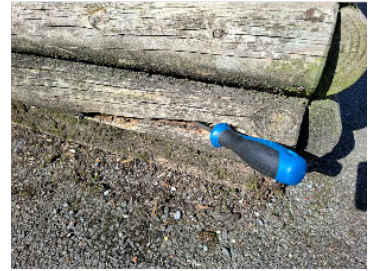
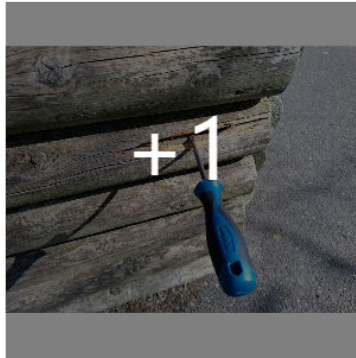
## Play Huts

| <b>Finding One:</b> | The item is in poor overall condition |

| <b>Finding Two:</b> | Some of the timbers require replacing due to fatigue |

| <b>Action(s):</b> | Due to the age and deterioration of the equipment it would be uneconomical to repair., Recommend start planning for replacement equipment |

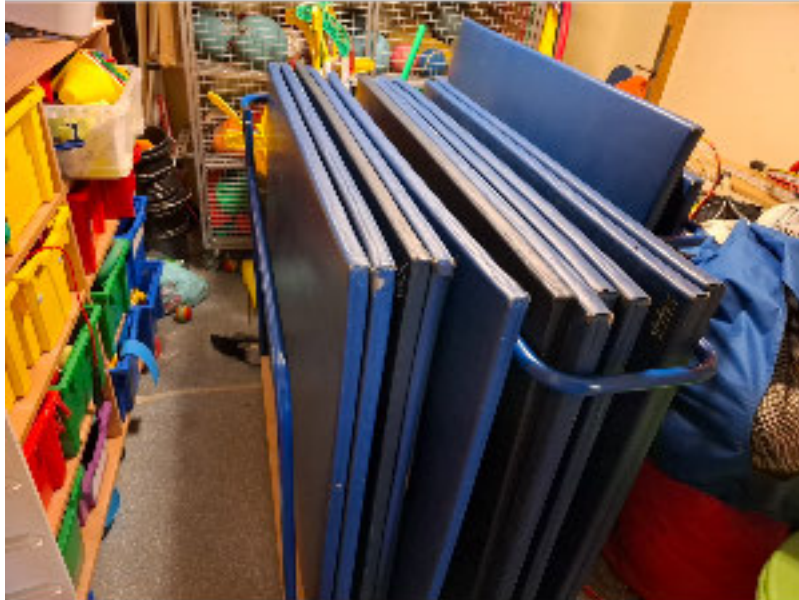
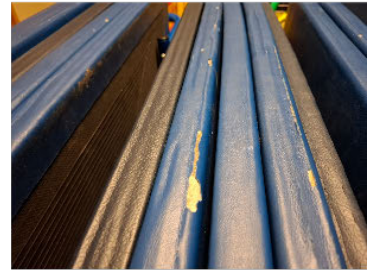
## Gym Mats

| <b>Finding Two:</b> | Some mats are showing signs of wear to corners and edges |

| <b>Action(s):</b> | This is a low risk finding and no remedial action is required at this time - monitor use |
