# Tree Safety Report

Public Spaces under care of Kirkbymoorside Town Council

Date: 07/04/2026

Manor Vale Woodland  
Ryedale View Play Area  
Old Road Play Area  
Kirkbymoorside Sports Field

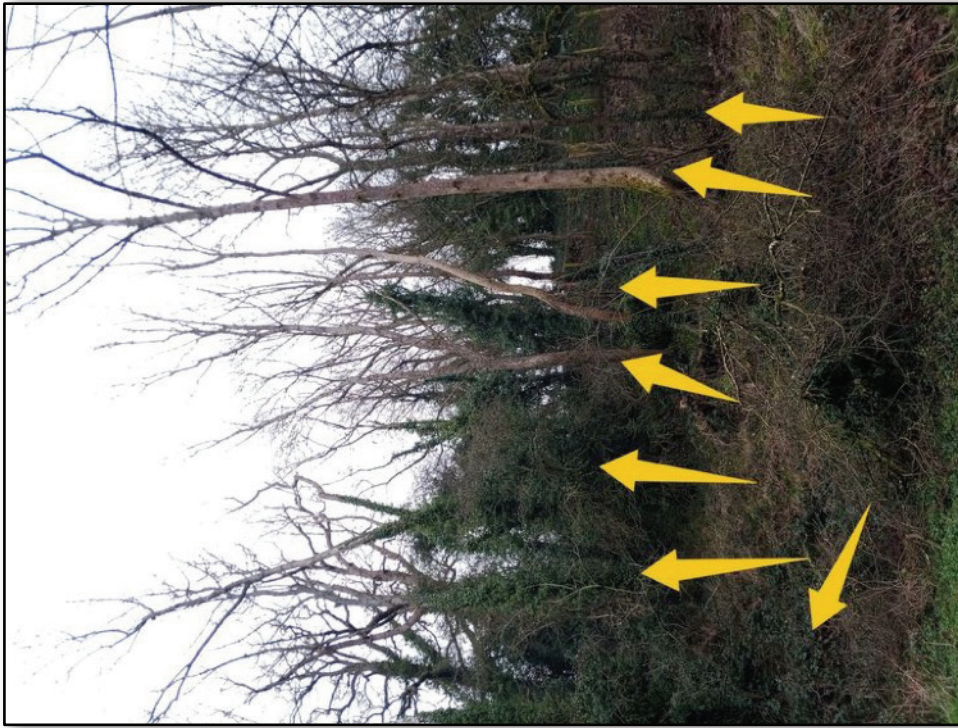
**Manor Vale - 1 - G038**

Ref.	What 3 Words	Species	Description	Measurements	QTRA	Physio' Condition	Structural Condition	Overall Condition	Public Amenity Value	Wildlife Value	Survey Notes	Recommendations
G048	/// looms.st ooping. explain	Common ash x7 (Fraxinus excelsior)	All mature Ash on bank above road and footpath. From path to bank top	Height (m): 18 DBH (cm): 50 Trees: 7 Life Stage: Mature Life Exp.: <10 years	QTRA T4 S2 PoF1 RoH 1/10k	Poor	Physical Defect	Poor			All ash in poor condition and subject to ADB. Several other Ash stems in vicinity have failed at root plate, altering exposure and presenting a pattern elevating the potential of failure. Understory damaged from recent tree failures with several sections remaining on woodland floor.	Fell trees. Consider woodland management Timescale: 27- Aug-2026 (6 Months)

*Stems in group to be removed*

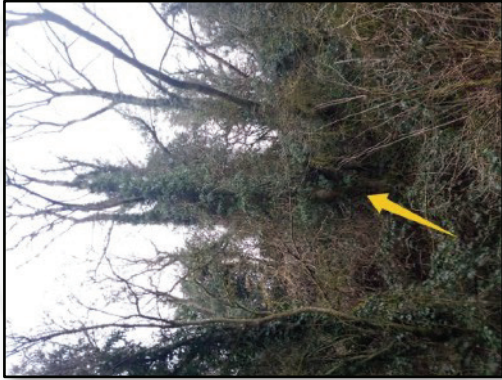
**Manor Vale - 2 - T011**

Ref.	What 3 Words	Species	Description	Measurements	QTRA	Physio' Condition	Structural Condition	Overall Condition	Public Amenity Value	Wildlife Value	Survey Notes	Recommendations
T011	/// fits.bibs. mason	Common ash (Fraxinus excelsior)	Ivy clad. Slight lean SE. Hawthorn undergrowth.	Height (m): 17 Crown Radius (m): 3 DBH (cm): 45 Life Stage: Dead Life Exp.: <10 years	QTRA T3 S2 PoF2 RoH 1/10k	Poor	Fair	Poor	Low	Low	Severe ash dieback. Little canopy left. Becoming dual stemmed at 6m.  Pests and Diseases: Ash Dieback Infection Level 4: 75% to 100%	Fell tree. Timescale: 26-Feb-2027 (1 Year)
T013	/// flasks.p aradise. chuggin g	Common ash (Fraxinus excelsior)	Small roadside tree S near passing place. Near start of path	Height (m): 12 Crown Radius (m): 2 DBH (cm): 25 Life Stage: Semi Mature Life Exp.: 10+ Years	Medium	Poor	Fair	Poor	Low	Low	Some weakening of canopy. Tree has declined since previous survey. Has leaning neighbouring stem hung up in canopy.  Pests and Diseases: Ash Dieback Infection Level 2: 25% to 50%	Fell tree Timescale: 26-Aug-2026 (6 Months)

*Ivy clad stem slated for removal*

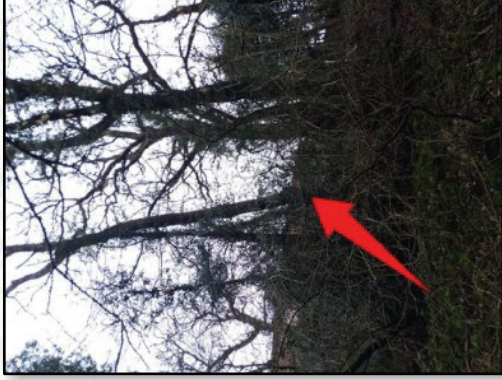
**Manor Vale - 3 - T030**

T030	/// songbo ok.rathe r.beelin e	Common ash (Fraxinus excelsior)		Height (m): 16 Crown Radius (m): 2.5 DBH (cm): 40 Life Stage: Mature Life Exp.: <10 years		Poor	Fair	Poor	Moderate	Low	Growing 2m away from larger healthy Ash. Holly understory. Tips completely dead. Minimal canopy remaining. Mainly epicormic on scaffold branches. Slight lean SE to path.  Pests and Diseases: Ash Dieback Infection Level 4: 75% to 100%	Fell tree. Timescale: 26- Feb-2027 (1 Year)
T032	/// referenc e.provid e.intro	Common ash (Fraxinus excelsior)		Height (m): 15 Crown Radius (m): 3 DBH (cm): 40 Life Stage: Mature Life Exp.: <10 years		Poor	Fair	Poor	Moderate	Low	Severely ivy clad. Tips completely dead. Minimal canopy remaining. Mainly epicormic on scaffold branches. Slight lean SE to path. One main limb growing E over footpath.  Pests and Diseases: Ash Dieback Infection Level 4: 75% to 100%	Fell tree. Timescale: 26- Feb-2027 (1 Year)

*Red line showing stem to be removed*

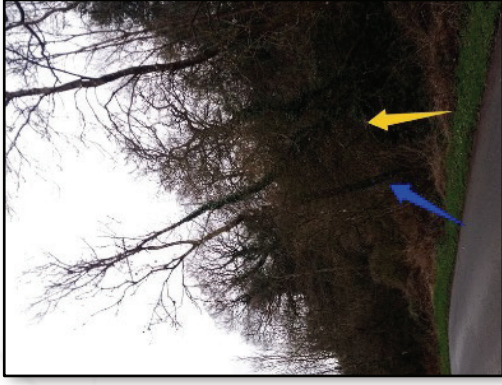
**Manor Vale - 4 - T013 & T041**

T041	/// trim.div oring.st arts	Common ash (Fraxinus excelsior)	Leaning tree set back from road	Height (m): 10 Crown Radius (m): 1 DBH (cm): 25 Life Stage: Semi Mature Life Exp.: <10 years	None	Poor	Poor	Poor	Low	Low	Poor condition. Strong lean hung up in neighbouring roadside tree also delayed for removal  Pests and Diseases: Ash Dieback Infection Level 3: 50% to 75%	Fell tree. Timescale: 26- Feb-2027 (1 Year)
T044	/// lasts.un signed.c oaching	Pedunculate oak (Quercus robur)	Tree above path on bank side.	Height (m): 7 Crown Radius (m): 5 DBH (cm): 50 Life Stage: Mature Life Exp.: 20+ Years	QTRA T4 S1 POF1 RoH 1/4k	Fair	Poor	Fair	Good	Moderate	Severe lean over path, in contact with neighbouring tree acting as slight protection from target. Failed at root plate with potential to impact neighbouring trees. Part of multi stemmed, group of the stems, middle one has failed previously. Large bulging reactionary growth and buttressing due to cliff location	Fell tree. Timescale: 27- Feb-2026 (Urgent)

*Blue line is T013, and yellow line is T041 showing proximity to road.*

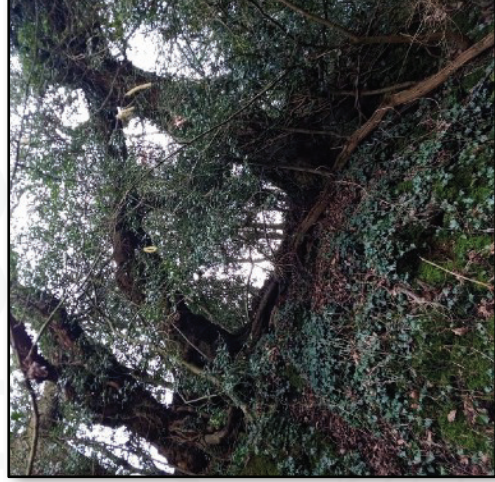
**Manor Vale - 5 - T044**

3.4. One tree was assessed as being high risk and therefore works are required with a high level of urgency. Identified as T044, a pedunculate oak above a footpath in Manor Vale Woodland. The tree is a large specimen currently failed at its root plate and resting on the top of the bank. This should be attended to by a contractor as soon as practicably possible.

*Showing stems photographed from lower down the bank*

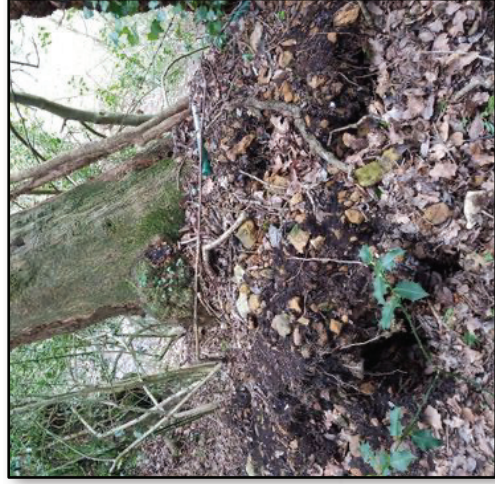
**Manor Vale - 6 - T044**

*Root plate with failure point including exposed roots.*
