Operational Inspection

Kirbymoorside Town Council

Old Road Play Area Junction of Old Road and , Swineherd Lane, Kirbymoorside, North Yorkshire, YO62 6LP

Operational Inspection - 2-October-2019 - 15:06 Inspector Joshua Frost Lunn

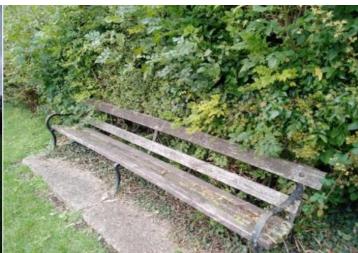
Finding: Hedge and tree canopy encroaching on various items of equipment around the play area

Action: Cut back

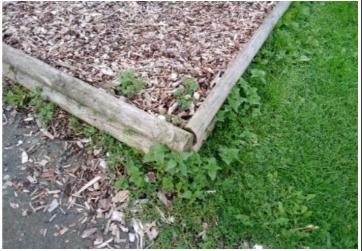
Finding: Fungal and metal growth to certain areas around Action: Remove and treat ground play area

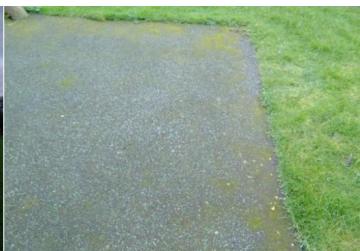
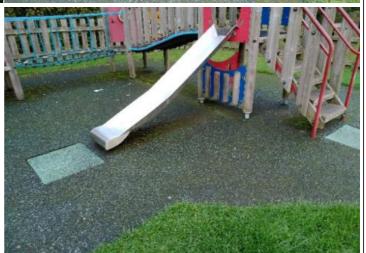
Finding: Moss and algae growth to various areas of wetpour making this slippery

Action: Clean and treat

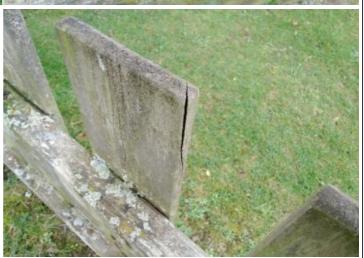
Finding: Splits to some slats

Action: Monitor

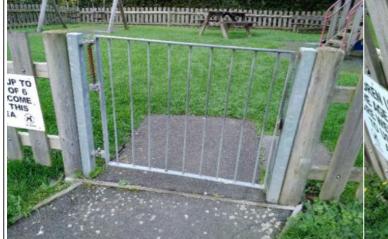
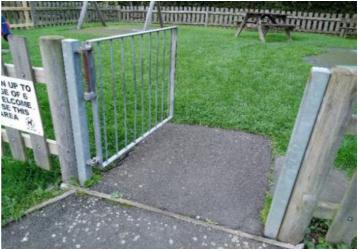
Finding: Gate sticking open

Action: Fit new mechanism as this is badly worn

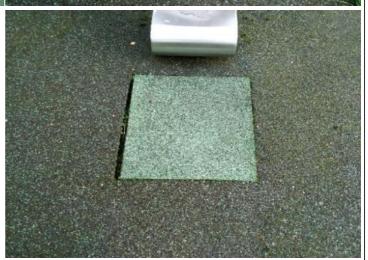
Finding: 2 x wetpour coloured tiles are shrinking away from Action: Cut back entire section and infill - 0.75m x 0.75m main wetpour base and pulling up

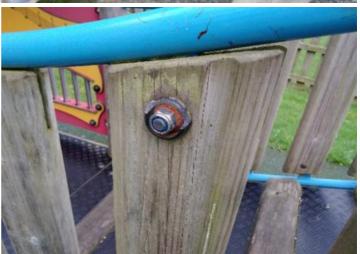
Finding: Caps and bases missing/damaged

Action: Replace x 5

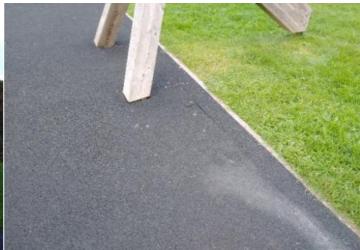
Finding: Wetpour sinking and splitting to lower area of legs Action: Cut back, lay new hardcore and infill - 2m x 1m

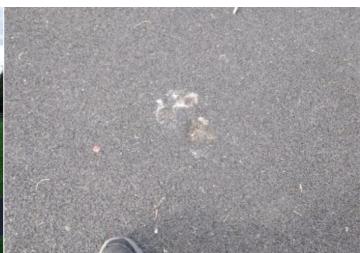
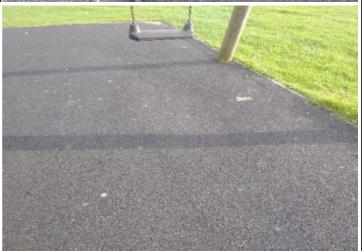
Finding: Wetpour slightly damaged and pushed down under Action: Monitor

one seat

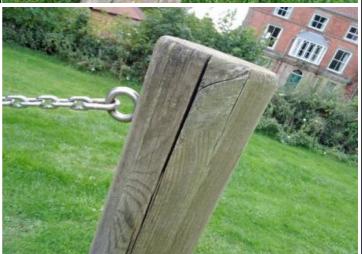
Finding: Cracks to wobble log and several posts

Action: Monitor

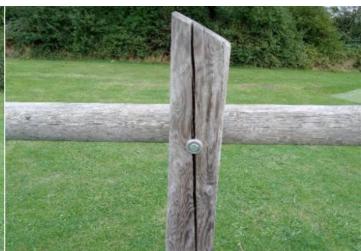
Finding: Split to timber post Action: Monitor

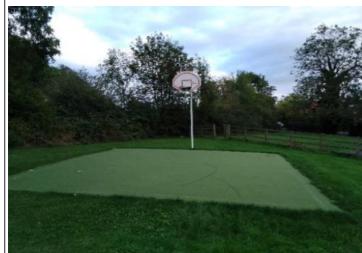
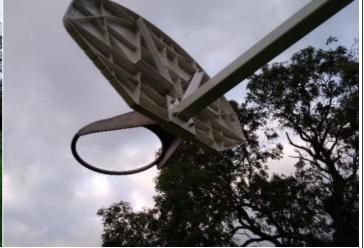
Finding: Excess bolt threads Action: Deburn

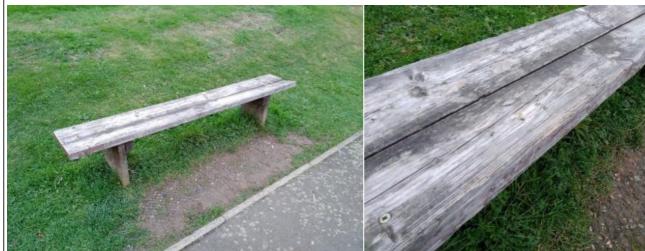
Finding: Slats worn Action: Monitor

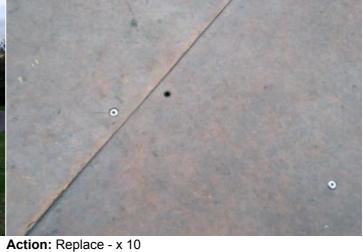
Finding: Several rivets missing Action:
