Annual inspection report

Kirkbymoorside Town Council play areas at

Old Road, Kirkbymoorside, York, YO62 6LT &

Ryedale View, Kirkbymoorside, York, YO62 6EH

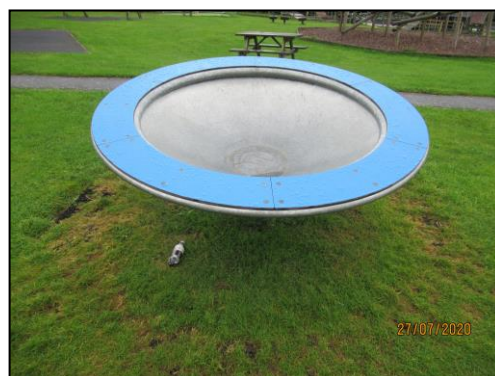
### 1. Sutcliffe Large Spinning Bowl

**Condition:** No defects were found

**Compliance:** Complies with BS EN 1176

**Low Risk: 4**

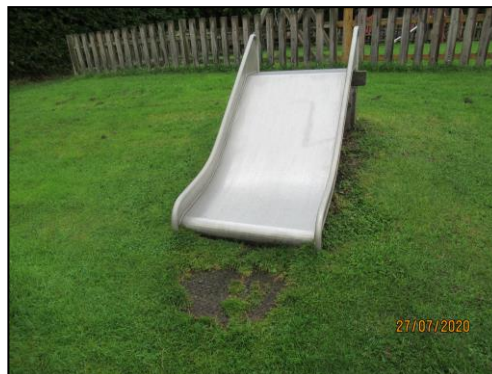
### 2. Richter Embankment Slide

**Condition:** No defects were found

**Compliance:** Complies with BS EN 1176

**Very Low Risk: 2**

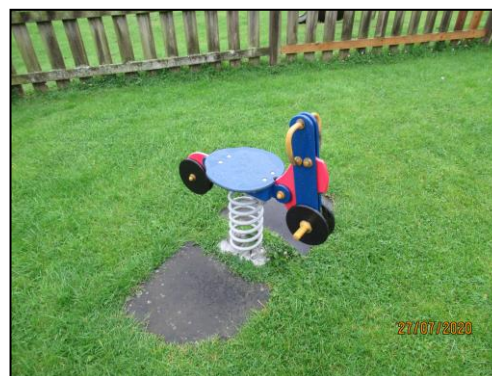
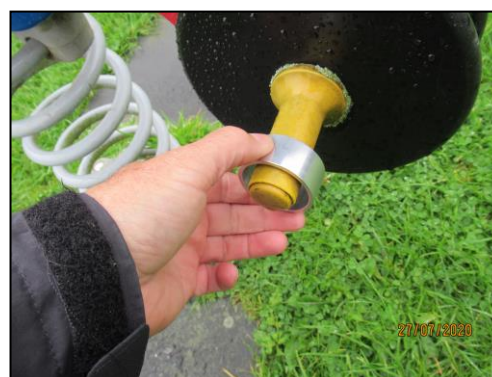
### 3. Ledon Spring Bike

**Compliance:** Fails BS EN 1176-6, Sec. 4.6, foot rests fail gauge test

**Very Low Risk: 3**

(Footrests fail gauge test)

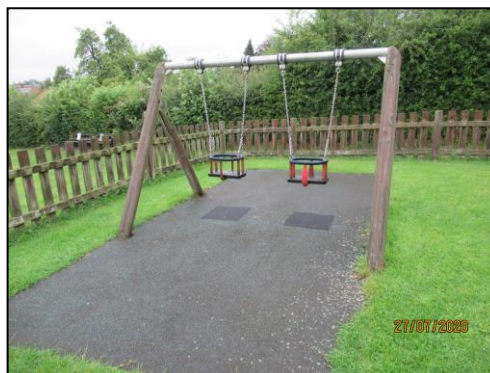
### 4. Playdale 1.75m 1 Bay Swing with 2 Cradle Seats

**Condition:** No defects were found

**Very Low Risk: 2**

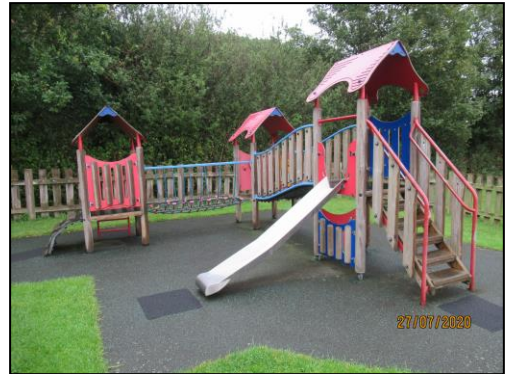
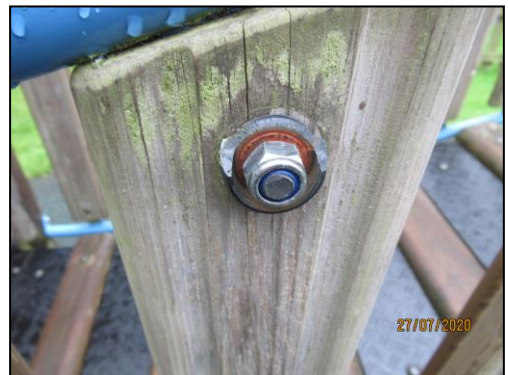
### 5. Playdale Toddler Multi Unit

**Low Risk: 4**

(Broken bolt cover cap)

**Condition:** Replace three broken bolt cover caps

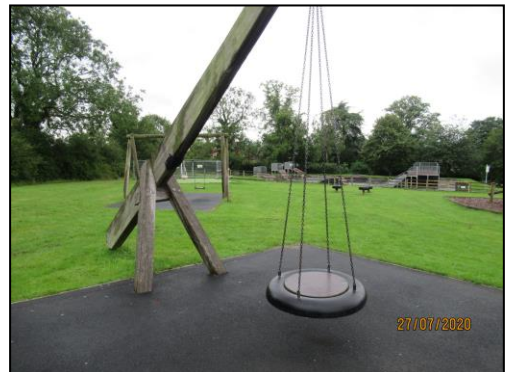
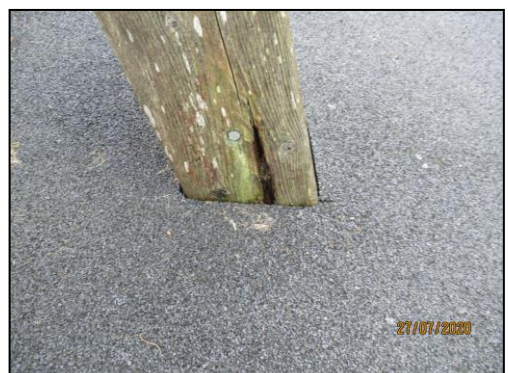
### 6. Richter Cantilever Swing

**Condition:** Beam damaged – monitor

One support showing signs of rotting – monitor

**Low Risk: 5**

(Rotting support)

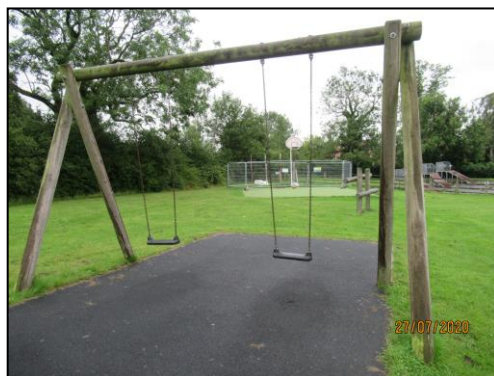
### 7. Richter 2.75m 1 Bay Swing with 2 Flat Seats

**Condition:** Splits in logs – monitor

**Low Risk: 4**

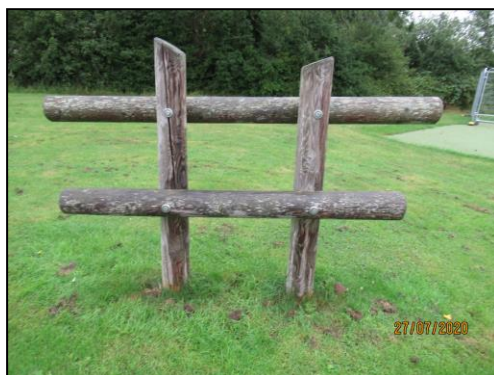
### 8. Richter Log Climber

**Condition:** Splits in logs – monitor

**Low Risk: 4**

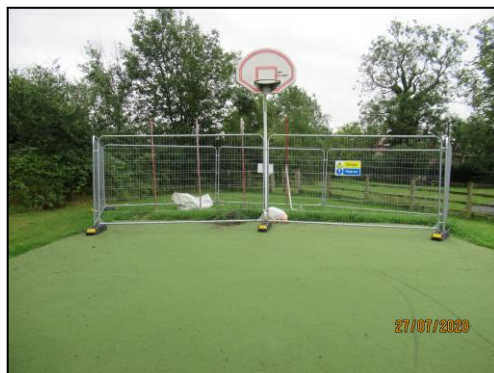
### 9. Sure Shot Basketball

**Security fence erected – visual inspection only**

**Condition:** No defects were found

**Medium Risk: 8**

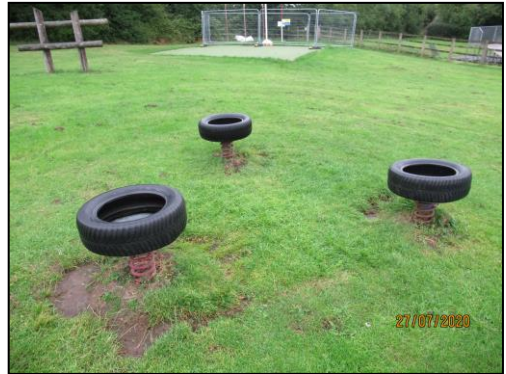
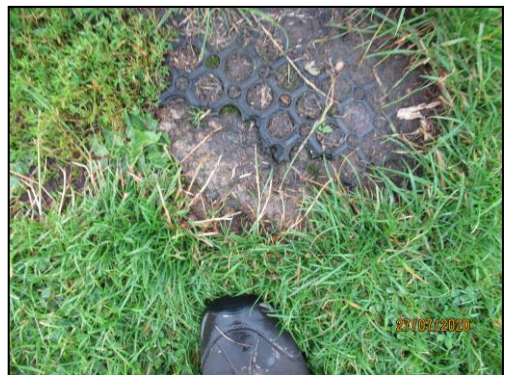
### 10. Three Tyre Springy/Rota items

**Surface Compliance:** Fails BS EN 1176-1, Sec. 4.2.14, exposed foundations at damaged grass mat

**Low Risk: 6**

(Exposed foundations at damaged grass mat)

**Surface Condition:** Repair/replace one damaged grass mat

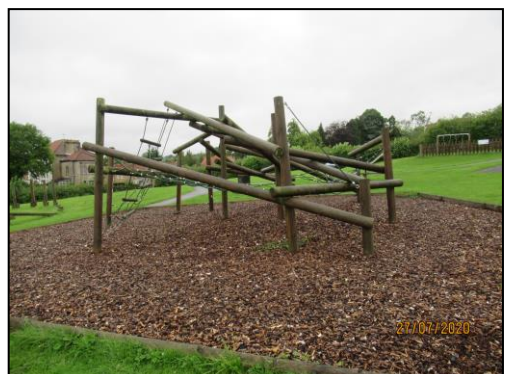
### 11. Playdale Log & Net Climber

**Condition:** No defects were found

**Low Risk: 4**

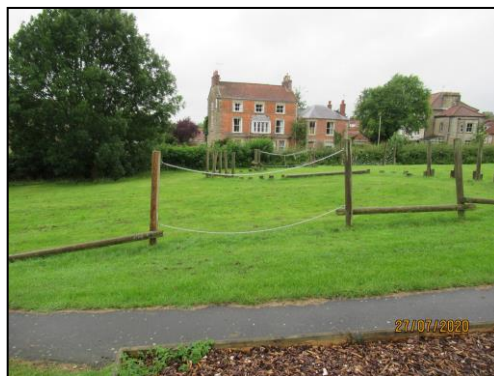
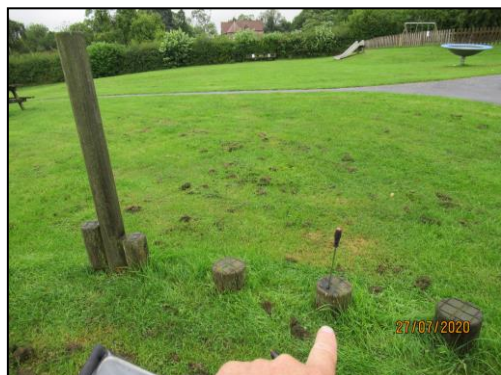
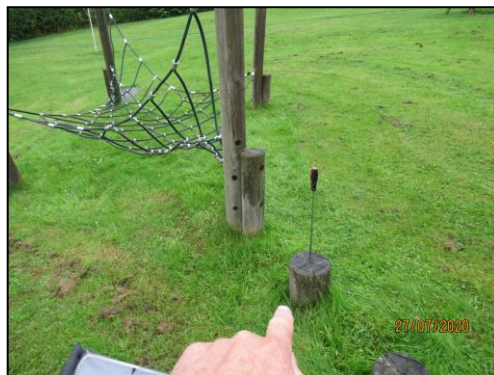
### 12. Playdale Trim Trail

**Condition:** Wobble log showing signs of rotting – monitor  
**Replace two rotten step posts**

**Low Risk: 4**

(Rotten step post)

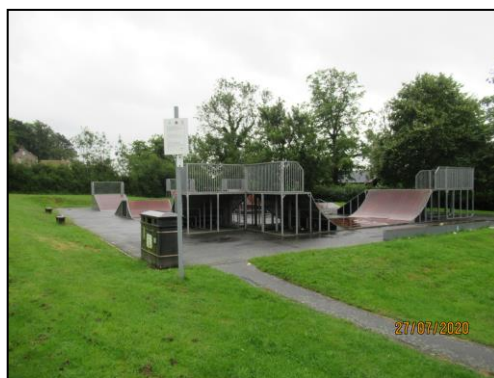
### 13. Eight-item Skate Park

**Condition:** Slight damage to two liners on half pipe combi unit – monitor

Slight damage to one liner on driveway – monitor

**High Risk: 14**

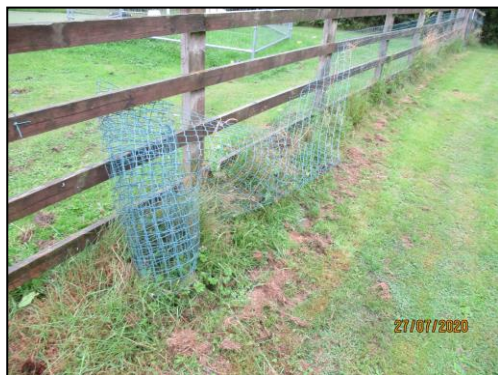
Fence (around skate park) c/w 4 pedestrian gates – potential head trap between top two rails on fence & gates. **Clearance of between 60mm & 110mm should be maintained at bottom of gates. Plastic mesh fence in poor condition – requires attention. Replace one broken rail & resecure others. (Low Risk) Remove excess thread on protruding bolts. Remove potential pinching/crushing hazard between gate & post at hinge side (a gap of at least 12mm should be maintained)** (**Medium Risk**)

(Poor condition mesh fence)

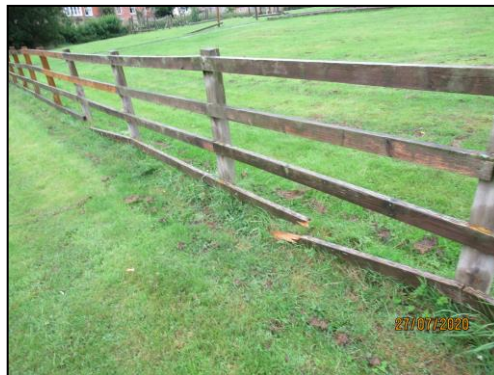
(Broken fence rail)

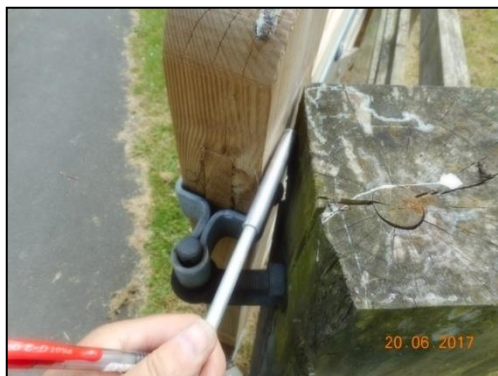
(Potential pinching/crushing hazard at gate – library photo)

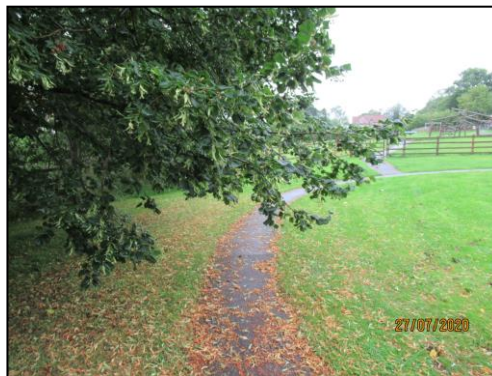
(Overhanging branches at path)

General area – **cut back low branches at path.** (**Medium Risk**) Tidy

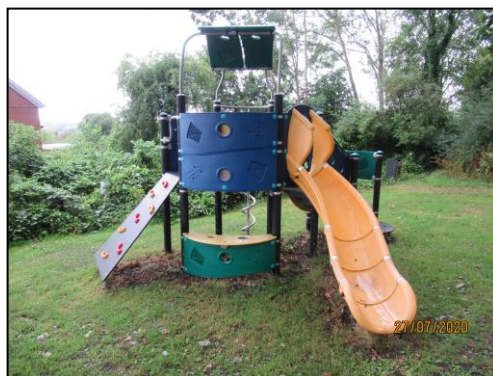
### 1. Kompan Junior Multi Unit

**Condition:** No defects were found

**Low Risk: 7**

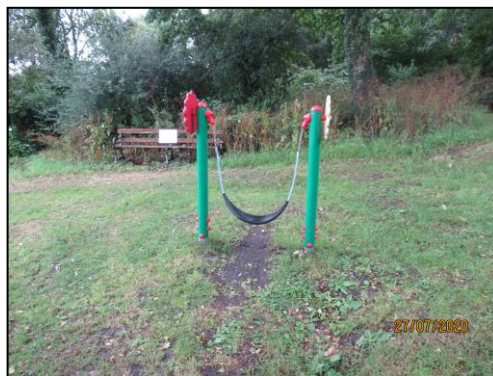
### 2. Kompan Daisy Swing

**Condition:** No defects were found

**Low Risk: 4**

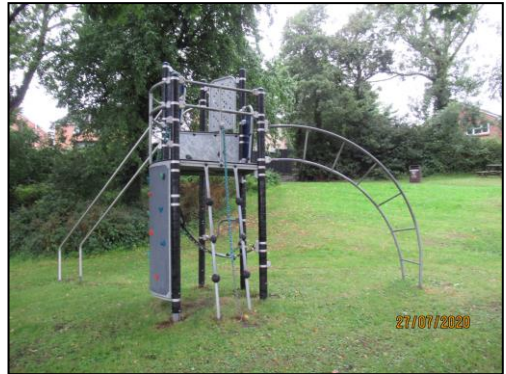
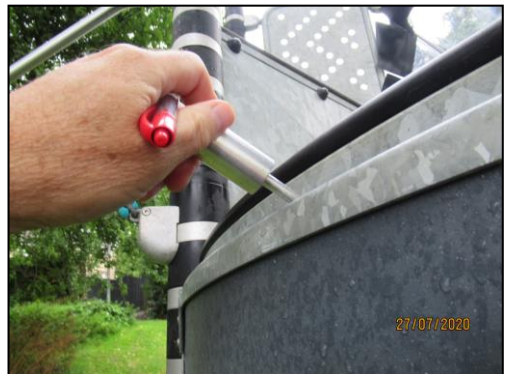
### 3. Kompan Multi Climbing Frame

**Compliance:** Fails BS EN 1176-1, Sec. 4.2.7.6, finger trap between top of climbing wall & platform

**Low Risk: 7**

(Potential finger trap)

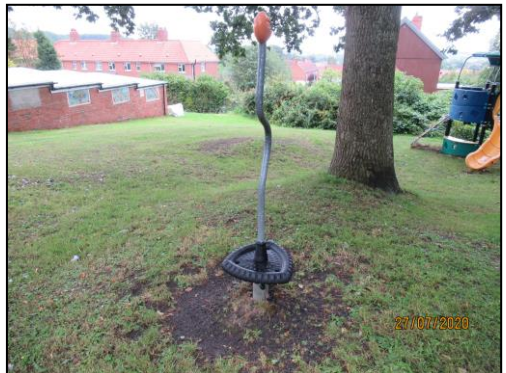
### 4. Kompan Pirouette

**Condition:** No defects were found

**Low Risk: 4**

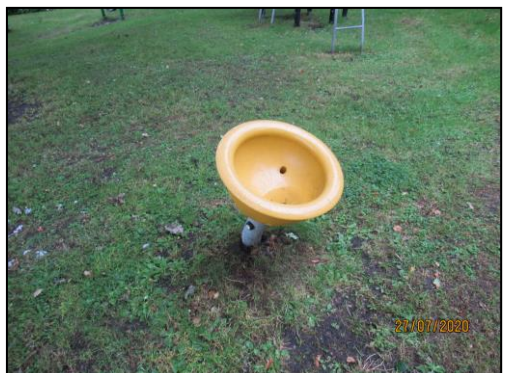
### 5. Kompan Spinning Bowl

**Condition:** No defects were found

**Very Low Risk: 2**

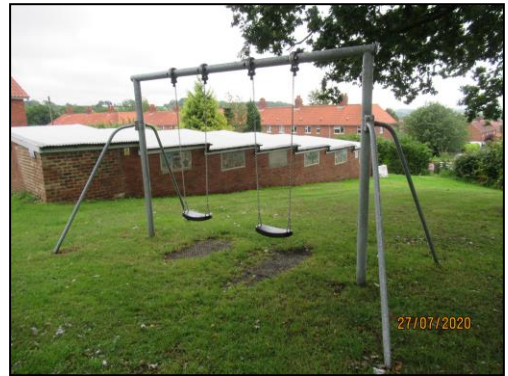
### 6. Kompan 2.4m 1 Bay Swing with 2 Flat Seats

**Condition:** No defects were found

**Low Risk: 4**

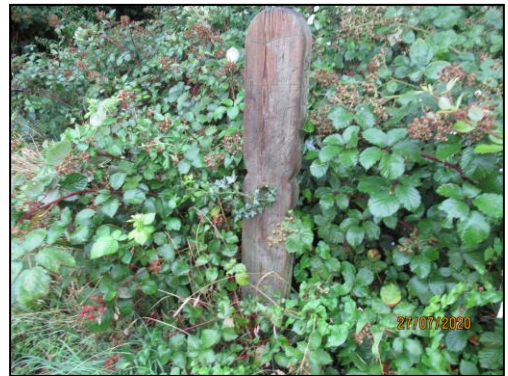
#### a) Post

**Condition:** Not ideally positioned beneath tree

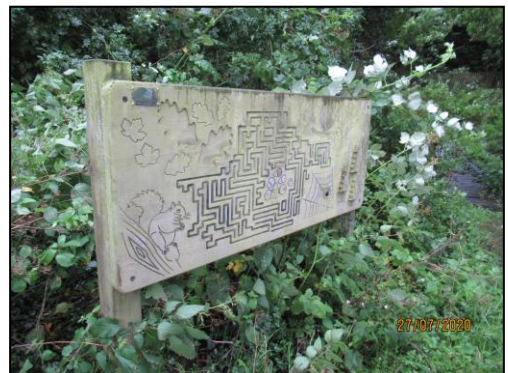
#### b) Information Panel

**Condition:** Not ideally positioned beneath tree

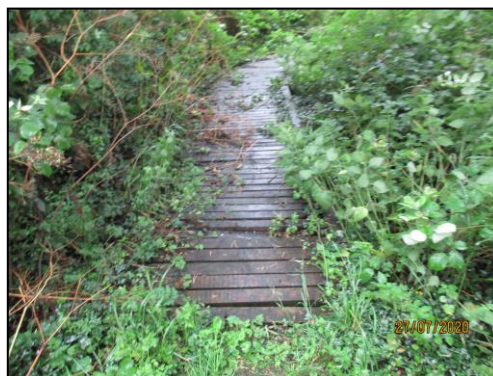
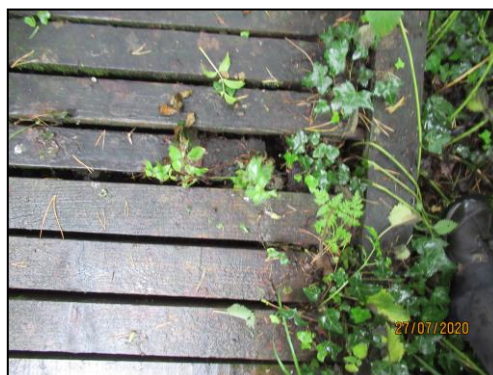
#### c) Board Walk

**Condition:** Not ideally positioned beneath tree

**Low Risk: 4 (items a-c)**

(Broken slat)

**Replace two broken slats**

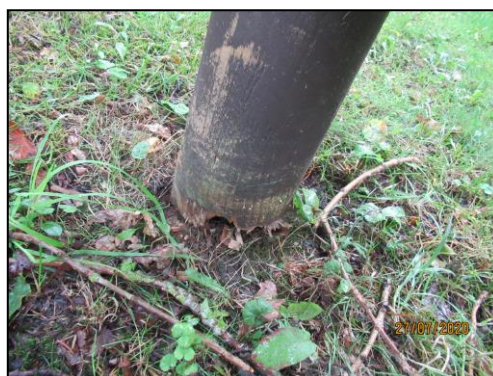
Seat x one – **one post rotten – REMOVE FROM SERVICE** (**Medium Risk**)

(Rotten post at seat)
