JK ARBORICULTURE

Tree Safety inspection – Ryedale Crescent Play Area, Kirkbymoorside.

September 2020

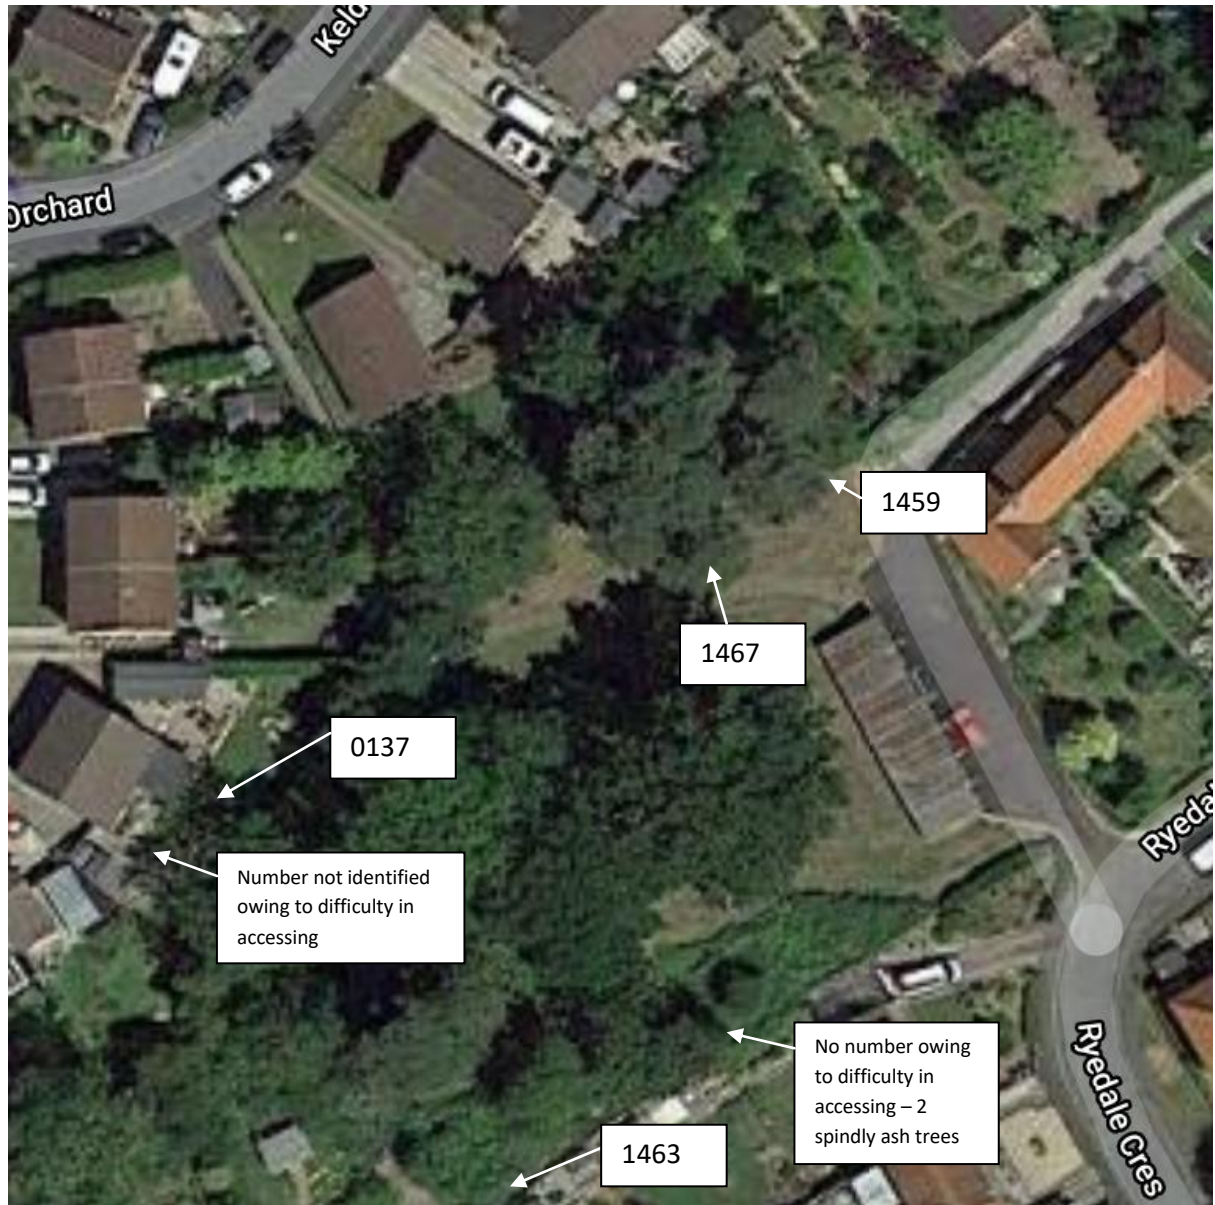
Appendix 1 TREE LOCATIONS

The trees were inspected from ground level. Tree locations are plotted at Appendix 1. and faults in individual trees are recorded within the Tree Survey at Appendix 2.
