INDEPENDENT PLAYGROUND INSPECTIONS LIMITED

Annual inspection report

Kirkbymoorside Town Council play areas at

21st July 2021

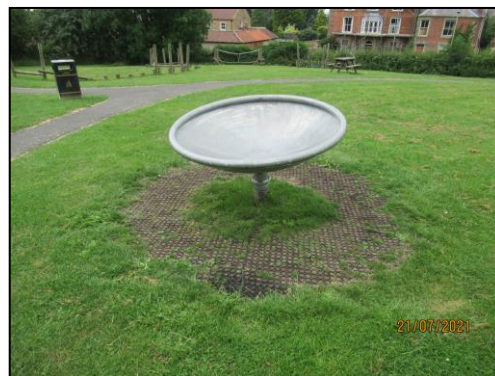
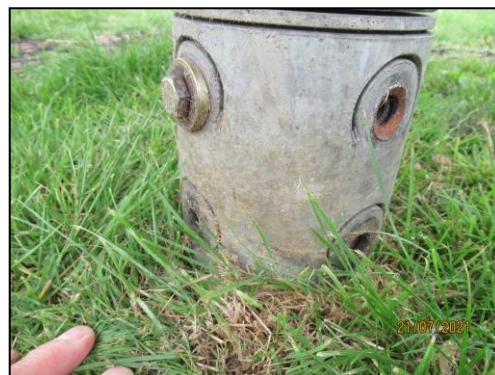
1. Sutcliffe Large Spinning Bowl

Condition: Replace three broken studs on ground fixing

Low Risk: 4

Broken studs at ground fixing

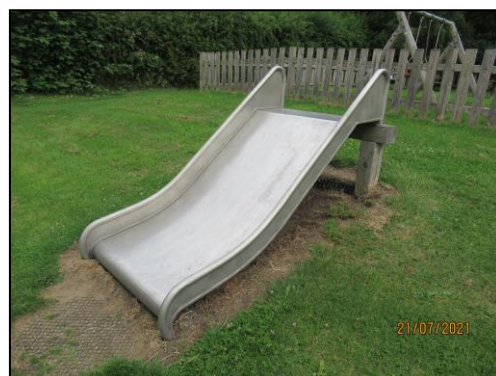
2. Richter Embankment Slide

Condition: No defects were found

Very Low Risk: 2

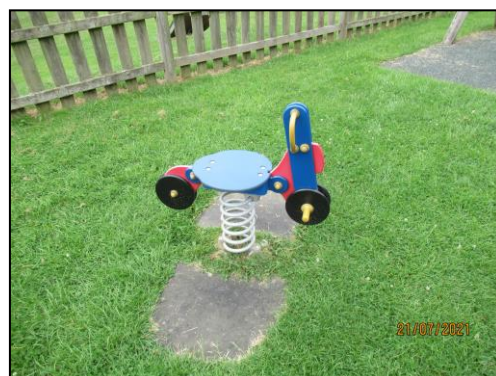
3. Ledon Spring Bike

Compliance: Fails BS EN 1176-6, Sec. 4.6, foot rests fail gauge test

Very Low Risk: 3

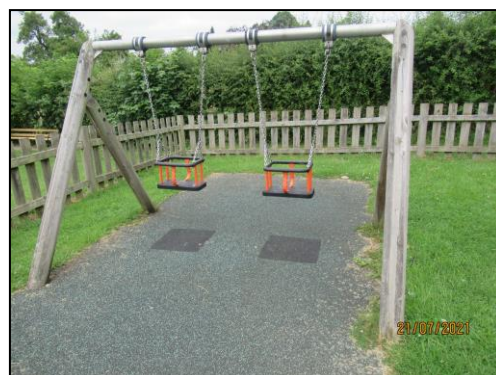
4. Playdale 1.75m 1 Bay Swing with 2 Cradle Seats

Condition: No defects were found

Very Low Risk: 2

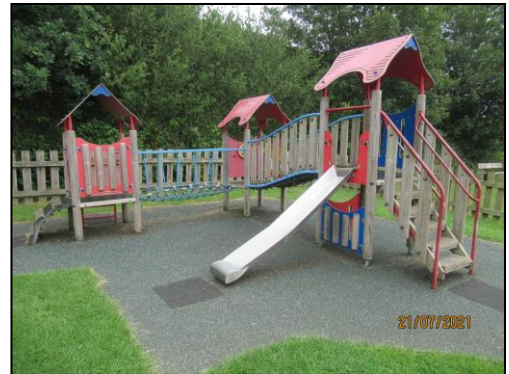
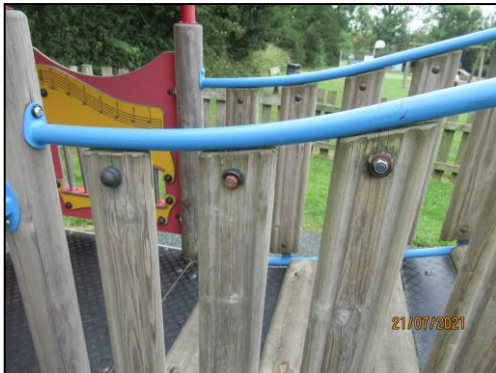
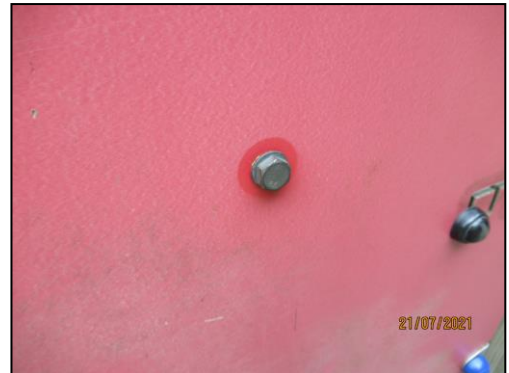
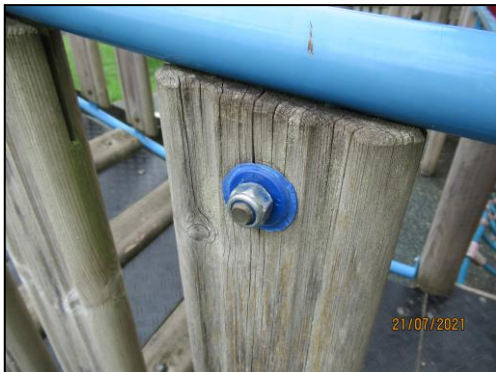
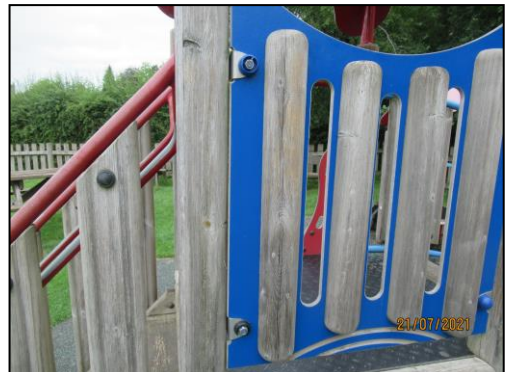
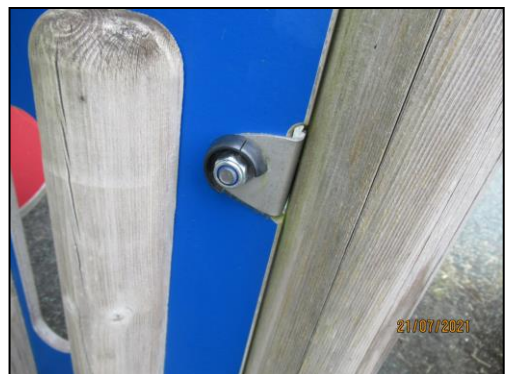
5. Playdale Toddler Multi Unit

Condition: Replace several broken bolt cover caps

Low Risk: 4

(Broken bolt cover cap)

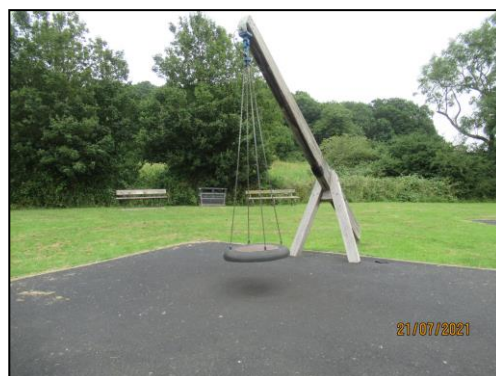
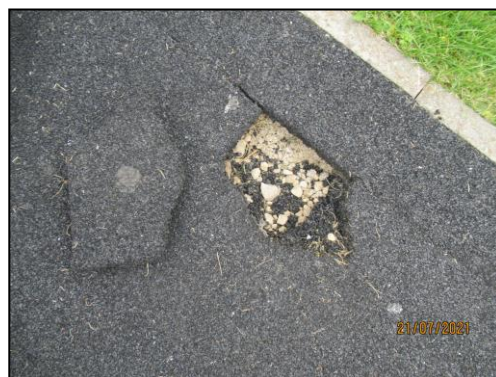
6. Richter Cantilever Swing

Condition: Beam damaged – monitor
One support showing signs of rotting – monitor

Surface Condition: Repair 200mm² x 60mm deep

Low Risk: 5

(Damaged wet pour)

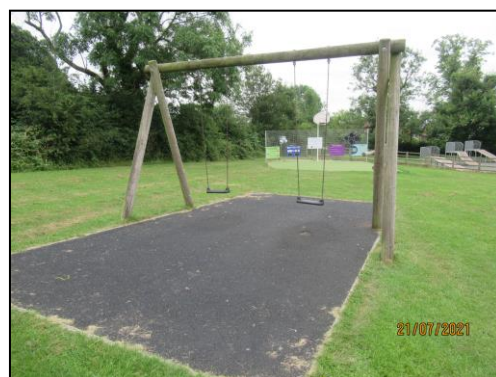
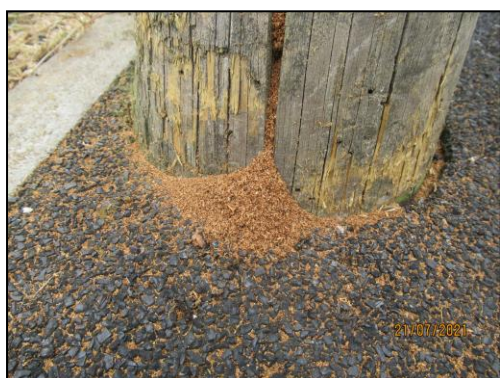
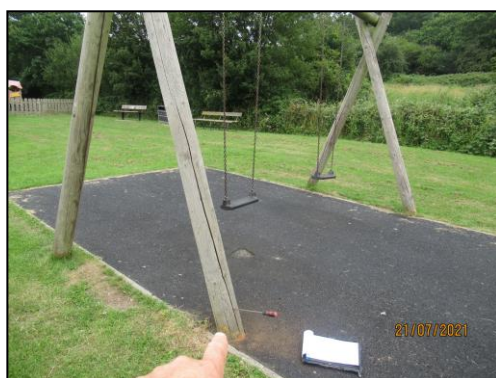
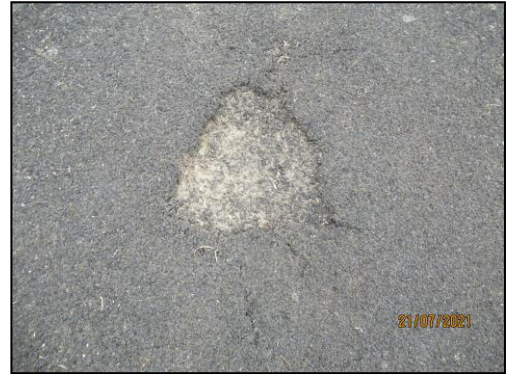
7. Richter 2.75m 1 Bay Swing with 2 Flat Seats

Condition: Splits in logs – monitor
End links on chains showing signs of wear – monitor
Replace one rotten support

Surface Condition: Repair 200mm² x 10mm deep

Low Risk: 6

(Rotten support)

(Location of rotten support)

(Worn wet pour)

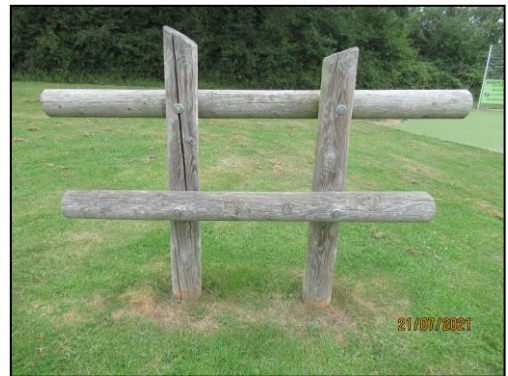
8. Richter Log Climber

Condition: Splits in logs – monitor

Low Risk: 4

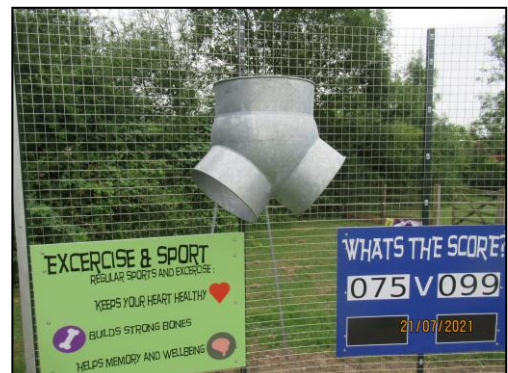
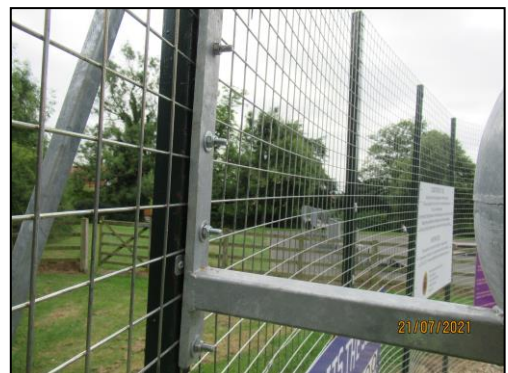
9. Unknown Make Ball Chute

Compliance: Fails BS EN 15312, Sec. 4.3, remove excess bolt thread

Medium Risk: 10

(Excess bolt thread)

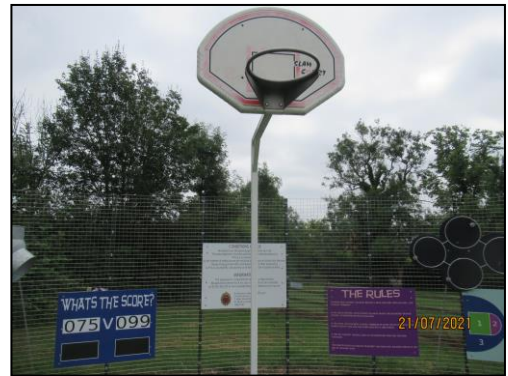
10. Sure Shot Basketball

Condition: No defects were found

Medium Risk: 8

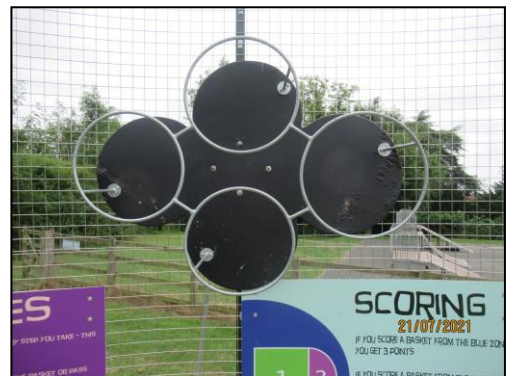
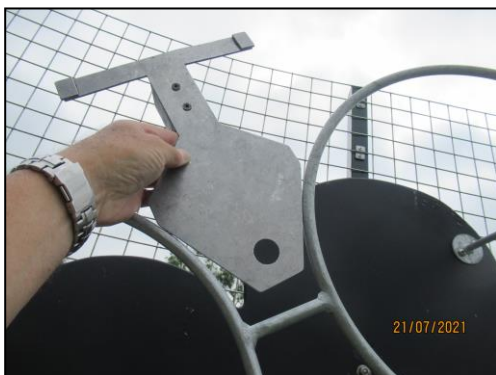
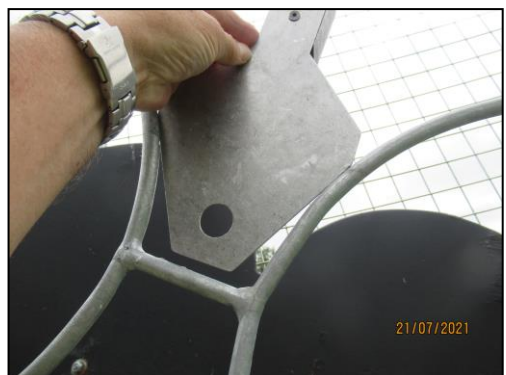
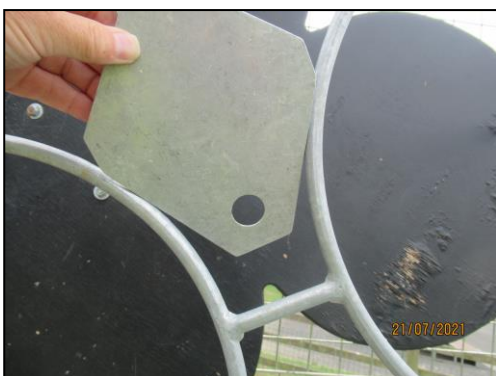
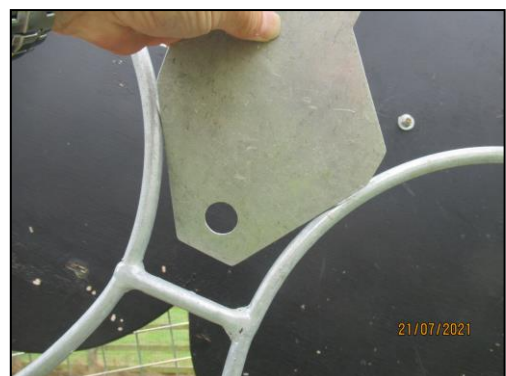
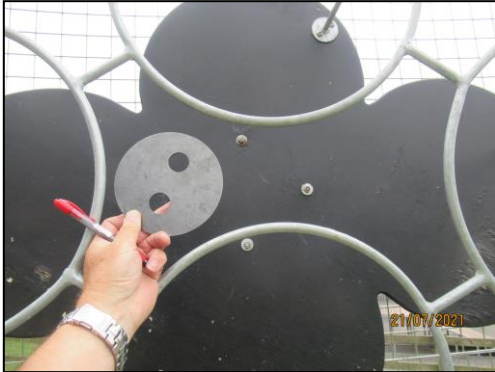
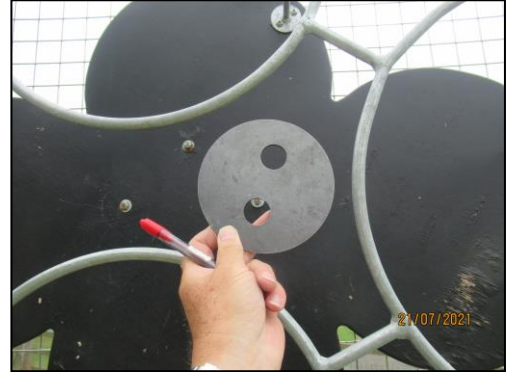
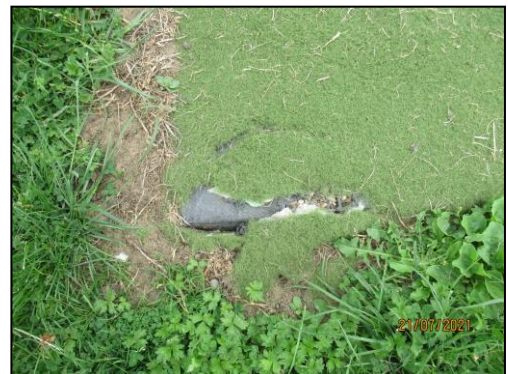
11. Unknown Make Target Panel

Compliance: Fails BS EN 15312, Sec. 4.4.2.1, neck & head traps present

Surface Condition: Repair 200mm²

Medium Risk: 12

(Potential neck trap)

(Potential head trap)

(Damaged artificial turf)

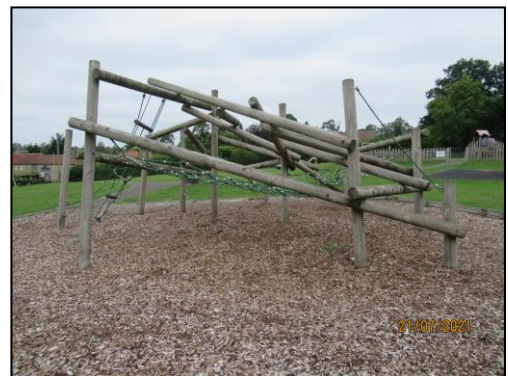
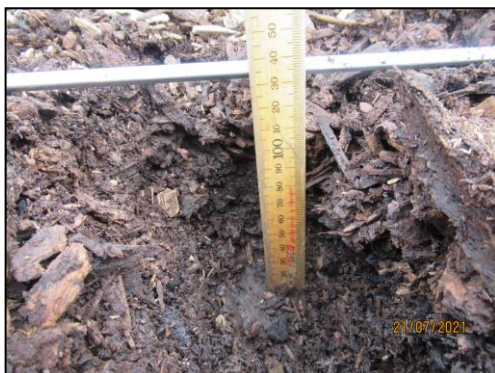
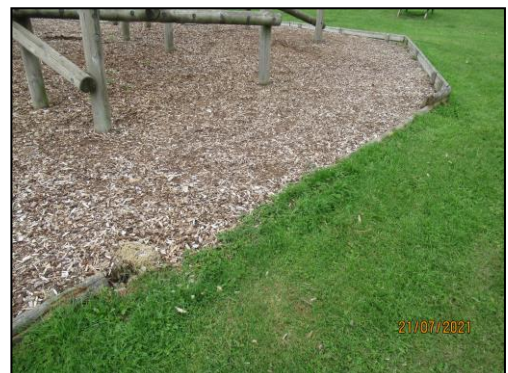
12. Playdale Log & Net Climber

Surface Condition: Require top up (actually 130mm deep, should be at least 300mm)

Low Risk: 6

(Insufficient depth wood chippings)

(Missing wood chipping retaining logs)

Replace 4m missing wood chipping retaining logs

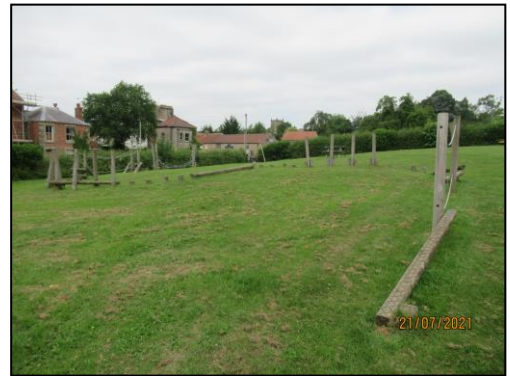
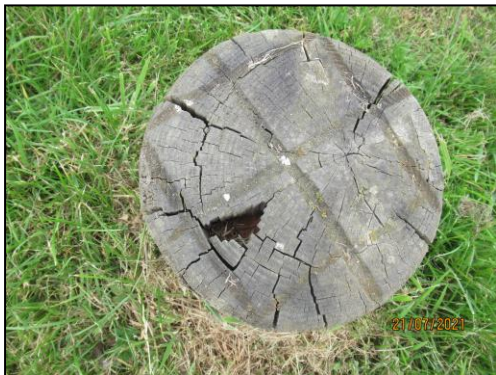
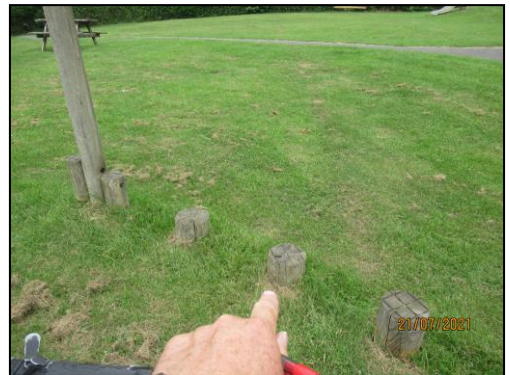
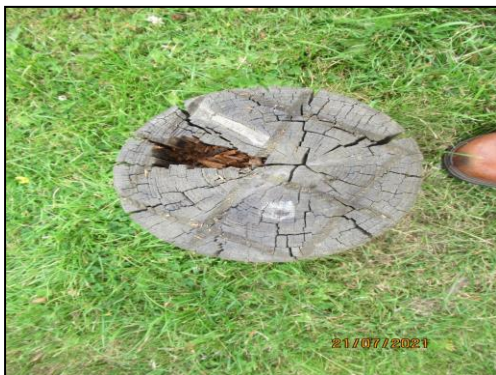
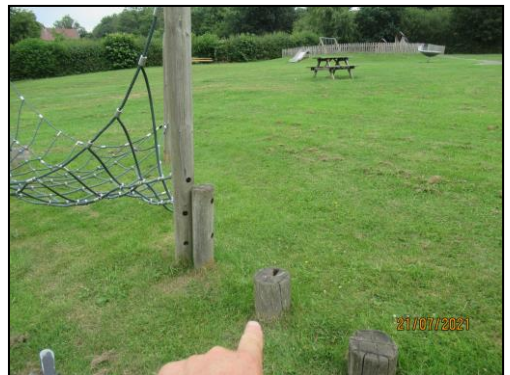
13. Playdale Trim Trail

Condition: Wobble log showing signs of rotting – monitor

Low Risk: 4

(Rotten step post)

(Location of rotten step post)

Replace two rotten step posts

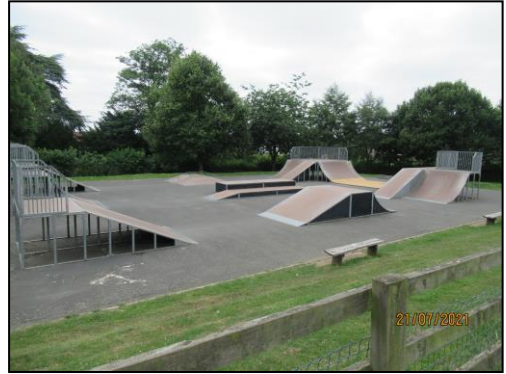
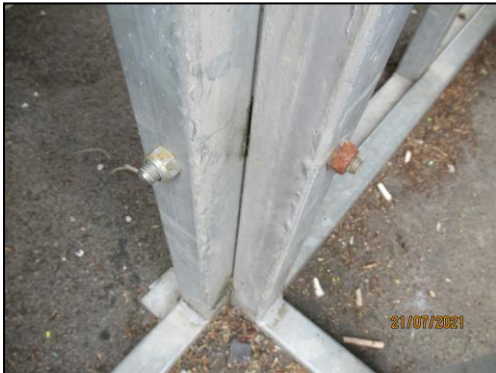
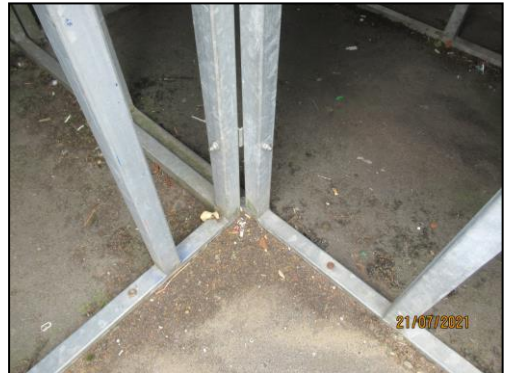
14. Eight-item Skate Park

Condition: Slight damage to two liners on half pipe combi unit – monitor

Slight damage to one liner on driveway – monitor

Compliance: Fails BS EN 14974, Sec. 6.1.7, remove excess bolt thread at various locations on half pipe

High Risk: 14

(Excess bolt thread at half pipe)

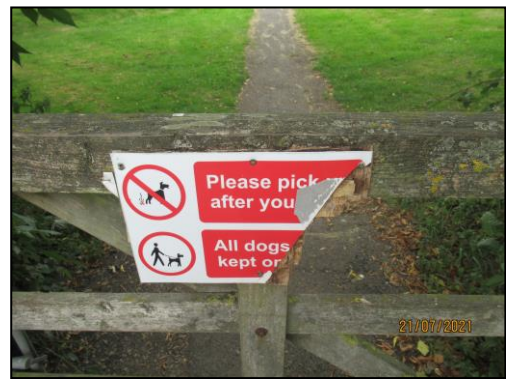
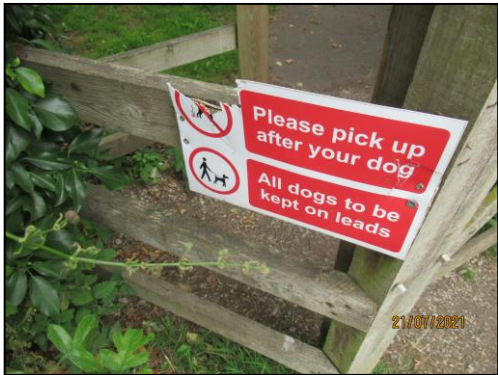
Signs – slight damage to two signs. Remove sign from gate (recommend signs are not put on gates) (**Low Risk**)

(Damaged sign)

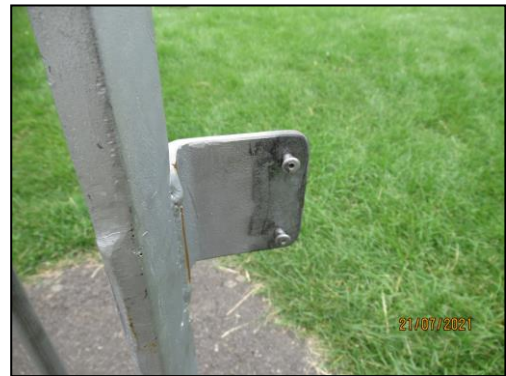
Fence (around items 2-5) c/w one pedestrian gate – potential neck trap between slats. Posts showing signs of rotting – monitor. Replace missing buffer on gate (**Low Risk**) Re-adjust self-closing device as gate closing too fast (closing in 3 seconds, should be at least 5 seconds) (**Medium Risk**)

(Missing buffer on gate)

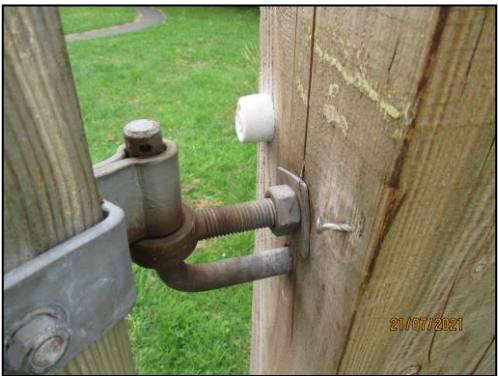
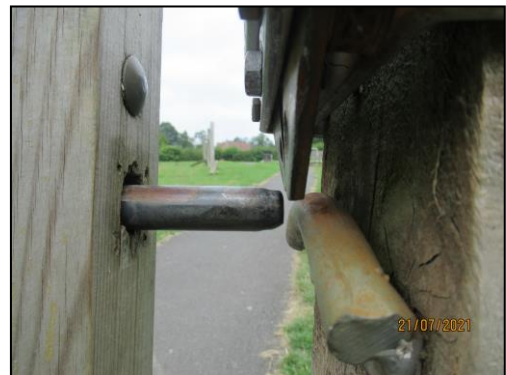
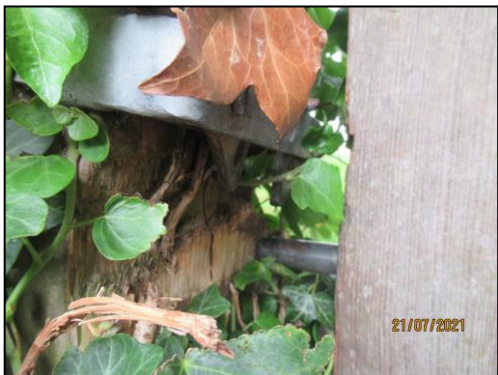
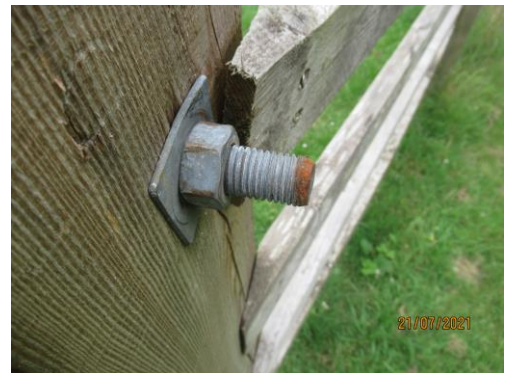
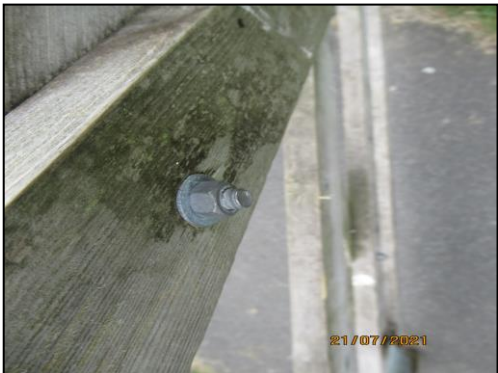
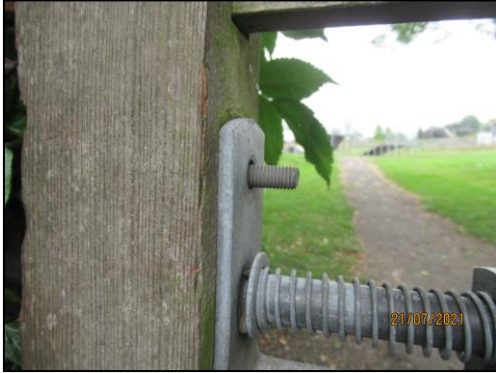
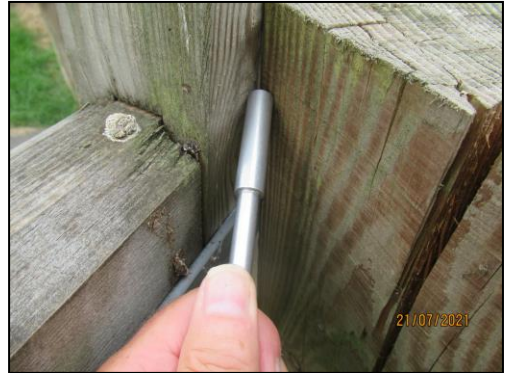
Fence (around skate park) c/w 4 pedestrian gates – potential head trap between top two rails on fence & gates. Clearance of between 60mm & 110mm should be maintained at bottom of gates. Replace one missing gate stop. Re-set gates (catches missing stoppers at two gates) (**Low Risk**) Remove excess bolt thread. Replace one missing nut on bolt. Remove potential pinching/crushing hazard between gate & post at hinge side (a gap of at least 12mm should be maintained) (**Medium Risk**)

(Missing gate stop)

(Gate catch missing stopper)

(Excess bolt thread at gate)

(Missing nut on bolt at gate)

(Potential pinching/crushing hazard at gate at skate park)

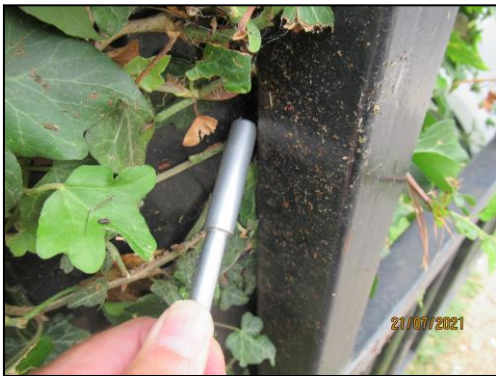
One pedestrian gate & one vehicular access gate to main area – remove potential pinching/crushing hazard at pedestrian gate (a gap of at least 12mm should be maintained) (**Medium Risk**)

(Potential pinching/crushing hazard at gate to main area)

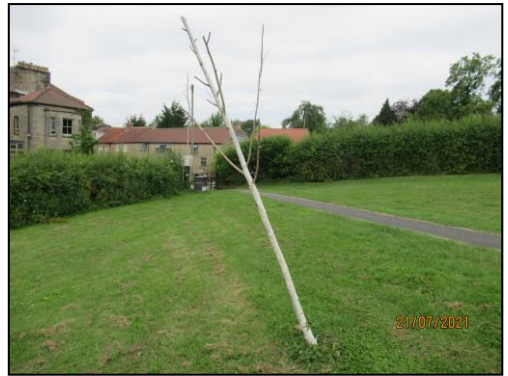
General area – remove one dead & loose tree. (**Low Risk**) Tidy

(Dead & loose tree)

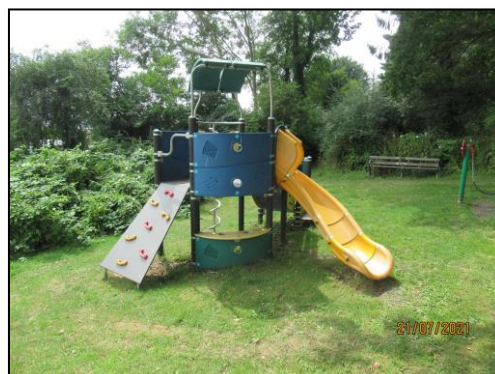
1. Kompan Junior Multi Unit

Condition: No defects were found

Low Risk: 7

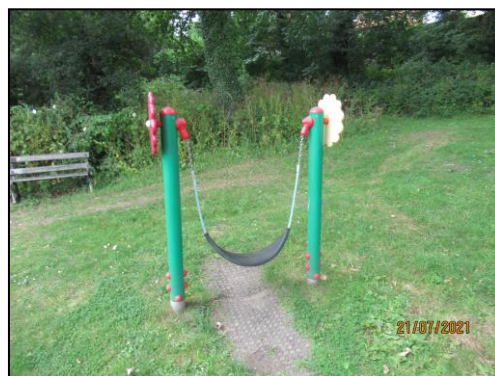
2. Kompan Daisy Swing

Condition: No defects were found

Low Risk: 4

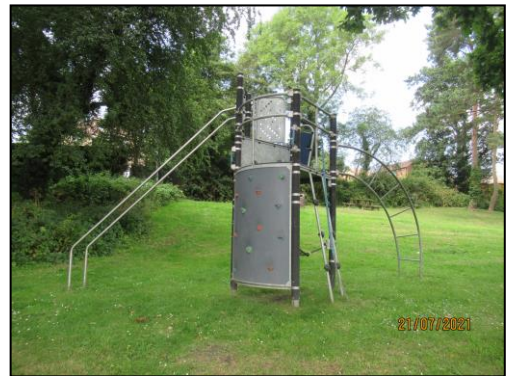
3. Kompan Multi Climbing Frame

Compliance: Fails BS EN 1176-1, Sec. 4.2.7.6, finger trap between top of climbing wall & platform

Low Risk: 7

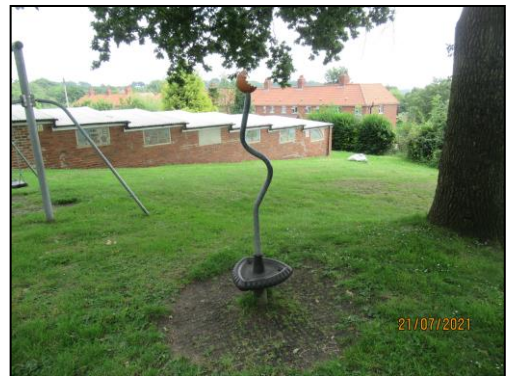
4. Kompan Pirouette

Condition: No defects were found

Low Risk: 4

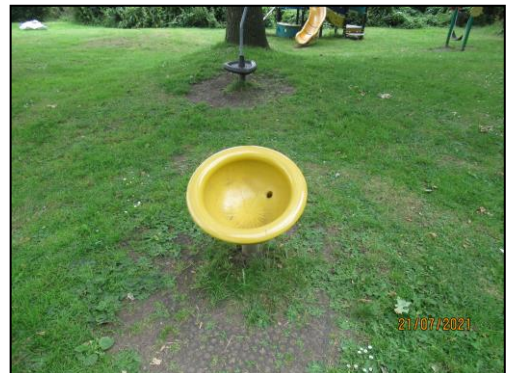
5. Kompan Spinning Bowl

Condition: No defects were found

Very Low Risk: 2

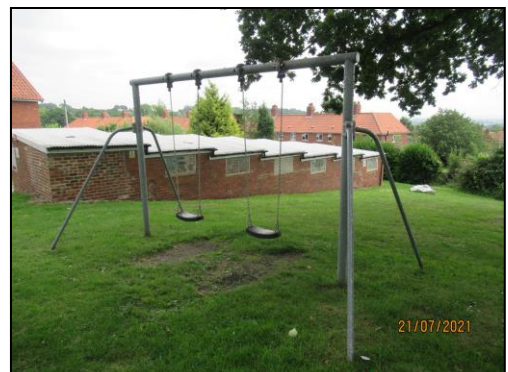
6. Kompan 2.4m 1 Bay Swing with 2 Flat Seats

Surface Condition: Grass worn (impact attenuating properties impaired if not well maintained) – requires attention

Low Risk: 6

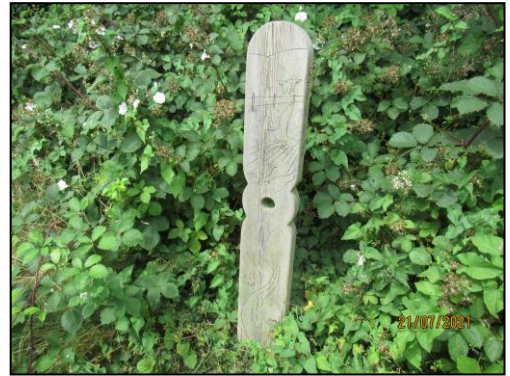
a) Post

Condition: Not ideally positioned beneath tree

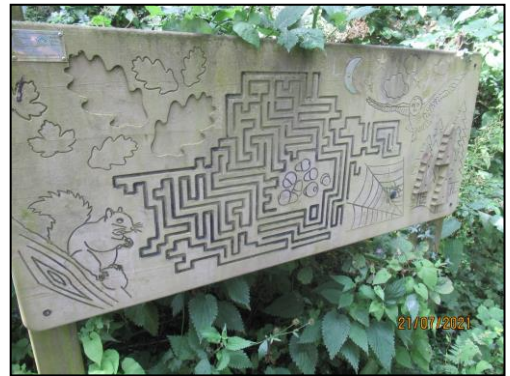
b) Information Panel

Condition: Not ideally positioned beneath tree

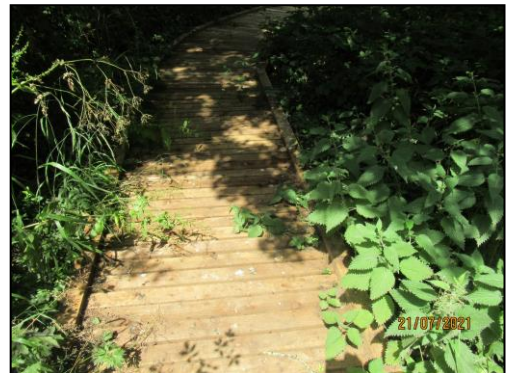
c) Board Walk

Condition: Not ideally positioned beneath tree

Very Low Risk: 2 (items a-c)

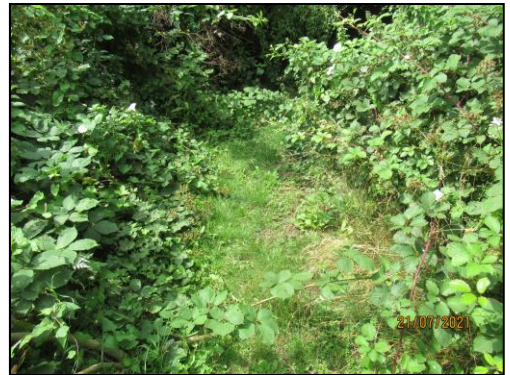
General area – **cut back shrubs at woodland walk. (Low Risk)** Tidy

(Overgrown shrubs at woodland walk)
