# Environmental Art LTD. Damage report

Site: Kirkbymoorside basketball area.

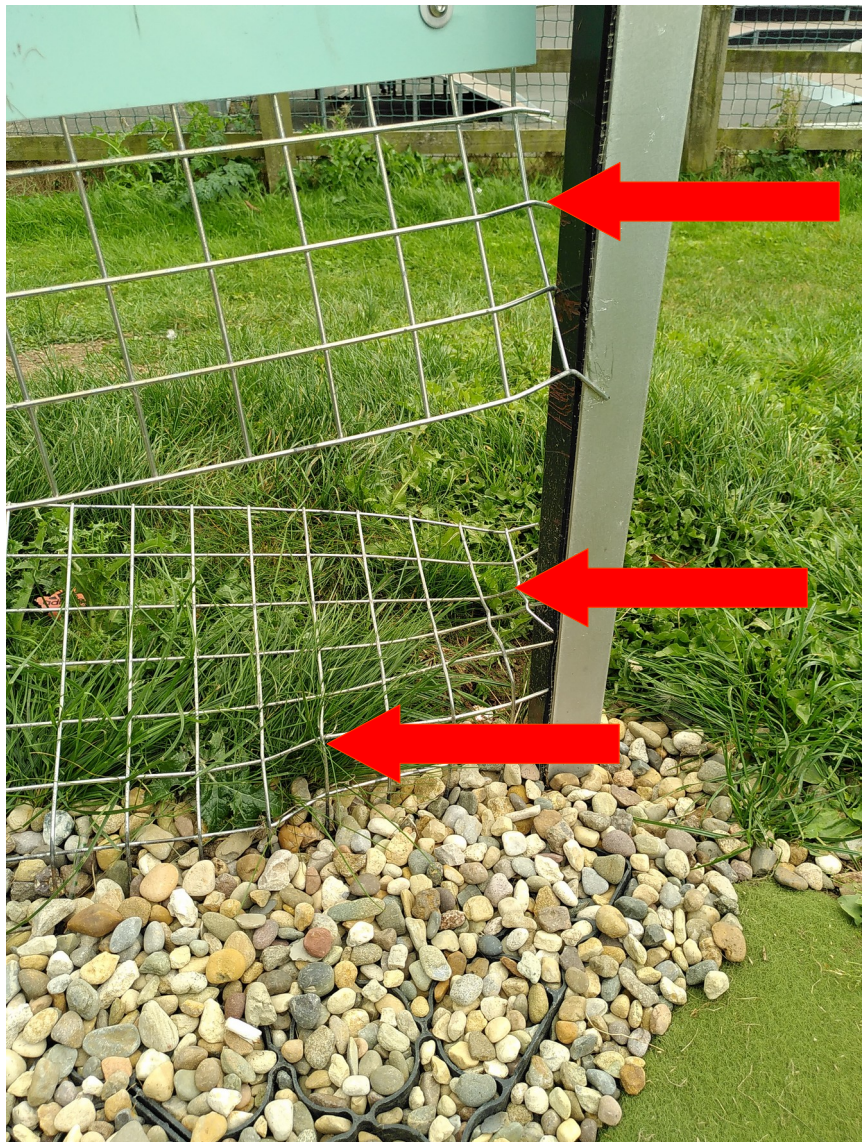
Arrows highlight where significant directed and repeated force has been applied; broken welds in the mesh and deformed grids. The mesh has been kicked in next to the post at the base of the mesh, wrenching it from the standard, riveted clamps inside the post assembly. The force has also broken the link clamps between the upper and lower sheets of mesh.

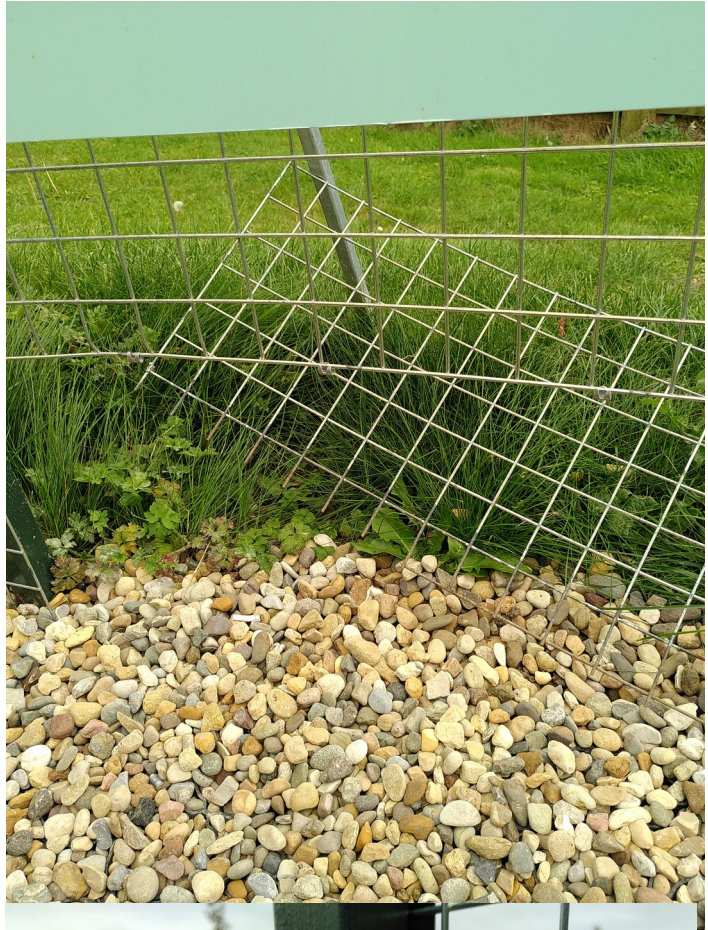
Bottom mesh section has been kicked repeatedly breaking the galvanised mesh clips on 2 side, severing the panel from the fence.

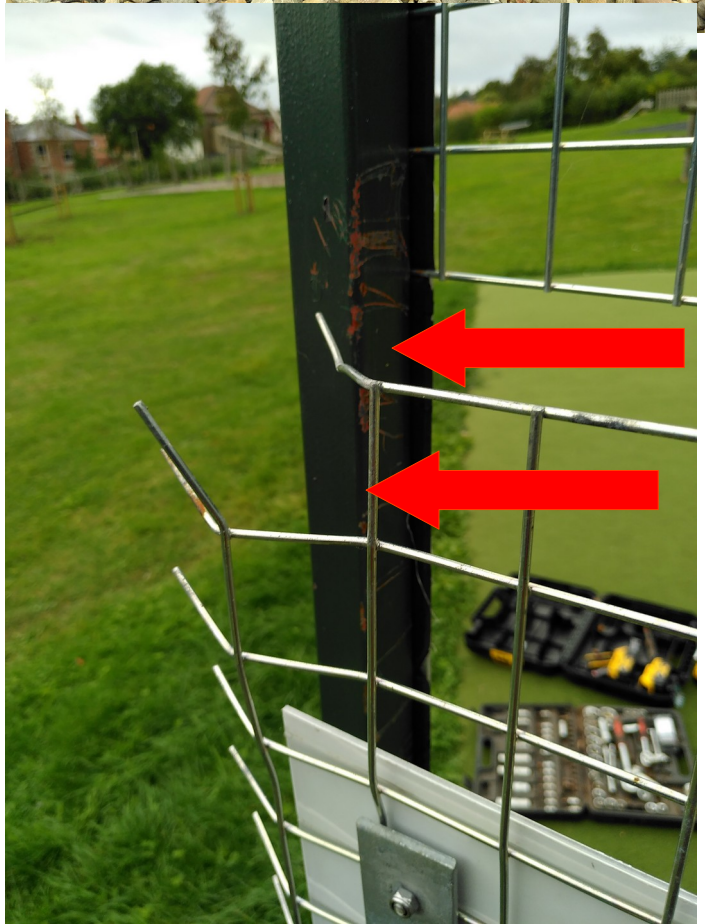
Arrows indicate broken weld on mesh and scratch marks indicative of the loose panel being pulled in and out against the post, this is not possible without manual interaction.

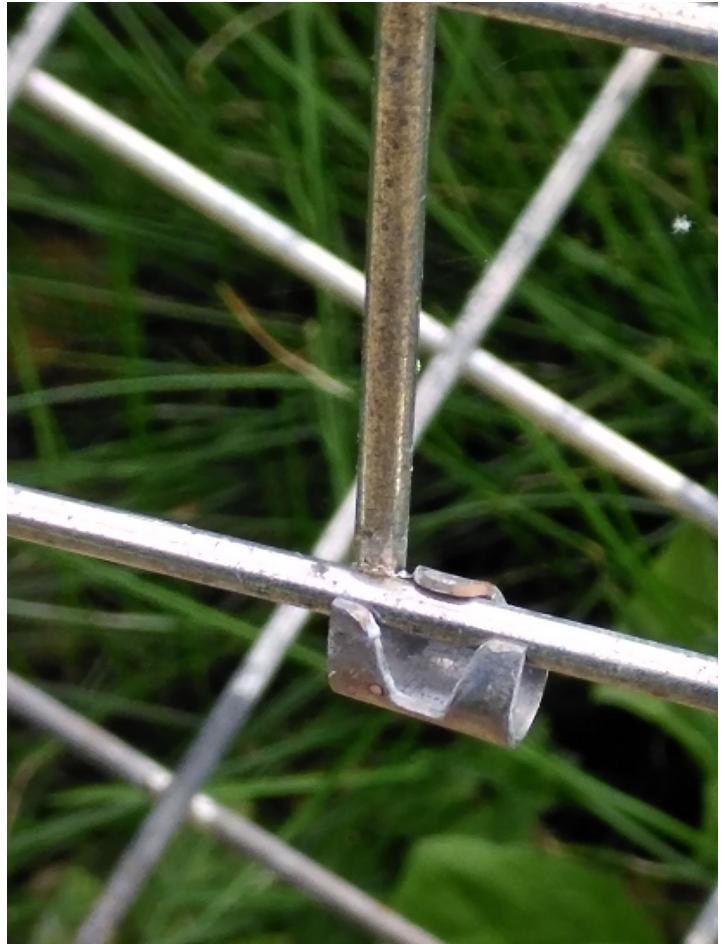
Detail of a torn galvanised mesh clip, these clips are rated to 150 N/m force well above the standard force expected by a ball, in all 24 clips have been broken or removed from this section.
