# JK ARBORICULTURE

Tree Safety inspection – Recreation Ground, Kirkbymoorside.

September 2020

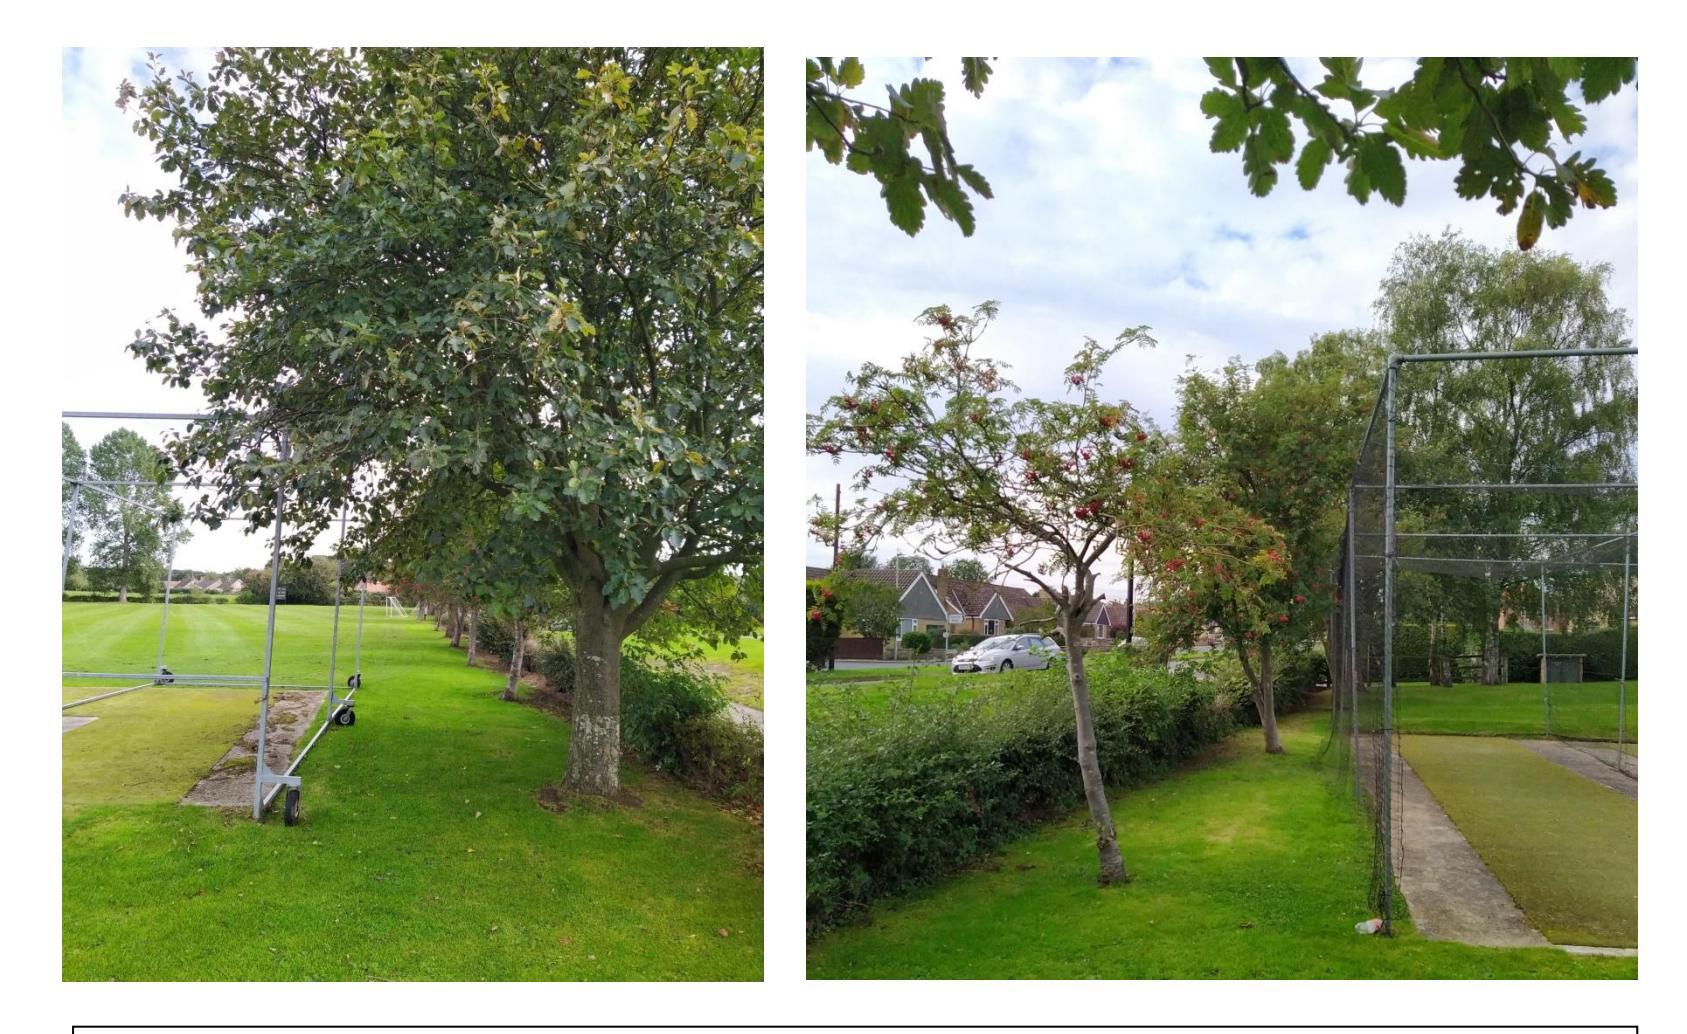
The trees along the southern boundary are not considered to carry any threat to users of the Recreation ground or passersby along the public highway. The current mowing regime passes very close to individual trunks and consequently damage to some trees is inevitable. It is therefore recommended that the area beneath these trees is mulched rather than cut. As well as preventing further damage the mulch will have the advantage of retaining moisture and preventing the grass growth. The preferred mulch is wood chips spread up to the individual trunks but not up trunks to prevent rotting of the bark.

Trees along the southern boundary (0144-0165)

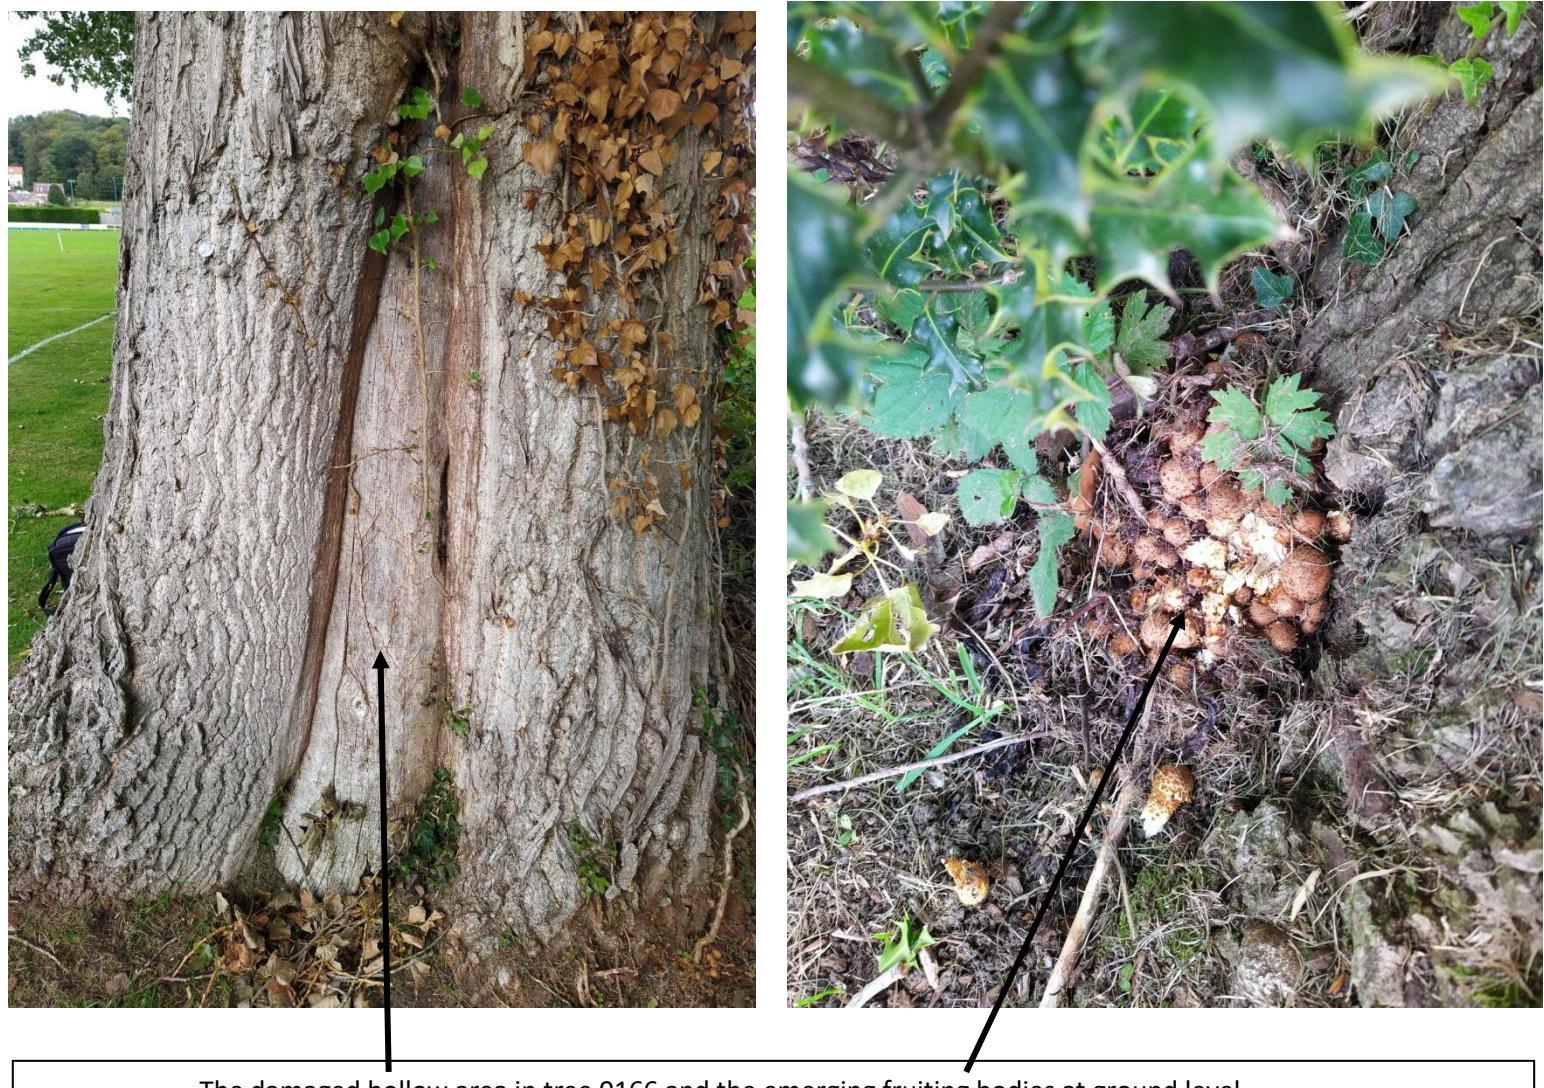
The trees along the eastern boundary are all mature consisting of two Poplars and four ashes. Poplar 0166 has an old scar on the southern side of its trunk and although there is good healing around the wound area the trunk is hollow at that point and there are two areas of Amalllaria media fungus at the base of the trunk. This fungus causes white rot in roots and stems and can cause the collapse of tree without warning. It is therefore advised that owing to the position of the tree it should be removed during the coming months. The fungus spreads through 'bootlace like' rhizomes through the soil and can affect other trees. It is therefore recommended that the remaining trees in the line are inspected annually.

Large mature tree,	Consider felling during the coming		
	Eastern		large scar on	winter.		
0166	boundary	Poplar	southern side of		М	M-H
			main trunk hollowing			
			in middle, Fruiting			
			bodies of Amilllaria			
			mellia (Bootlace			
			fungus)			
0167	•	•	Large mature tree,	Could ultimately be affected by the		
			appears outwardly	adjacent fungus as it can spread	М	L-M
			sound	through neighbouiring root		
				systems Monitor		
0168	•	Ash	Extensive ivy growth	Sever ivy at the base of the tree to		
			on main stem	prevent encroachment into the	М	L-M
				crown.		
0169	•	•	Extensive ivy growth	Sever ivy at the base of the tree to		
(no			on main stem	prevent encroachment into the	М	L-M

The damaged hollow area in tree 0166 and the emerging fruiting bodies at ground level
