**River Dove Natural
Flood Management
Potential Assessment**

Final Report

October 2021

**Kirkbymoorside
Town Council
Church House
7 High Market
Place
Kirkbymoorside
YORK
YO62 6AT**

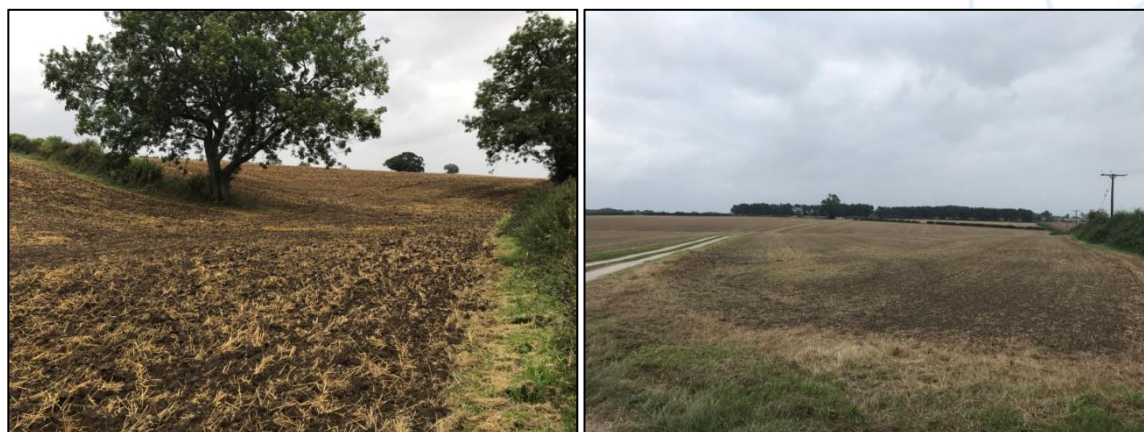
Figure 3-3: Arable field suitable for creation of offline storage upstream of Manor Vale woods (Left), Potential for offline storage by raising farm track and creating small bund along field boundary (Right)

The footpath through Manor Vale Wood then follows the edges of several, currently, arable fields. The gradient of the fields highlights the movement of water into the woods, and there are opportunities for earthen bunds (Table 4-1) to be added to create offline storage features in a number of places (Figure 3-2). When first leaving the woods, there is an opportunity to add a bund and create offline storage by taking advantage of the steeply sided fields (Figure 3-3). At the time of the site visit, arable crops had been present in this location which could be a potential constraint to a scheme. However, the feature could be designed to only be wet in times of flood and therefore maximise the potential for continued arable use. Further upstream, the gradient of the land is shallower. However, there is an opportunity to raise the track (Figure 3-2), where the surface naturally dips, to act as a bund feature and create a similarly low-level bund at the field boundary (Figure 3-3). Although there was no access closer, the gradient of the land in the improved grassland field immediately upstream of the golf course may also provide potential for offline storage (Figure 3-4). Given the dry weather conditions during the site visit, there is a need to ground truth the surface water flood maps to confirm surface water is apparent in the previously mentioned areas in periods of heavy rainfall to increase the optimum use of NFM.

As there have been potential storage opportunities identified within arable fields, there may be a need for compensation to the landowner for loss of crops if a flood were to occur. This is therefore a potential constraint to the opportunities identified here.

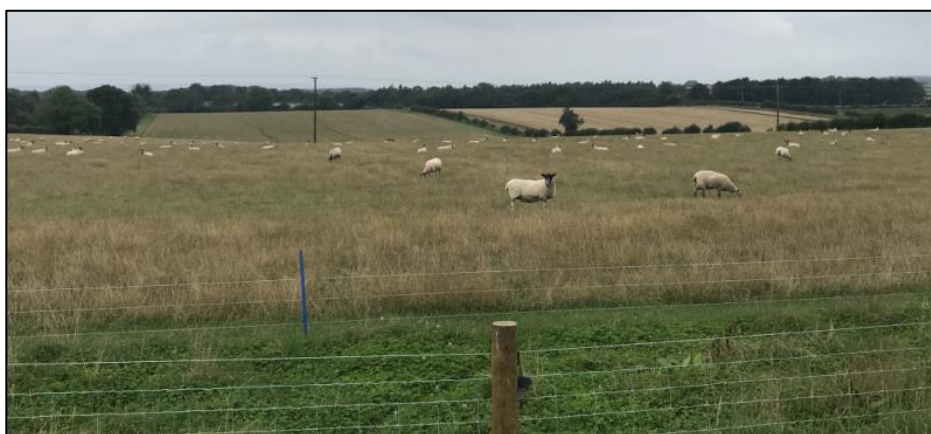
Figure 3-4: Potential for bunded offline storage immediately upstream of the golf course.

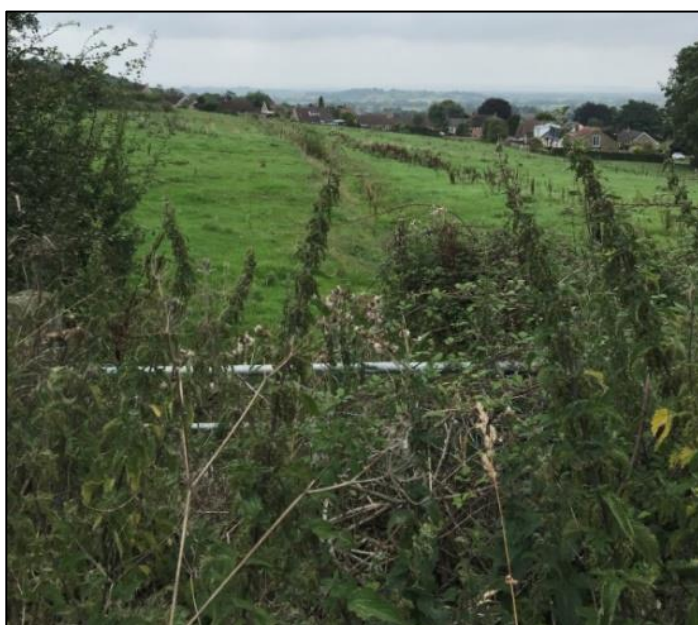
Figure 3-5: Ditch running through field adjacent to Neville Castle, suitable for woody debris or leaky boards

A number of smaller springs arise within the catchment which are controlled by the local geological complexity, and also contribute to the flooding in Kirkbymoorside. Although it was difficult on the site visit to identify where these contributed to flooding in town directly, it is thought they contribute to the flow within the ditch running through the churchyard. These flow pathways are not represented on the surface water flood maps (Figure 3-2), due to the catchment's geology. However, the previous flood risk studies provide some understanding as to their origin and route into town¹. The first was a small ditch in, what appeared to be an unused field near Neville Castle (Figure 3-2). This ditch could be filled with woody debris or leaky boards (Table 4-1) to slow and store water within the ditch. The second spring has a more substantial channel, where leaky barriers could be installed which utilised the floodplain which sits below the general level of the adjacent field. The riparian vegetation is generally coarse. There was, however, evidence of poaching due to the livestock having direct access to the watercourse causing degradation and erosion of bankside material. This material will reduce the water quality and has the potential to increase the risk of blockage to downstream infrastructure, including the culvert running under the churchyard. It is therefore advised that the watercourse be fenced off to reduce the risk of damage of measures implemented.

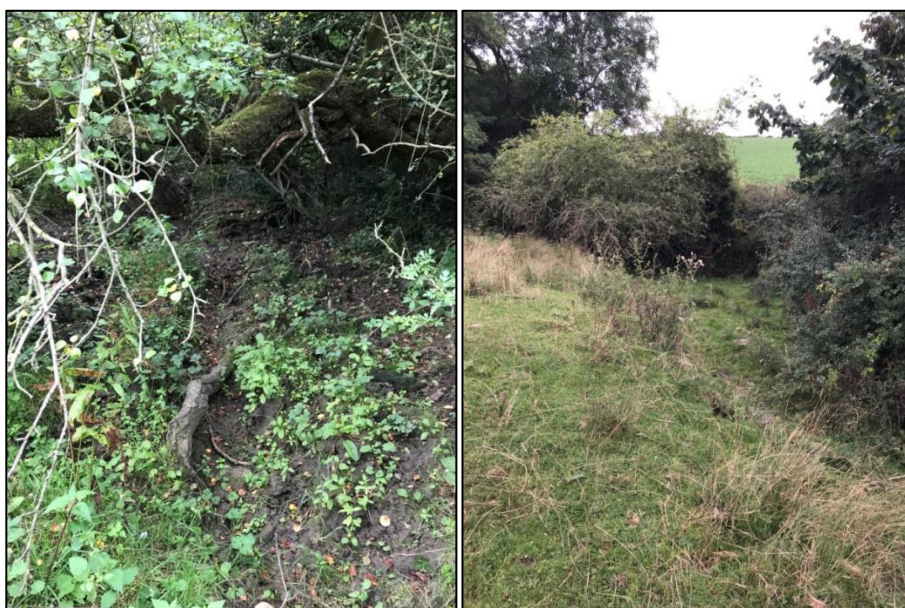
Figure 3-6: Spring running into the churchyard channel, suitable for leaky barriers extended onto the small floodplain

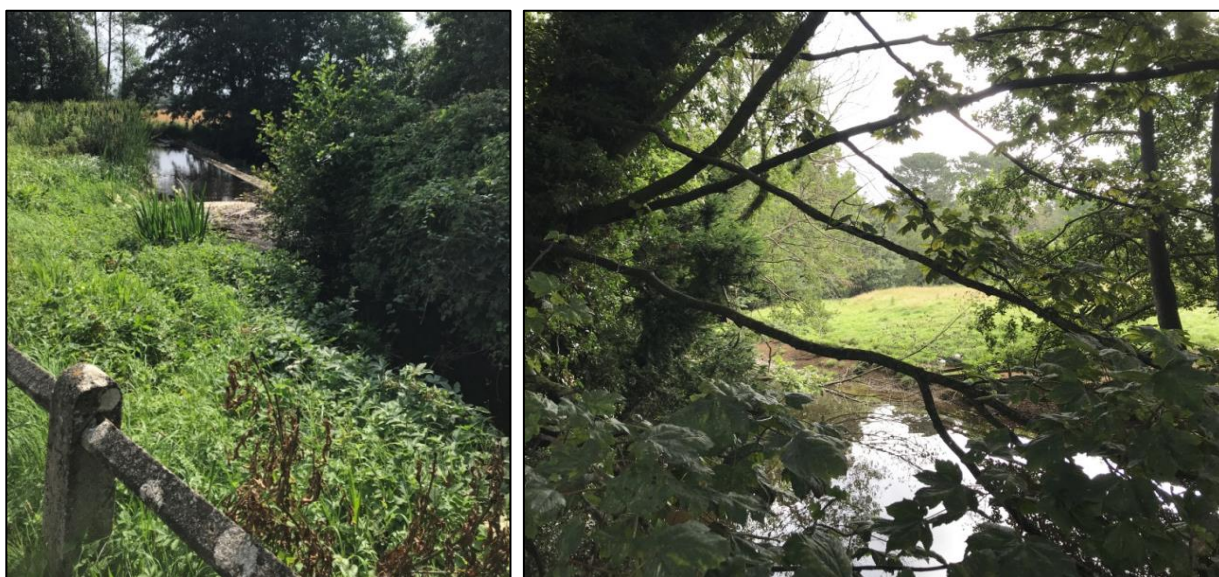
Figure 3-7: Mill Race weir, which could be removed to increase channel capacity and conveyance (Left). Improved grassland on riverbank which could be excluded from grazing (Right).

At Keldholme, the channel is too wide for any in-channel NFM measures. The majority of the floodplain is set far above the channel. However, in areas where the floodplain level is lower, fencing could be erected to exclude currently grazing livestock, which currently keeps the existing grass very short, and would allow for easy passage of water over the floodplain. Excluding livestock will encourage the natural re-growth of rougher vegetation to increase the potential for out-of-bank flow attenuation. This can be aided by the planting of a riparian buffer strip of rougher vegetation (Figure 3-7).

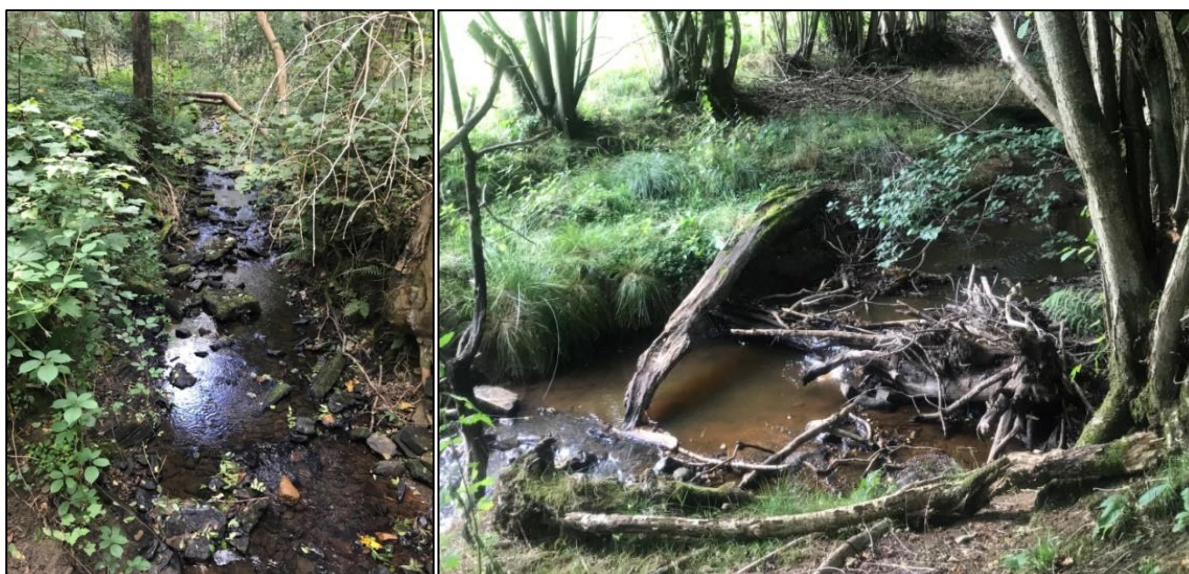
Figure 3-11: Channel character at the confluence of Harland Beck and River Dove (Left). Existing, naturally occurring large woody debris in West Gill Beck (Right).

The tributaries of the River Dove provide greater opportunity for in-channel NFM measures due to their smaller size. Although Harland Beck, at the confluence with the River Dove, is too deep and wide for in-channel NFM measures (Figure 3-11), the channel further up will likely be more suitable, although it would be beneficial to try and gain access to the channel further upstream to confirm this.

On West Gill Beck (Figure 3-9), there is existing naturally occurring large woody debris, from decaying and living trees, blocking the channel (Figure 3-11). These blockages have collected additional smaller debris increasing water storage upstream. There is evidence on low lying floodplains that inundation and ponding of water occurs at higher flows, with debris and sediment collecting at the hillslope edge of the floodplain. Where the public footpath crosses the channel upstream of High Barn, a large dead tree trunk rests on the hillslope (Figure 3-12), this could be pulled down onto the floodplain to act as a blockage to high flows and increase storage on the floodplain.

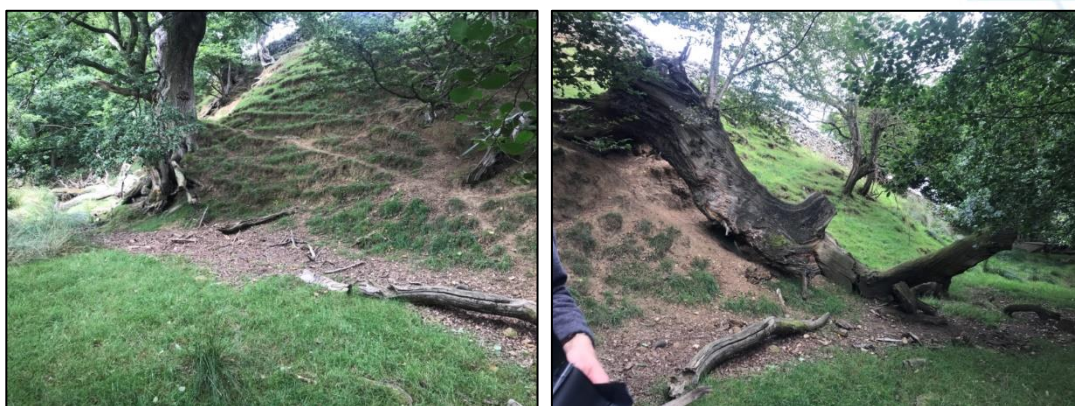
Figure 3-12: Evidence of floodplain inundation (top) and potential material which could be used to increase floodplain storage (bottom) on West Gill Beck

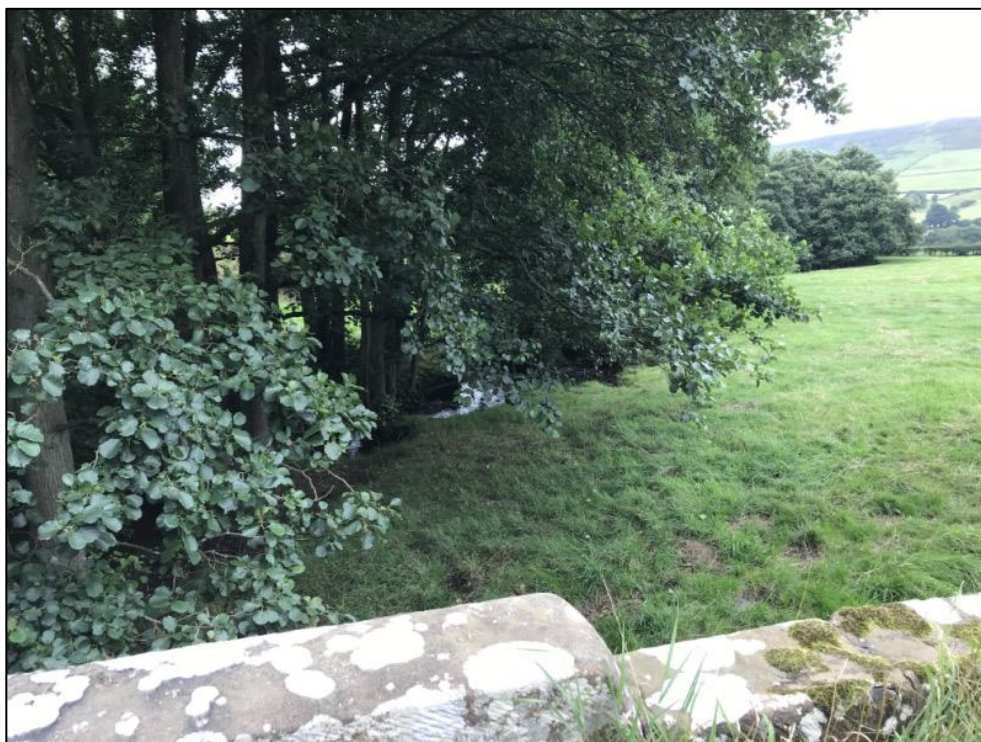
Figure 3-13: Fish Beck at Church Houses, leaky barriers could be implemented here to utilise the floodplain

The channel of Fish Beck is suitable for within channel NFM, such as leaky barriers, at Church Houses (Figure 3-13). Leaky barriers here and further upstream should be designed to take advantage of any floodplain which sits below the typical elevation of the adjacent fields. There was also evidence of poaching of the banks, therefore it would be advantageous for fencing to be erected in the riparian zone to exclude livestock and allow for the growth of rougher vegetation to increase the potential for attenuation of higher flows. We assume the channel is of a similar character upstream of Church Houses and would therefore be suitable for leaky barriers, however access is likely to become an issue within the more remote headwater areas.

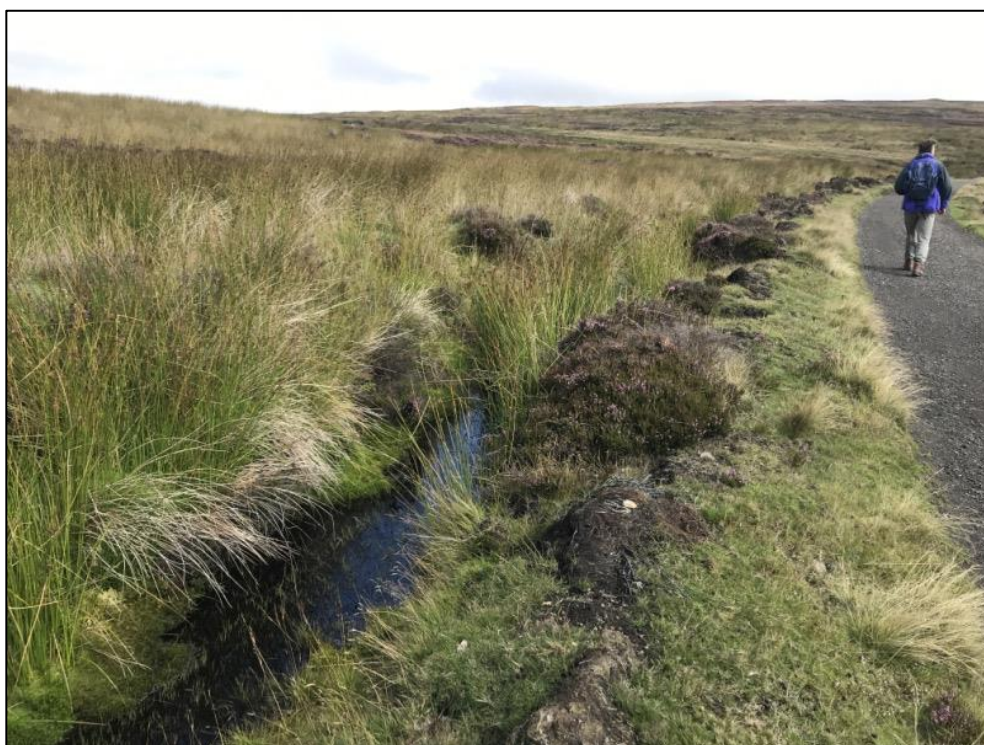
Figure 3-14: Smaller drainage ditches parallel to railway embankment which could be blocked to create pool features

Upstream of Fish Beck is Blakey Gill, on the moorland plateau, there are opportunities to block the existing drains that runs parallel to the old Rosedale Iron Ore railway (Figure 3-14). Where Blakey Gill crosses the old railway embankment, there is an opportunity to utilise the existing embankment as a bund feature and sensitively modify the existing infrastructure (culvert/pipe), to allow for water to be stored upstream of the embankment in heavy rainfall (Figure 3-15).

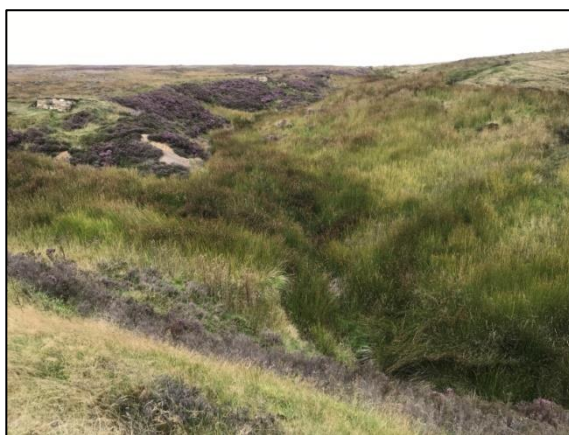
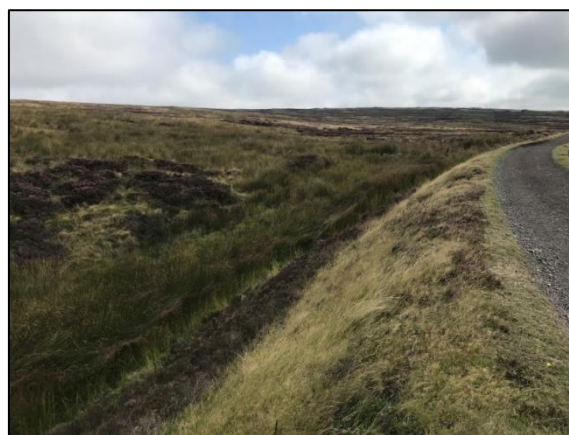
Figure 3-15: Large potential storage opportunity upstream of the disused railway embankment

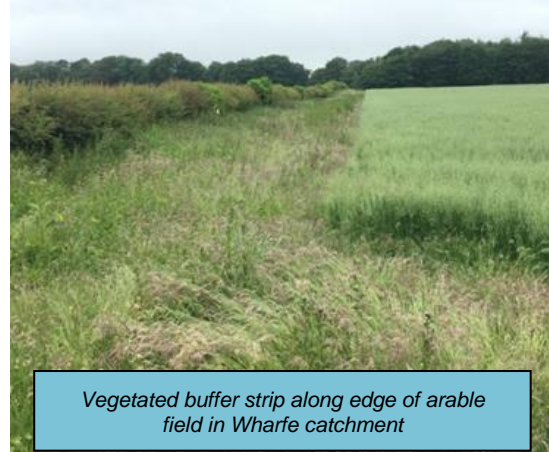
<p><i>Vegetated buffer strip along edge of arable field in Wharfe catchment</i></p>
Benefits	<p>Flooding</p> <p>A well-managed woodland cover can increase the capture and evaporation of rainfall by interception. This can reduce the amount of rainfall reaching the ground by as much as 45%, or more for some types of woodland. A reduction of even half of this amount could therefore make a major contribution to flood control.</p>
	<p>Sediment</p> <p>Buffer strips can provide a physical barrier that helps restrict the flow of flood water, carrying sediment and nutrients, and prevents them from being washed from the field into the watercourse.</p> <p>The further development of the vegetated buffer strip will aid the improvement of bank stability and reduce the erosion risk through an increased root network within the soil substrate.</p>
	<p>Habitat</p> <p>Buffer strips help create wildlife corridors and sites for ground nesting birds, small mammals, and beneficial insects. Buffer strips can also provide support for more foraging pollinators.</p> <p>They also improve woodland connectivity to the wider landscape for mammals and birds and additionally provide areas of shelter for livestock.</p>

Design considerations	<p>Riparian buffer strips should be 5-10m wide and may require fencing to exclude livestock from the riverbanks. This allows the natural vegetation within this zone to grow producing a rough vegetated surface.</p> <p>These planted areas can be further enhanced into hedgerows or woodland planting which are natural weather barriers, protecting crops, soils, and livestock. They provide ideal habitat for farmland birds and wildlife species, and also perform a natural flood management function by trapping and slowing water flow.</p>

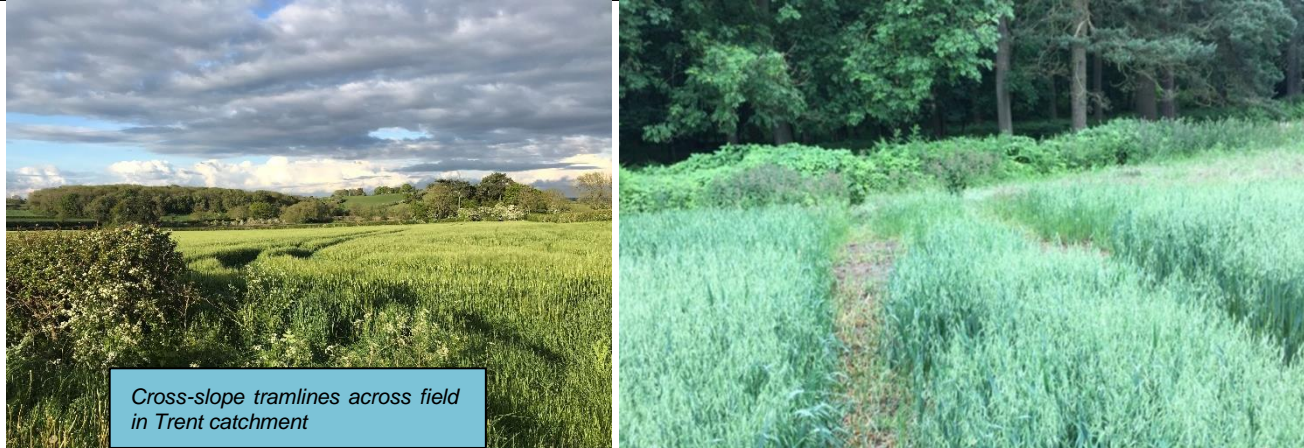
<p><i>Cross-slope tramlines across field in Trent catchment</i></p>

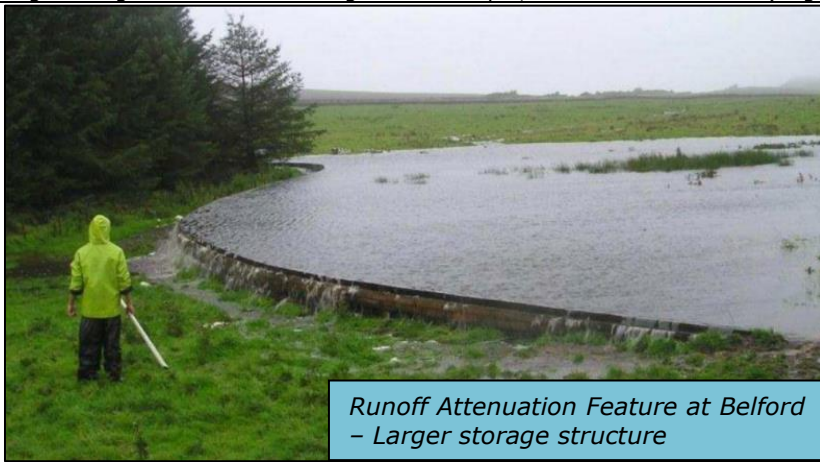
<p><i>Runoff Attenuation Feature at Belford – Larger storage structure</i></p>

Offline Storage Areas	
Description	Offline storage areas are floodplain areas that have been adapted to retain and attenuate floodwater in a managed way. They usually require the construction of a containment bund which increases the amount of water that can be stored on a floodplain and may also require an inlet, outlet and potentially a spillway mechanism. Many different terms are used internationally to describe offline storage areas. However, the important difference between these definitions is the size and amount of engineering involved in the design. For example, the terms washlands (larger scale) and run-off attenuation features (smaller scale) are frequently used.
Examples

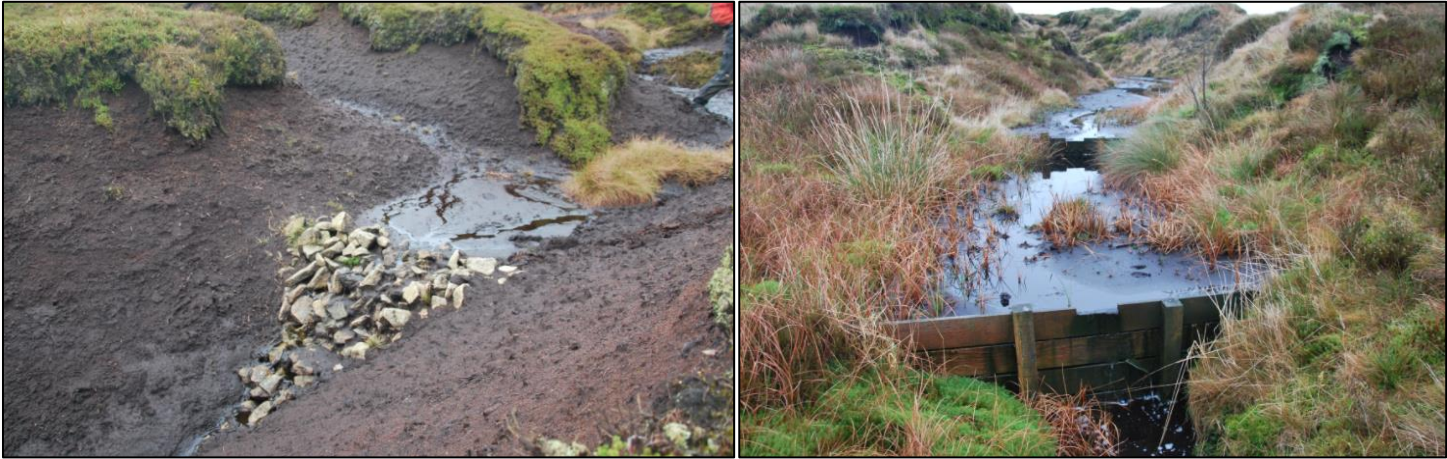
<p>Moors for the future – gully blocking</p>
Benefits	Flooding Similar to a leaky barrier, each individual barrier in turn will not have significant impacts on any hydrograph peak. Multiple barriers within a system are needed to significantly reduce and slow any flood flows.
	Sediment Gully blocking has been shown to decrease erosion and encourage fine sediment accumulation. In addition, flood velocities are decreased downstream to aid further erosion.
	Habitat Small pools of stored water are created which can enhance local wildlife. In addition, the higher water table encourages restabilisation and filling in of the gully, revegetation will occur, increasing carbon sequestration and habitat availability.

Grip and Gully Blocking	
Description	Grip and Gully blocking ¹² involves the construction of dams across gullies or grips to block the flow pathway and slow the flow of water. Sediment and vegetation accumulate behind the dam restoring the eroded gully. It can also involve completely infilling the gully.
Examples

Design considerations	Dams should be wider than the grip or gully they are blocking, with a lower section in the middle to reduce the risk of erosion at the edges. Completely infilling the gullies will create wetter areas, allowing water to dissipate over the moor. Variety of materials can be used (timber, stones, heather) which vary in cost and permeability. Built in succession, dams should not overtop as this may impact the integrity of the dam itself and cause erosion downstream. Timber dams are built in a similar fashion to leaky boards (see below), where the retaining posts are knocked into the ground and trenches dug into the sides of the gully to slot the timber boards in. The size of gaps between each board will alter the amount of water ponding that will occur.
Maintenance	Check for damage, including erosion, after significant rainfall events.
Permissions, consents, surveys	Planning permission may be required for moorland restoration.

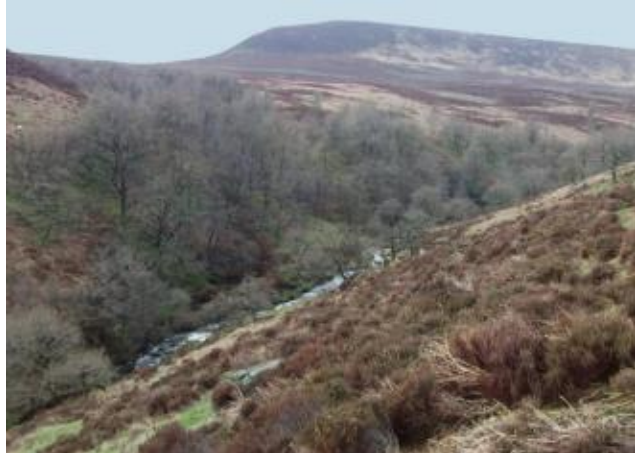
<p>Clough woodland – Moors for the Future</p>
Benefits	Flooding Increase roughness of the surface in areas where flow is usually very fast, encouraging water to slow down on steep slopes
	Sediment Planting trees can improve the soil structure and resilience, reducing erosion and improving water quality
	Habitat Clough woodland connects moorland to high value habitat in the valley, providing a corridor for wildlife movement. Trees provide food and shelter for both moorland species and livestock.
Design considerations	Trees should be planted in accordance with UK Forestry Standard, aiming to achieve National Vegetation Classification. Each block should consist of 40% open ground and 60% varied density tree planting (~1,600 trees per hectare). Fencing may be required, particularly during initial woodland establishment.

Clough Planting	
Description	Small blocks of broadleaf tree planting in areas of steep-sided valleys on the edges of open moorland ¹³ . Native species include Oak, Birch, Rowan, Aspen, Alder, Willow, Hawthorn and Holly and clough woodlands often have varied structures. Benefits may include contribution to bracken control, shade and shelter for livestock and a source of timber.
Examples
