Inspection Report For:
Kirkbymoorside Town Council

Inspection Location:
70790 - Kirkbymoorside Town Council

Inspection Date:
17/08/2026

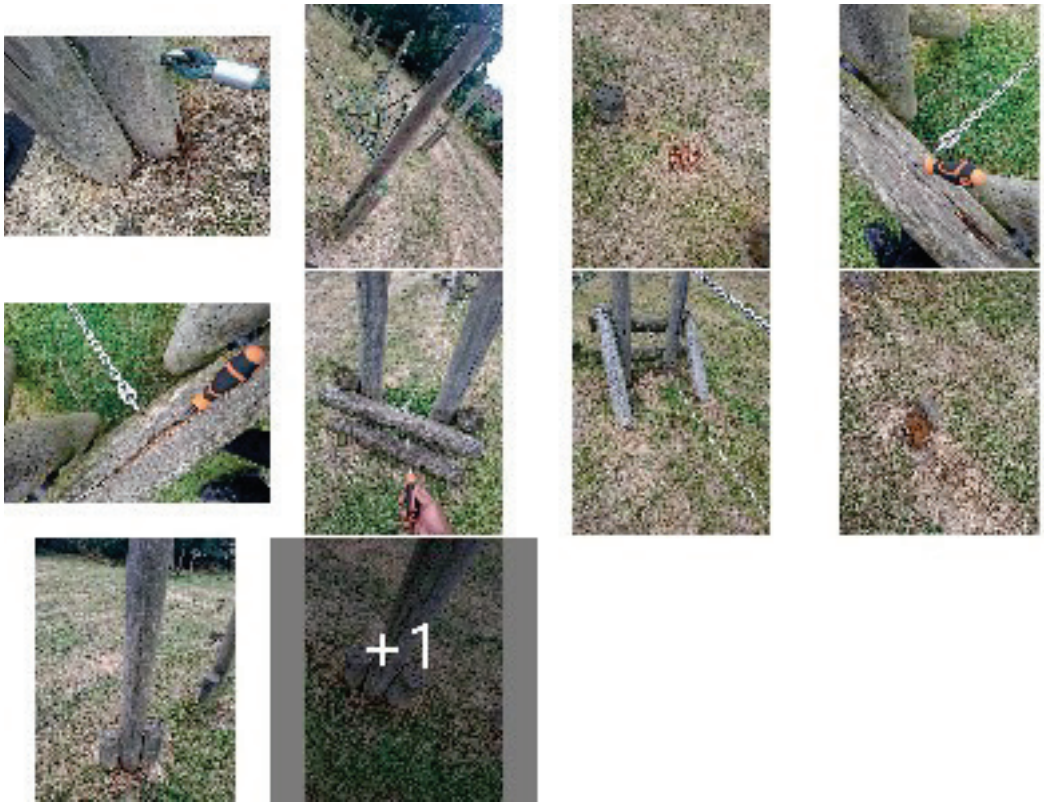
Trim Trail

Medium Risk

Finding One:	The item is in poor overall condition
Action(s):	Refer to original suppliers Operation Manual for guidance on routine inspections and maintenance
Finding Two:	Equipment was nearing end of life
Action(s):	Recommend to start planning on replacing the trim trail
