Annual inspection report

Kirkbymoorside Town Council play areas at

Old Road, Kirkbymoorside, York, YO62 6LT &

Ryedale View, Kirkbymoorside, York, YO62 6EH

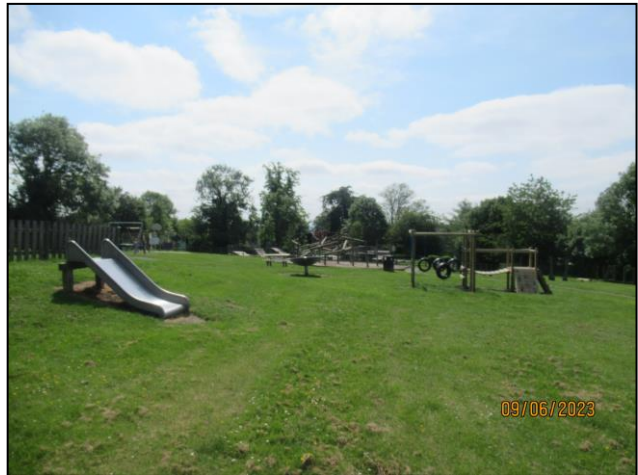
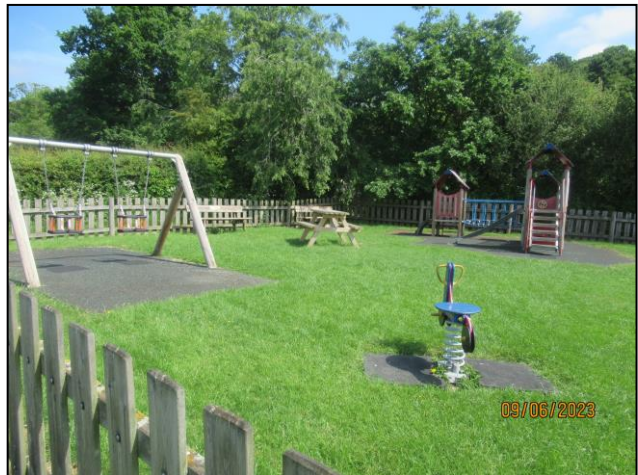
1. Sovereign Multi Climbing Frame

Condition: No defects were found

Compliance: Complies with BS EN 1176

Surface Condition: Satisfactory

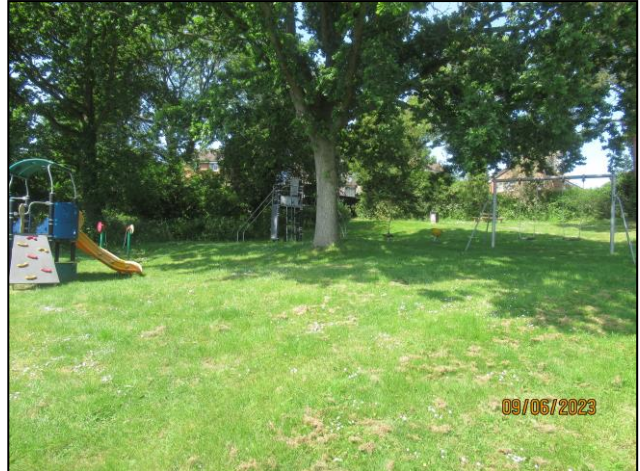
1. Kompan Junior Multi Unit

Condition: Slide requires cleaning due to bird fouling

Surface Condition: Satisfactory
