Annual inspection report

Kirkbymoorside Town Council play areas at

Old Road, Kirkbymoorside, York, YO62 6LT &

Ryedale View, Kirkbymoorside, York, YO62 6EH

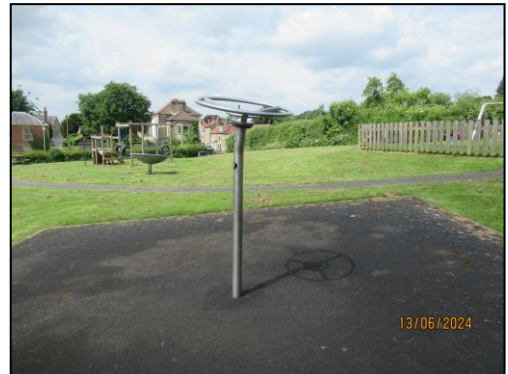
Condition: No defects were found

Surface Condition: Satisfactory

Surface Compliance: Meets the dimensional requirements of BS EN 1176

Low Risk: 6

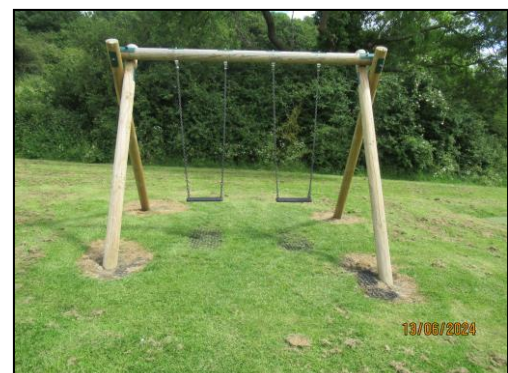
Condition: No defects were found

Surface Condition: Satisfactory

Surface Compliance: Meets the dimensional requirements of BS EN 1176

Low Risk: 4

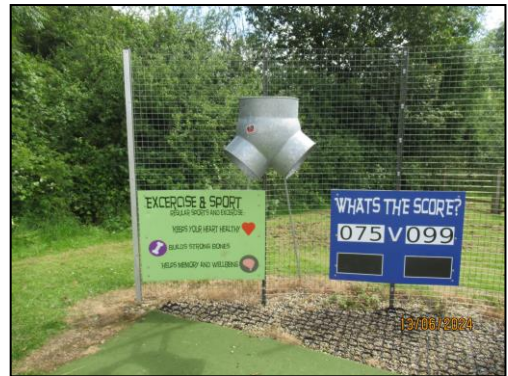
10. Unknown Make Ball Chute

Condition: No defects were found

Surface Condition: Satisfactory

Low Risk: 4

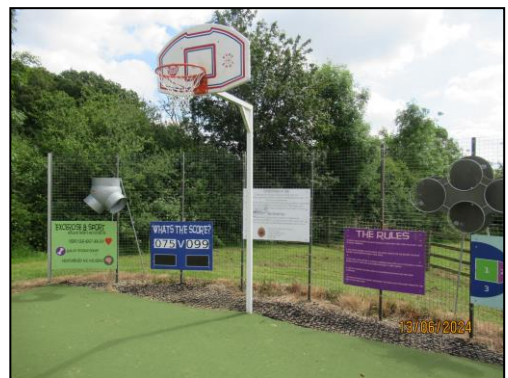
11. Sure Shot Basketball

Condition: No defects were found

Surface Condition: Satisfactory

Medium Risk: 8

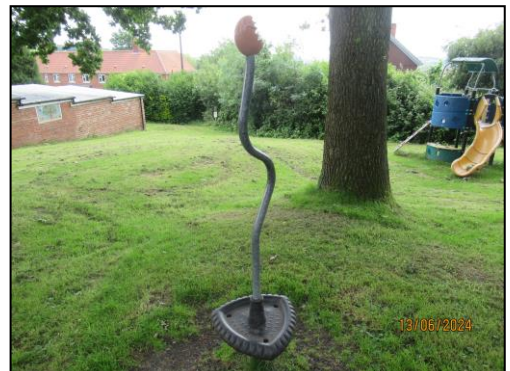
Condition: No defects were found

Surface Condition: Satisfactory

Surface Compliance: Meets the dimensional requirements of BS EN 1176

Low Risk: 4

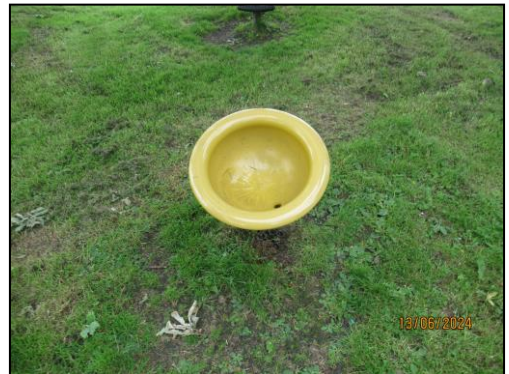
5. Kompan Spinning Bowl

Condition: No defects were found

Surface Condition: Satisfactory

Surface Compliance: Meets the dimensional requirements of BS EN 1176

Very Low Risk: 2
