Annual inspection report

Kirkbymoorside Town Council play areas at

Old Road, Kirkbymoorside, York, YO62 6LT &

Ryedale View, Kirkbymoorside, York, YO62 6EH

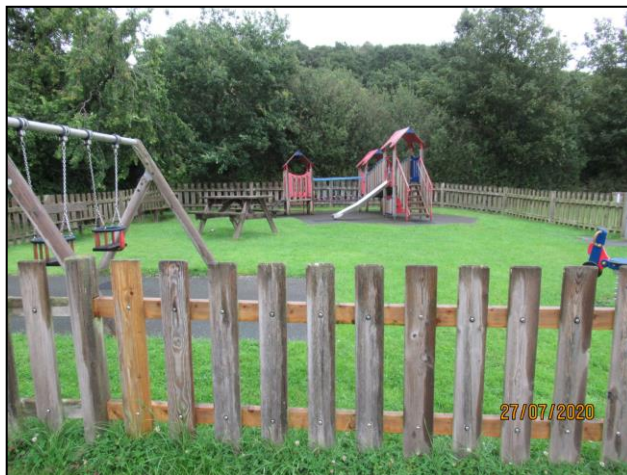
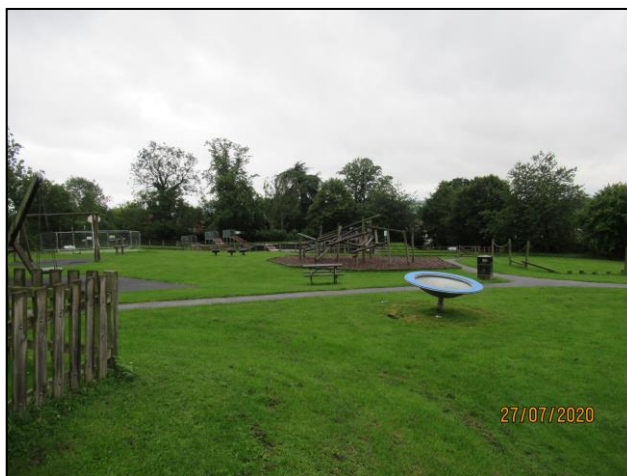
### 1. Sutcliffe Large Spinning Bowl

**Condition:** No defects were found

**Compliance:** Complies with BS EN 1176

**Surface Condition:** Satisfactory

**Surface Compliance:** Meets the dimensional requirements of BS EN1176

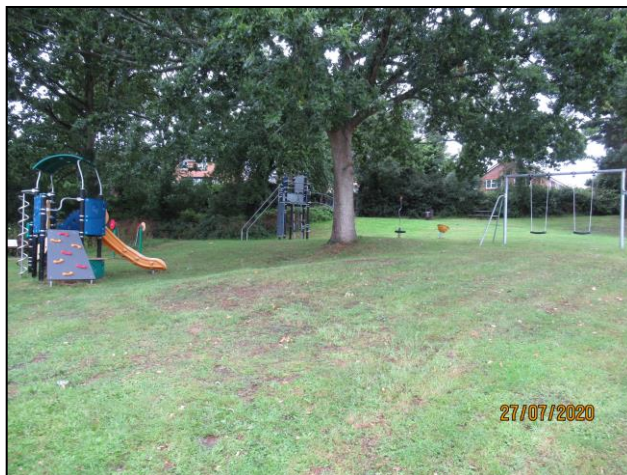
### 1. Kompan Junior Multi Unit

**Condition:** No defects were found

**Surface Condition:** Satisfactory
