# JK ARBORICULTURE

Tree Safety inspection – Recreation Ground, Kirkbymoorside.

September 2020

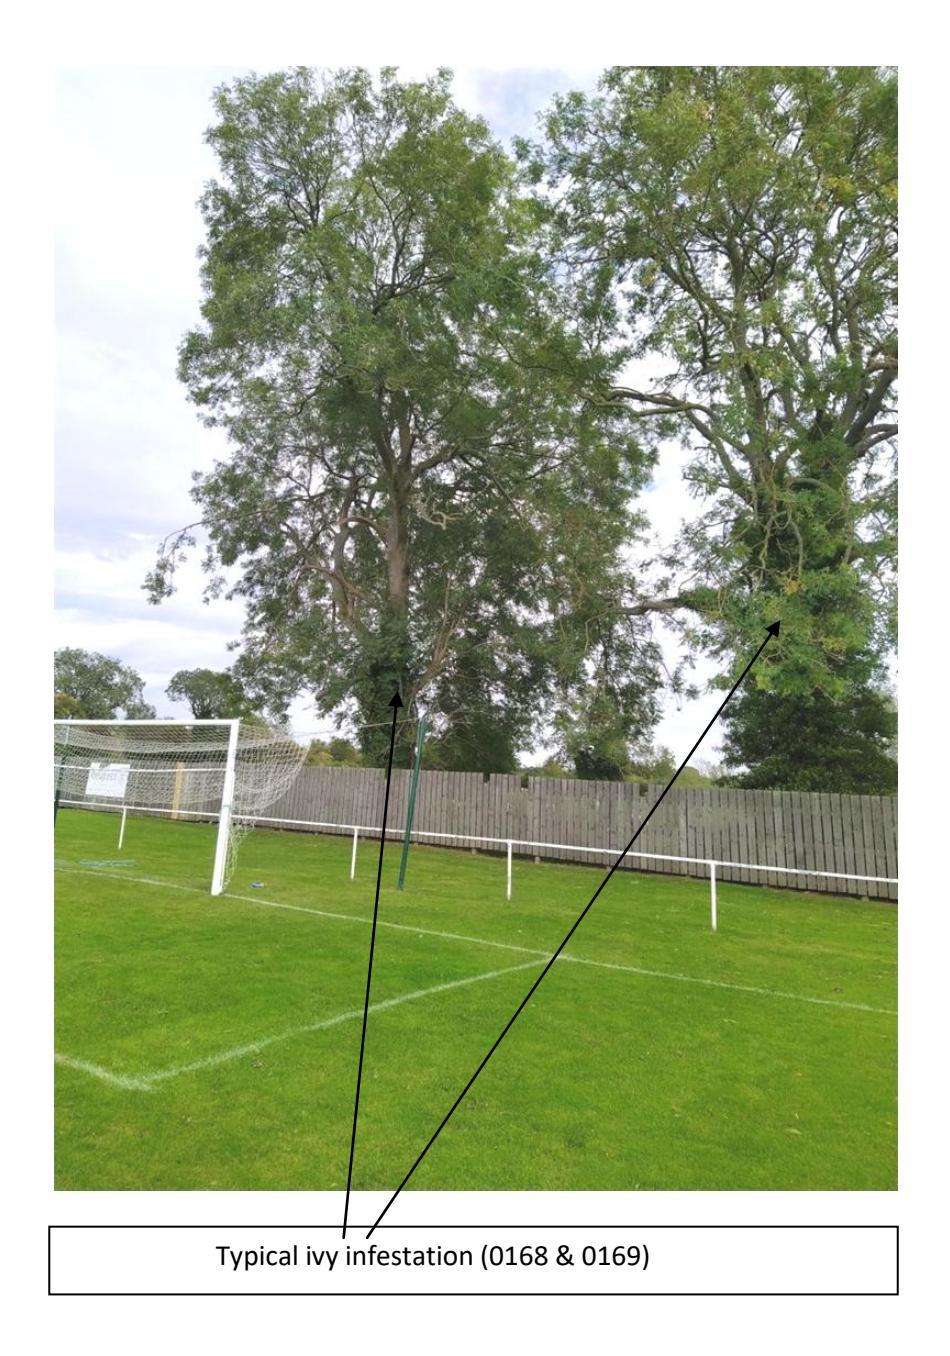
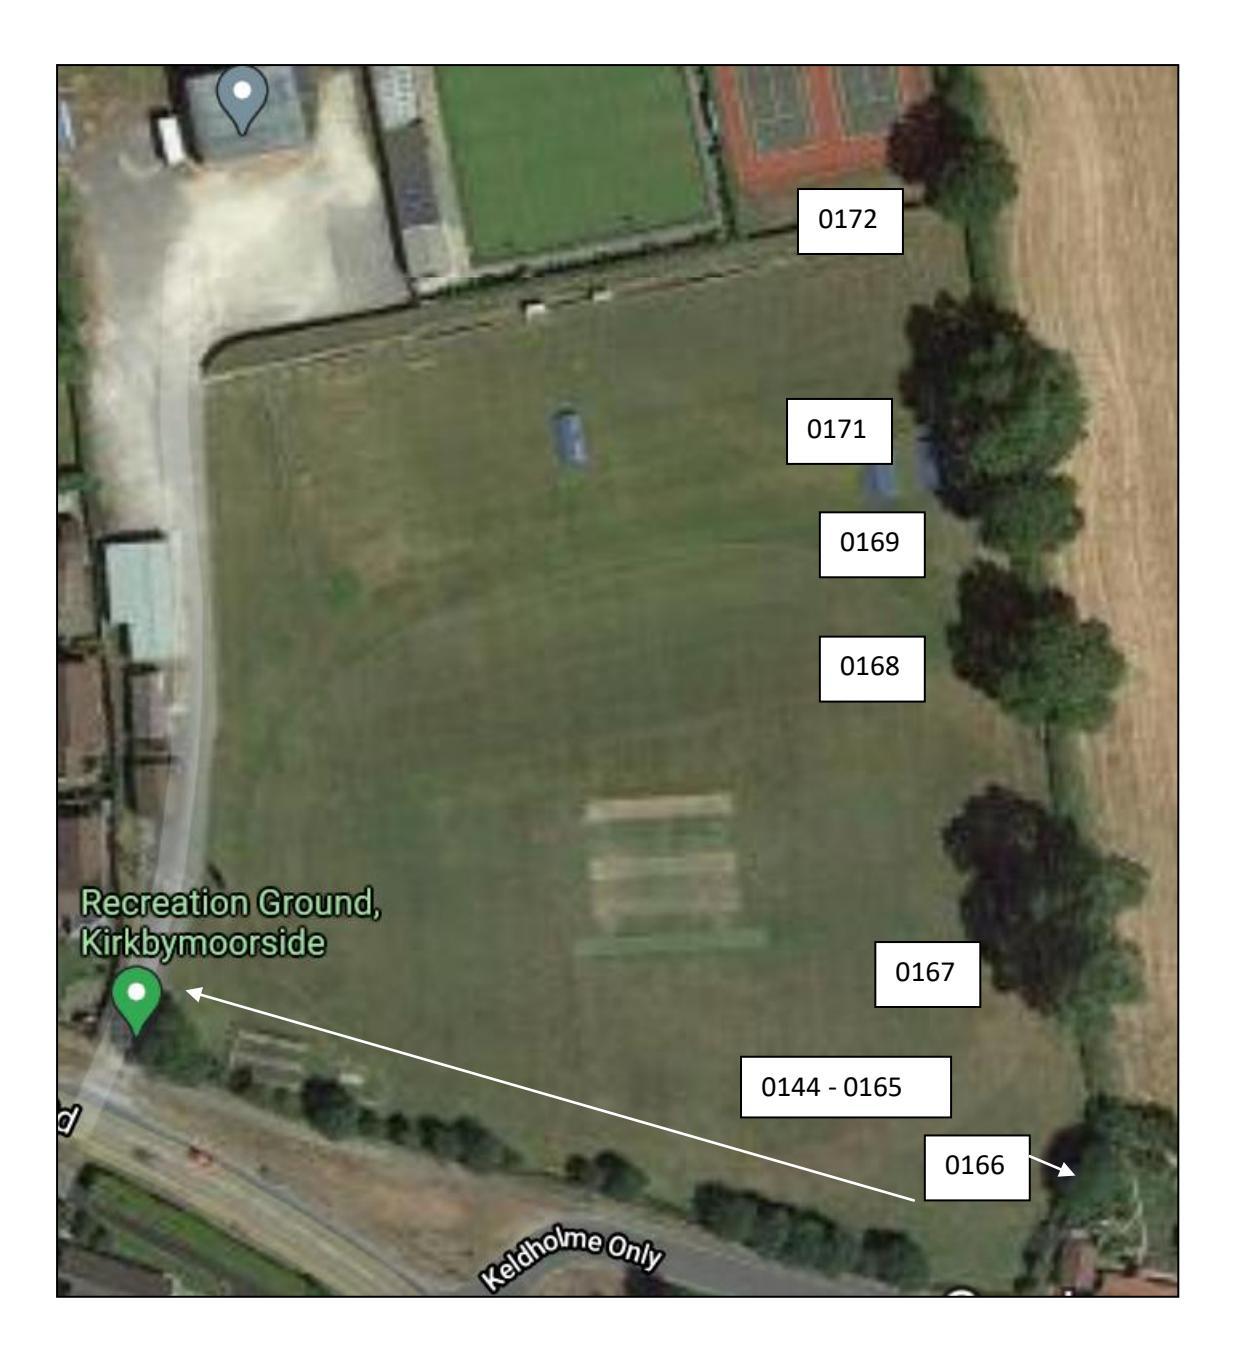
The trees along the eastern boundary are all mature consisting of two Poplars and four ashes. Poplar 0166 has an old scar on the southern side of its trunk and although there is good healing around the wound area the trunk is hollow at that point and there are two areas of Amalllaria media fungus at the base of the trunk. This fungus causes white rot in roots and stems and can cause the collapse of tree without warning. It is therefore advised that owing to the position of the tree it should be removed during the coming months. The fungus spreads through 'bootlace like' rhizomes through the soil and can affect other trees. It is therefore recommended that the remaining trees in the line are inspected annually.

Large mature tree,	Consider felling during the coming		
	Eastern		large scar on	winter.		
0166	boundary	Poplar	southern side of		М	M-H
			main trunk hollowing			
			in middle, Fruiting			
			bodies of Amilllaria			
			mellia (Bootlace			
			fungus)			
0167	•	•	Large mature tree,	Could ultimately be affected by the		
			appears outwardly	adjacent fungus as it can spread	М	L-M
			sound	through neighbouiring root		
				systems Monitor		
0168	•	Ash	Extensive ivy growth	Sever ivy at the base of the tree to		
			on main stem	prevent encroachment into the	М	L-M
				crown.		
0169	•	•	Extensive ivy growth	Sever ivy at the base of the tree to		
(no			on main stem	prevent encroachment into the	М	L-M

The damaged hollow area in tree 0166 and the emerging fruiting bodies at ground level
