Inspection Report For:
Kirkbymoorside Town Council

Inspection Location:
70790 - Kirkbymoorside Town Council

Inspection Date:
13/03/2026

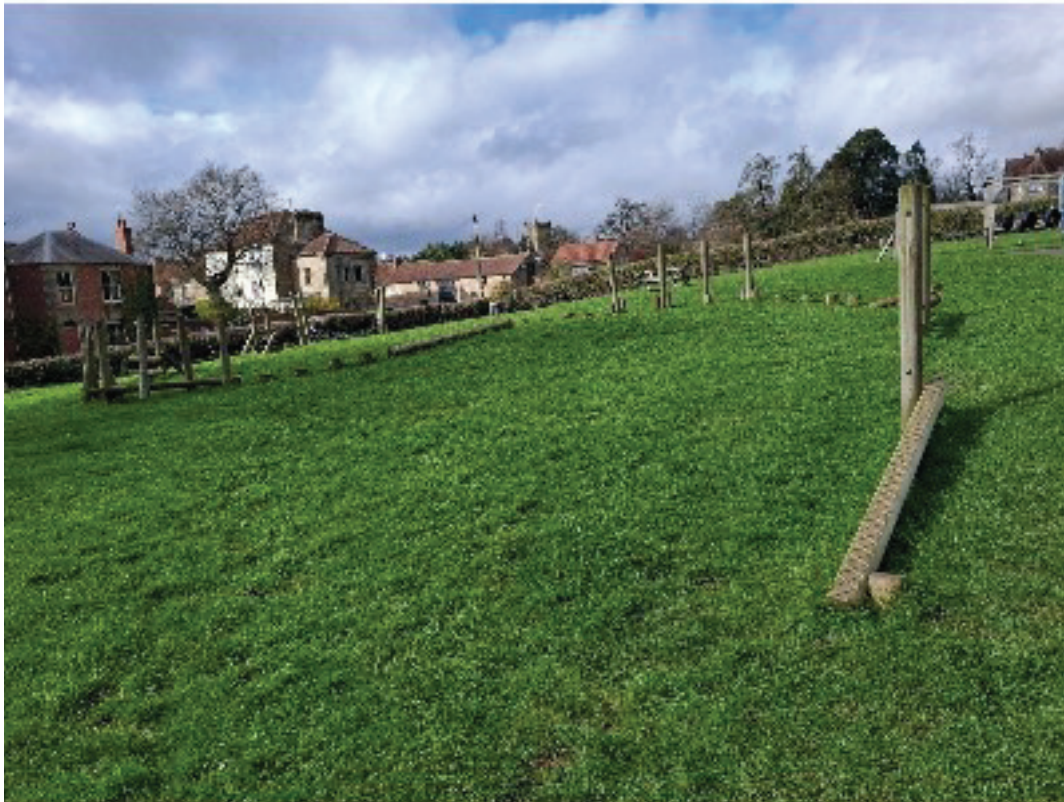
Trim Trail

Medium Risk

Surfacing Type:	Grass	Surfacing is without defect:	Yes
Equipment Supplier:	Playdale	Equipment is without defect:	No
Equipment is labelled:	Yes

Finding One: The item is in moderate overall condition

Finding Two: Some of the timbers were showing early signs of fatigue

Action(s): Refer to original suppliers Operation Manual for guidance on routine inspections and maintenance

Action(s): The affected timbers require replacing

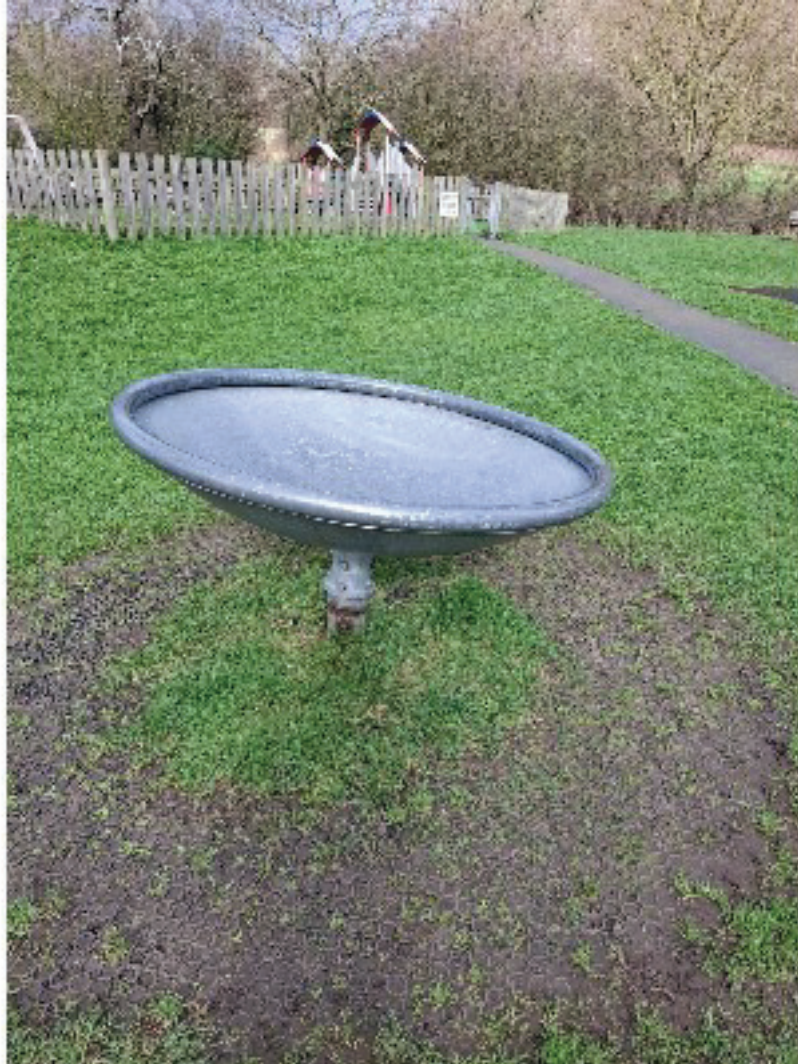
Spinner

Low Risk

Surfacing Type:	Grass Guard	Surfacing is without defect:	Yes
Equipment Supplier:	Unknown	Equipment is without defect:	Yes
Equipment is labelled:	No

Finding One: The item is in good overall condition

Action(s): Refer to original suppliers Operation Manual for guidance on routine inspections and maintenance

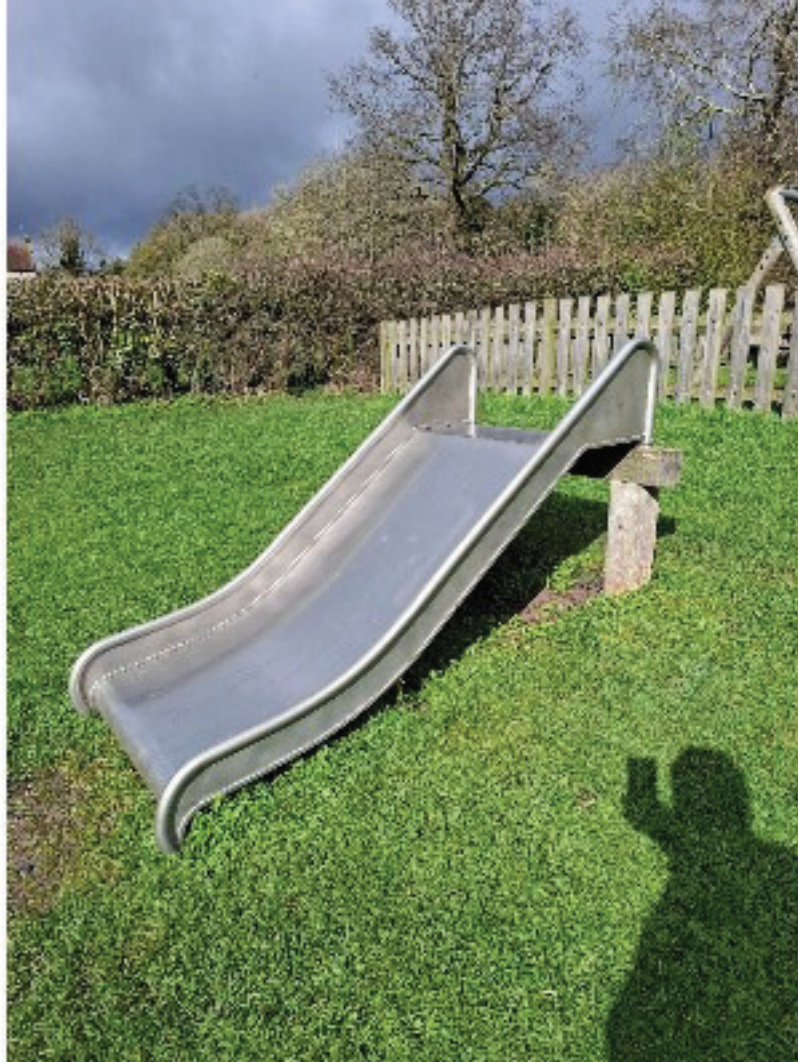
Mini Embankment Slide

Low Risk

Surfacing Type:	Grass Guard	Surfacing is without defect:	Yes
Equipment Supplier:	Unknown	Equipment is without defect:	No
Equipment is labelled:	No

Finding One: The item is in moderate overall condition

Finding Two: Some of the timbers were showing early signs of fatigue

Action(s): Refer to original suppliers Operation Manual for guidance on routine inspections and maintenance

Action(s): Repair/replace as required

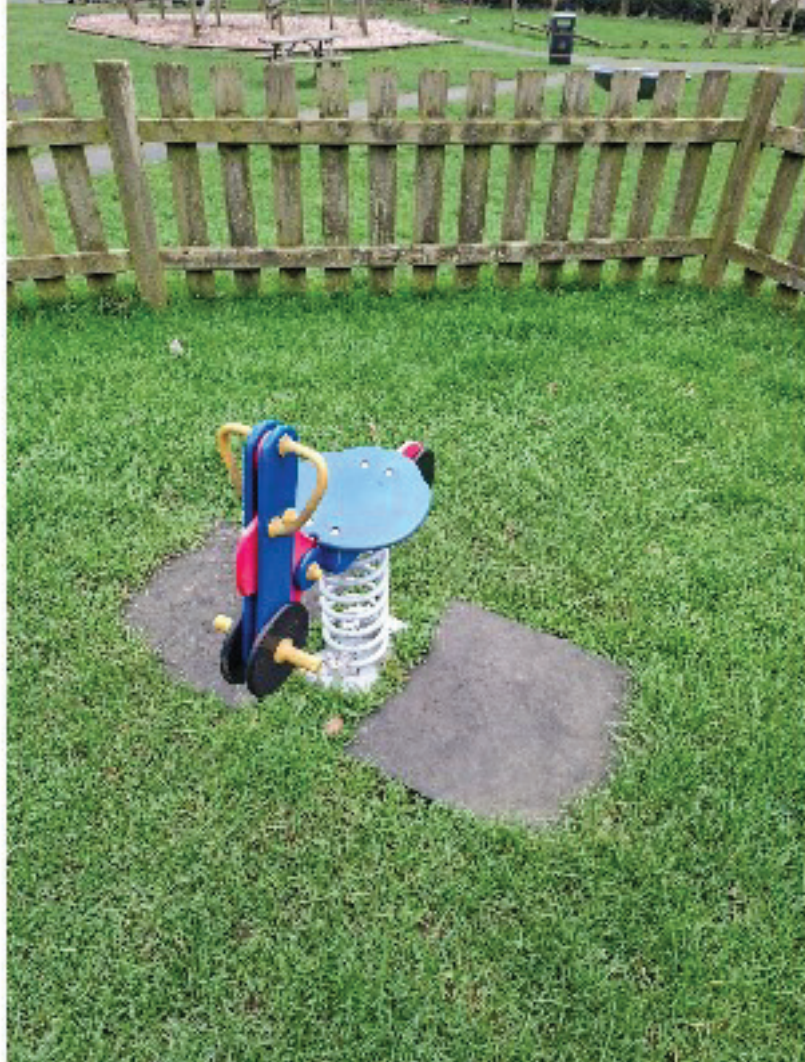
Rocker

Low Risk

Surfacing Type:	Grass	Surfacing is without defect:	Yes
Equipment Supplier:	Unknown	Equipment is without defect:	Yes
Equipment is labelled:	No

Finding One: The item is in moderate overall condition

Action(s): Refer to original suppliers Operation Manual for guidance on routine inspections and maintenance

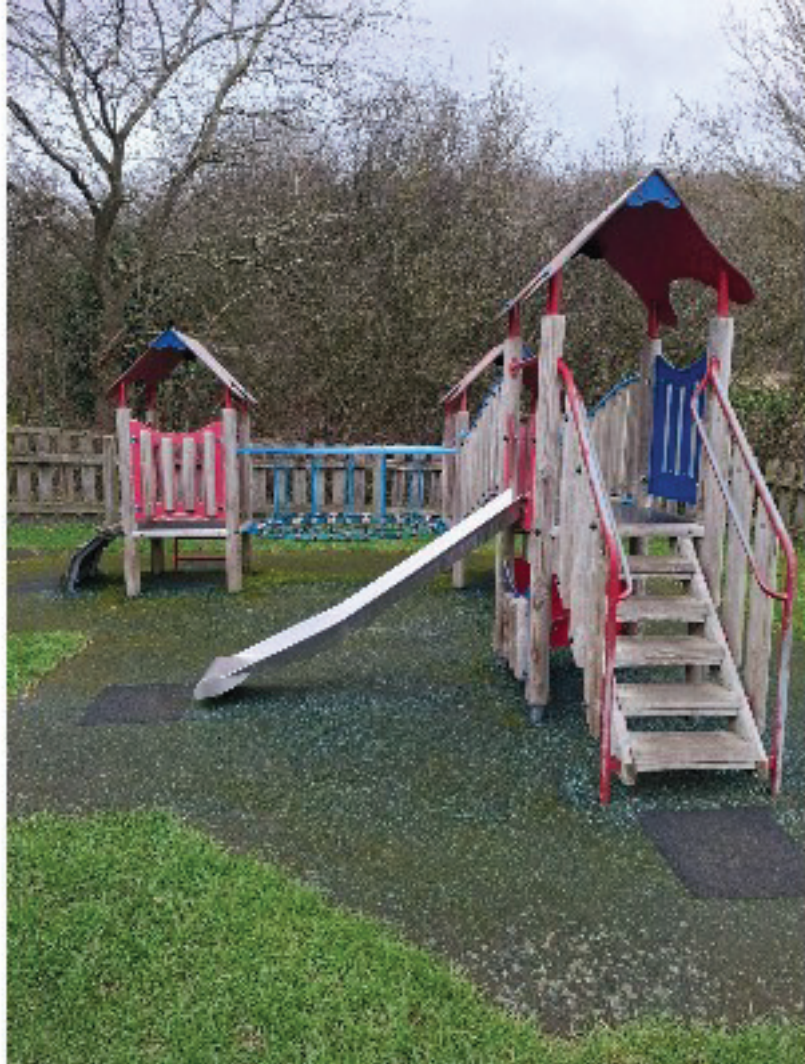
Multi Play Tower

Low Risk

Surfacing Type:	Wetpour	Surfacing is without defect:	No
Equipment Supplier:	Playdale	Equipment is without defect:	Yes
Equipment is labelled:	Yes

Finding One: The item is in moderate overall condition

Finding Two: There was algae or moss growth on the surface, causing a potential slip hazard

Action(s): Refer to original suppliers Operation Manual for guidance on routine inspections and maintenance

Action(s): Clean and treat appropriately

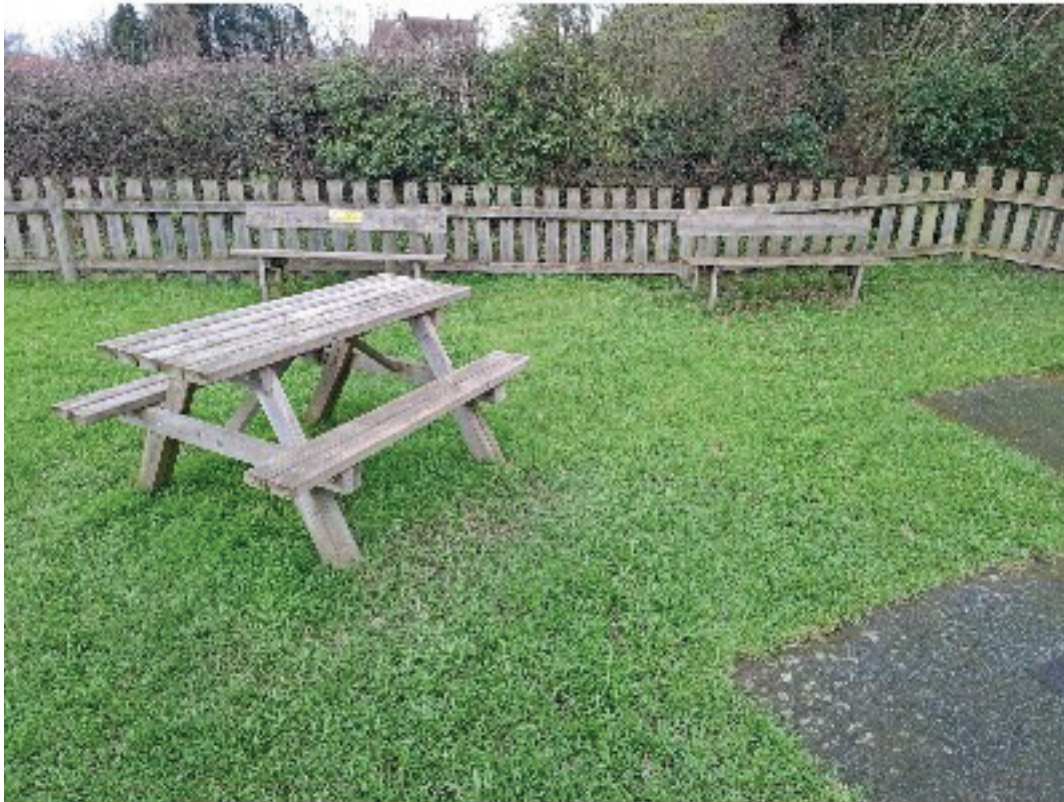
Various Benches

Low Risk

Surfacing Type:	N/A	Surfacing is without defect:	Yes
Equipment Supplier:	Unknown	Equipment is without defect:	No
Equipment is labelled:	No

Finding One: The item is in moderate overall condition

Finding Two: Some of the timbers were showing early signs of fatigue

Action(s): Refer to original suppliers Operation Manual for guidance on routine inspections and maintenance

Action(s): This is a low risk finding and no remedial action is required at this time - monitor use

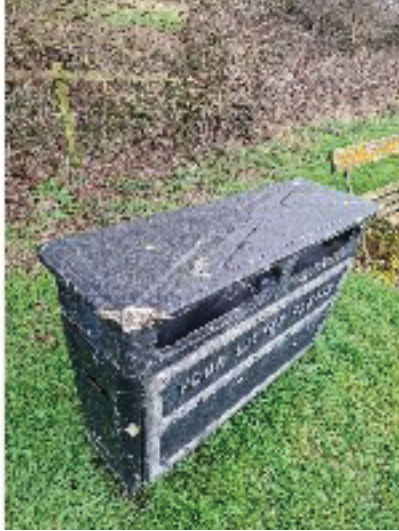
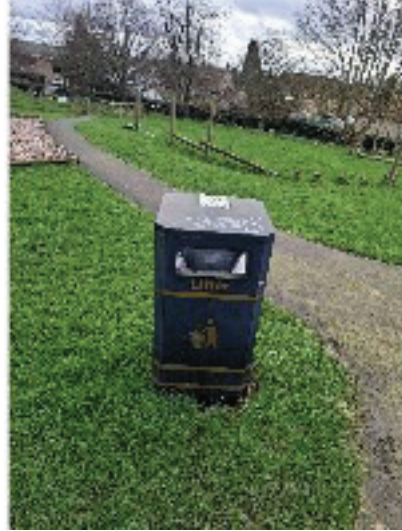
Various Bins

Low Risk

Surfacing Type:	N/A	Surfacing is without defect:	Yes
Equipment Supplier:	Unknown	Equipment is without defect:	Yes
Equipment is labelled:	No

Finding One: The item is in moderate overall condition

Action(s): Refer to original suppliers Operation Manual for guidance on routine inspections and maintenance

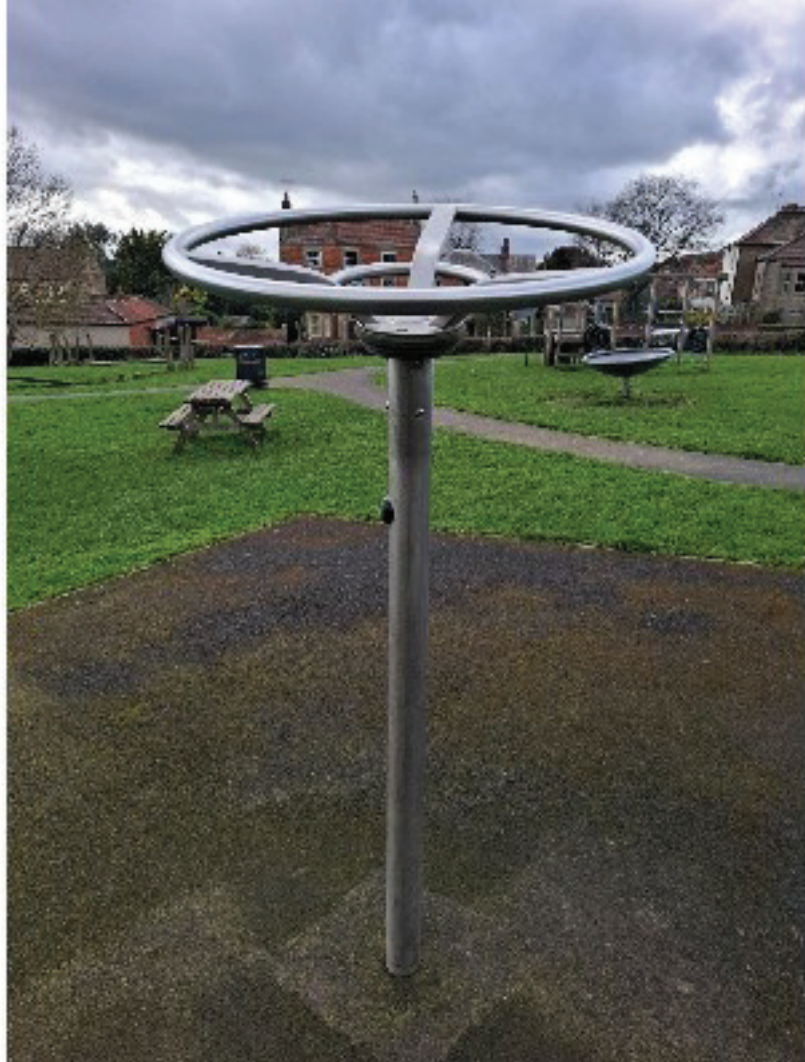
Spinner

Low Risk

Surfacing Type:	Wetpour	Surfacing is without defect:	Yes
Equipment Supplier:	Playdale	Equipment is without defect:	Yes
Equipment is labelled:	Yes

Finding One: The item is in good overall condition

Action(s): Refer to original suppliers Operation Manual for guidance on routine inspections and maintenance

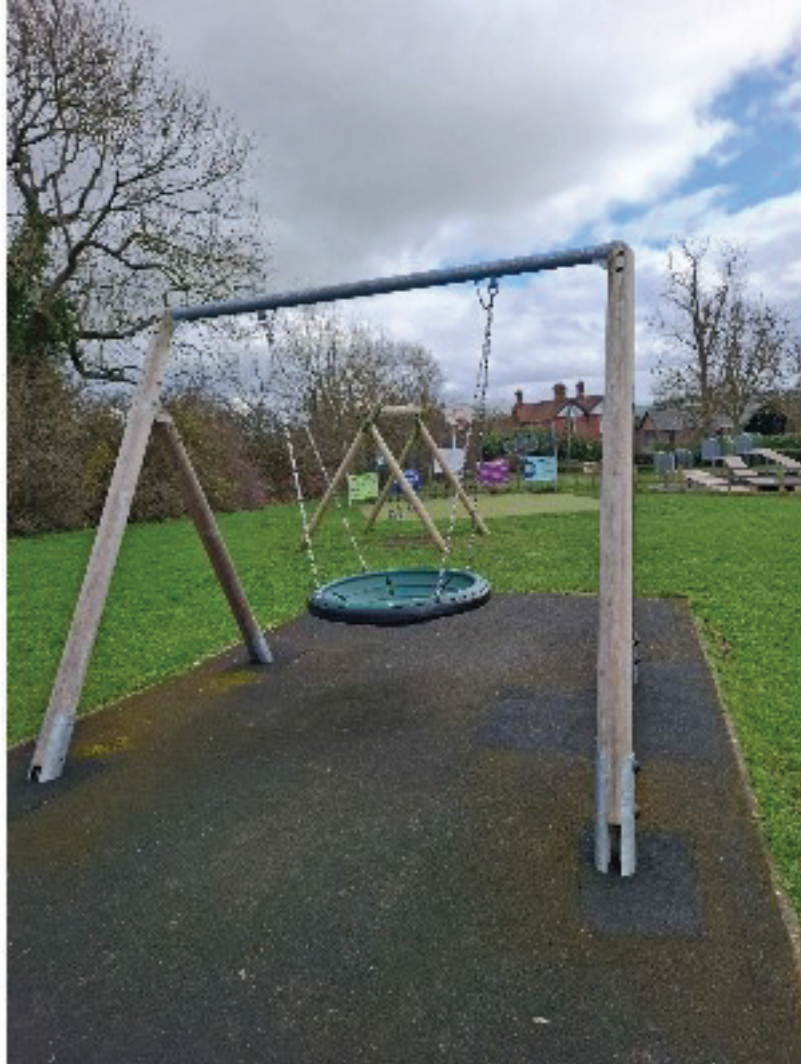
Basket Swing

Low Risk

Surfacing Type:	Wetpour	Surfacing is without defect:	Yes
Equipment Supplier:	Playdale	Equipment is without defect:	Yes
Equipment is labelled:	Yes

Finding One: The item is in good overall condition

Action(s): Refer to original suppliers Operation Manual for guidance on routine inspections and maintenance

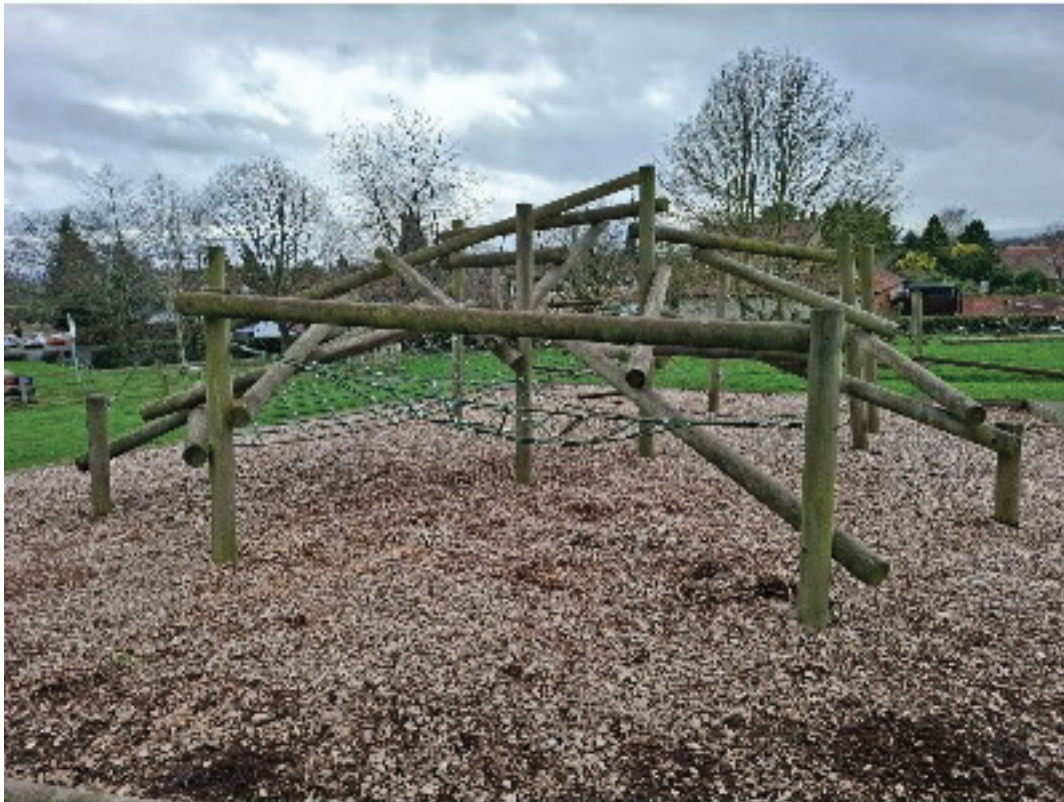
Log Climber

Medium Risk

Surfacing Type:	Bark	Surfacing is without defect:	Yes
Equipment Supplier:	Playdale	Equipment is without defect:	No
Equipment is labelled:	Yes

Finding One: The item is in moderate overall condition

Finding Two: Some of the timbers require replacing due to fatigue

Action(s): Refer to original suppliers Operation Manual for guidance on routine inspections and maintenance

Action(s): The affected timbers require replacing

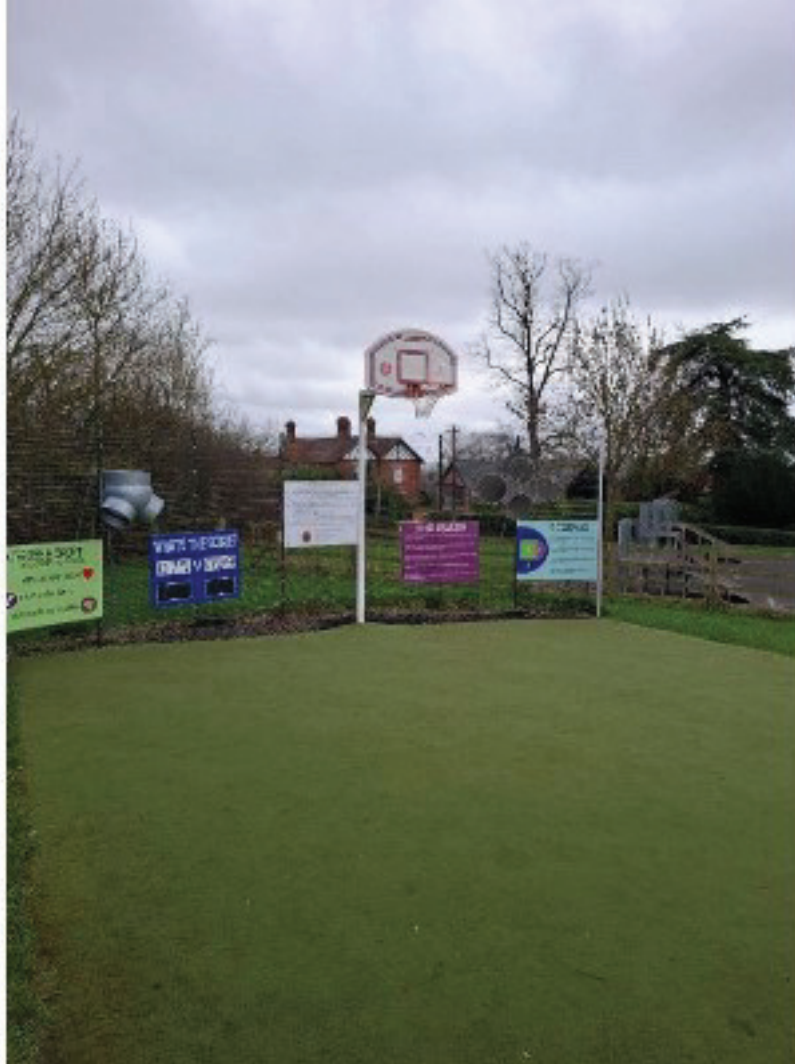
Basketball

Low Risk

Surfacing Type:	Artificial Grass	Surfacing is without defect:	Yes
Equipment Supplier:	Unknown	Equipment is without defect:	Yes
Equipment is labelled:	No

Finding One: The item is in moderate overall condition

Action(s): Refer to original suppliers Operation Manual for guidance on routine inspections and maintenance

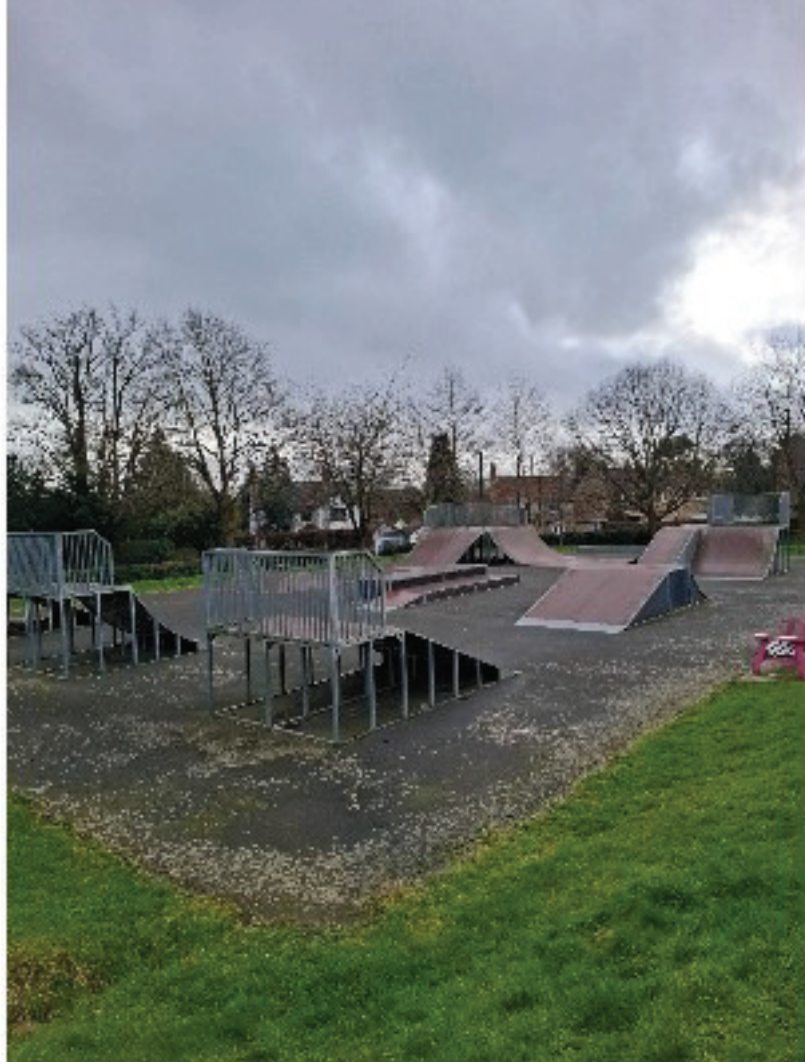
Skatepark

Medium Risk

Surfacing Type:	N/A	Surfacing is without defect:	Yes
Equipment Supplier:	Unknown	Equipment is without defect:	No
Equipment is labelled:	No

Finding One: The item is in moderate overall condition

Finding Two: Something seems to be pushing the flat section of the ramp up

Action(s): Refer to original suppliers Operation Manual for guidance on routine inspections and maintenance

Action(s): Refer to manufacturer for repair or replacement

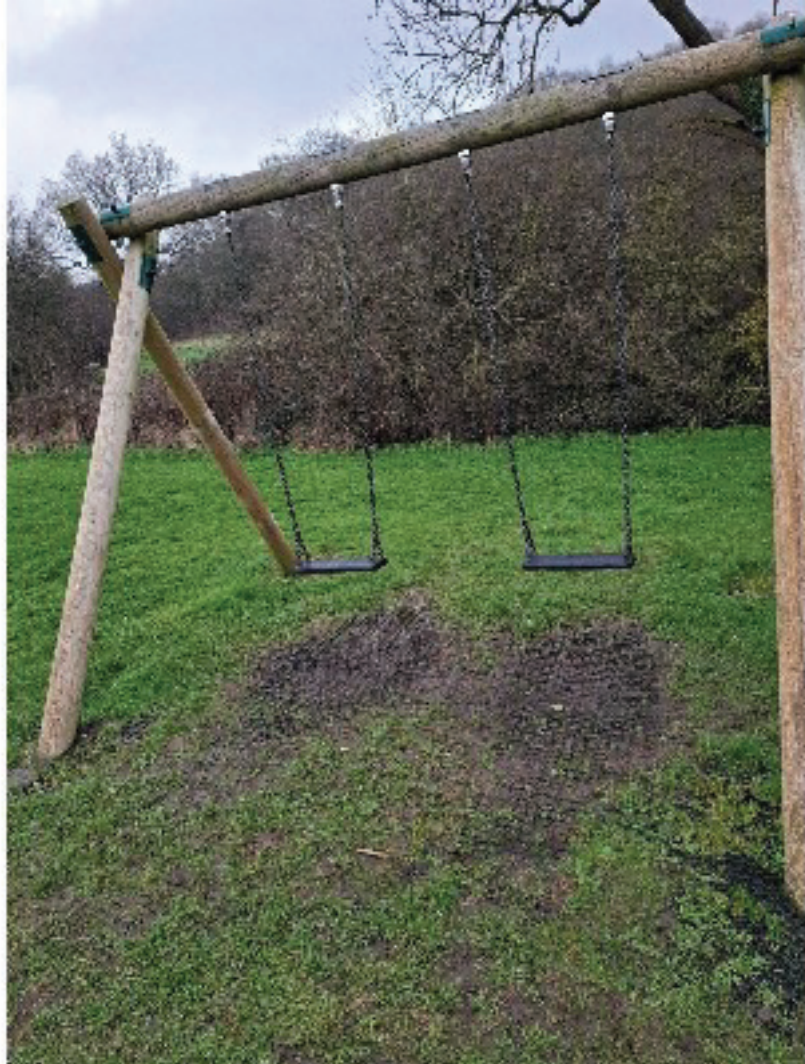
Swing Set

Low Risk

Surfacing Type:	Grass	Surfacing is without defect:	Yes
Equipment Supplier:	Sovereign Play	Equipment is without defect:	Yes
Equipment is labelled:	No

Finding One: The item is in good overall condition

Action(s): Refer to our Operation Manual for guidance on regular routine inspections and maintenance
