## Inspection Report For:

SOVEREIGN DESIGN PLAY SYSTEMS LIMITED

## Activity Tower

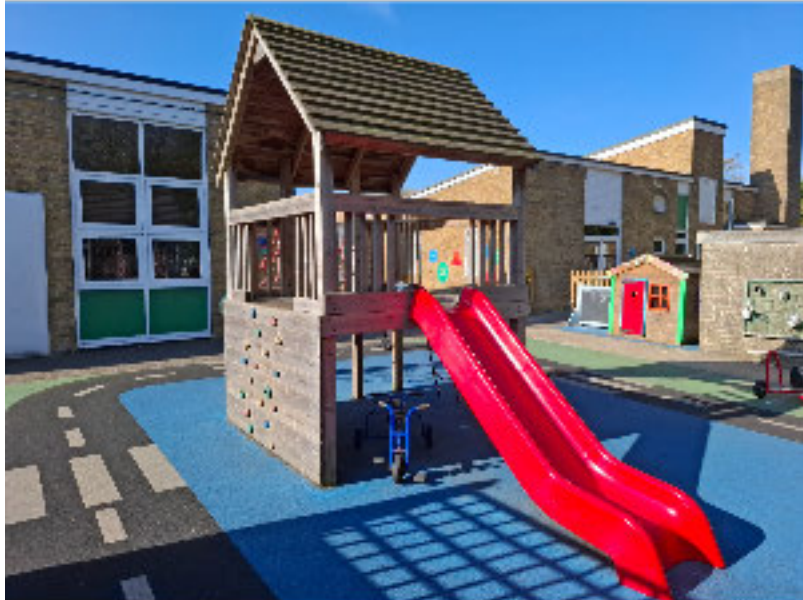
**Finding One:** The item is in good overall condition

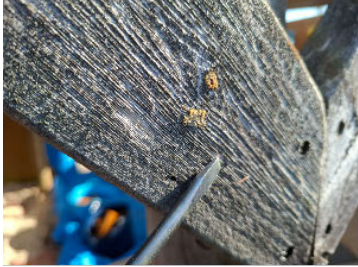
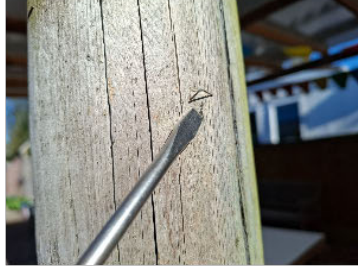
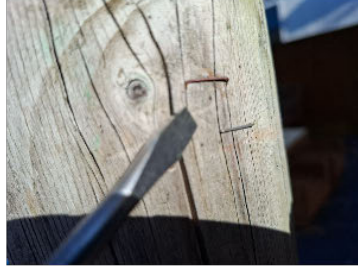
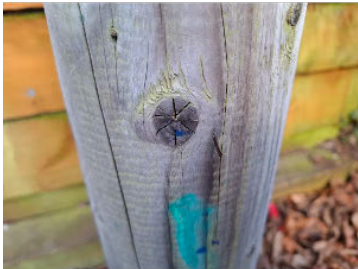
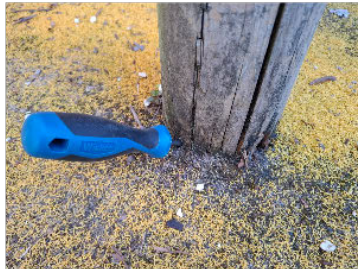
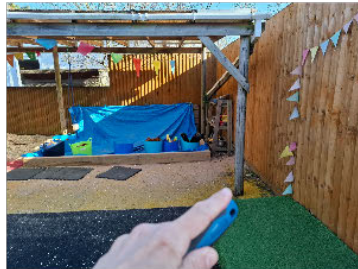
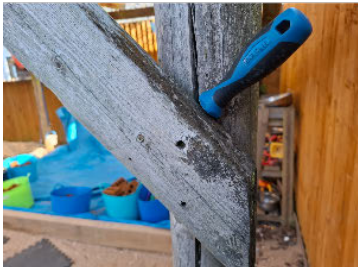
| <b>Finding One:</b> | The item is in moderate overall condition |
| <b>Finding Two:</b> | Staples/unused fixings were found in the timbers |

| <b>Action(s):</b> | Recommend adding a new fixing., Recommend the site maintenance team rectify this finding |

Clean and treat appropriately

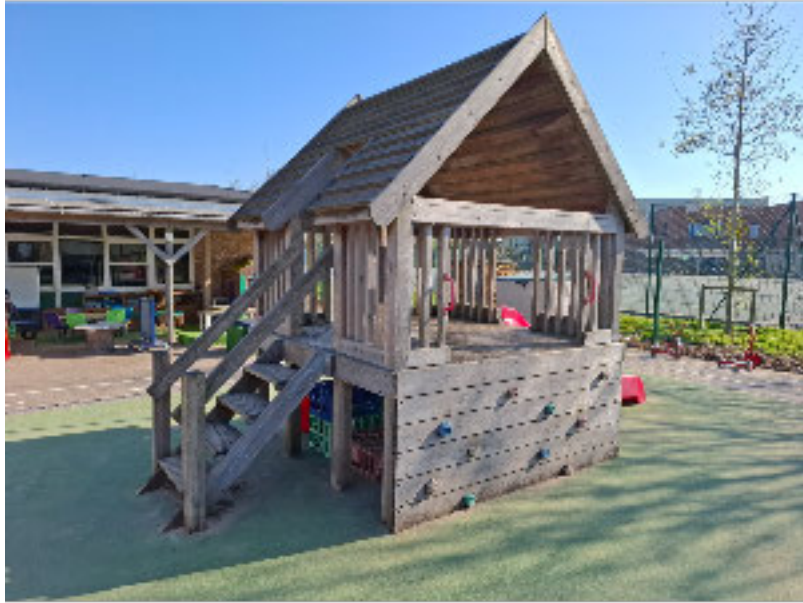
## Activity Tower

**Finding One:** The item is in good overall condition

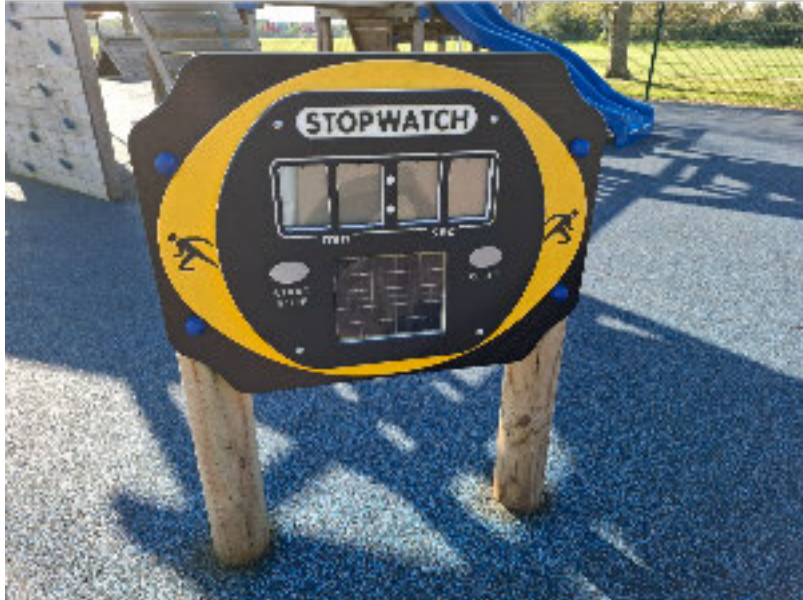
## Activity Panel

**Finding One:** The item is in good overall condition

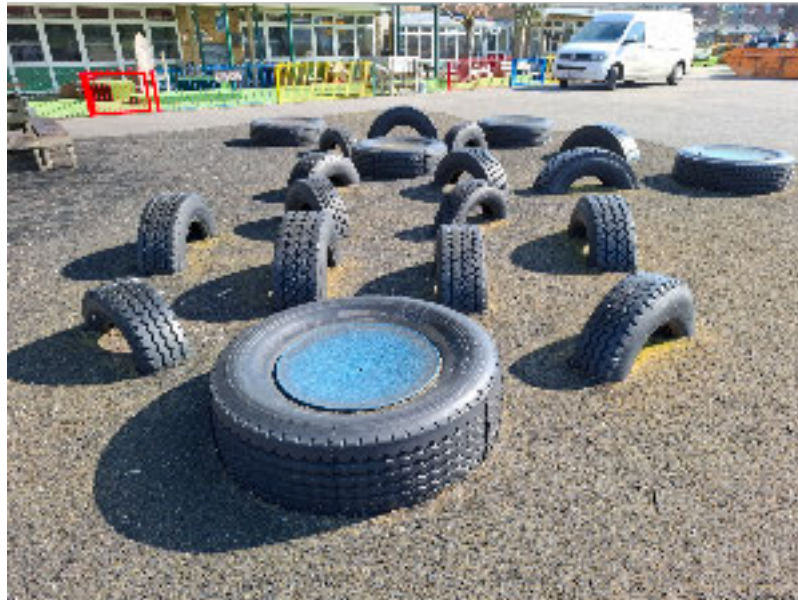
## Tyre Park

**Finding One:** The item is in good overall condition

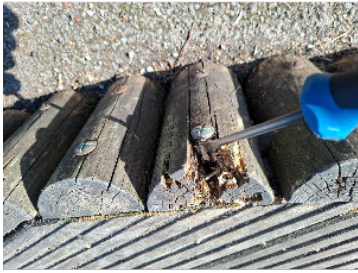
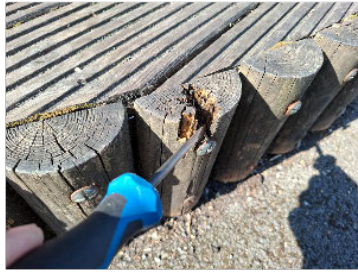
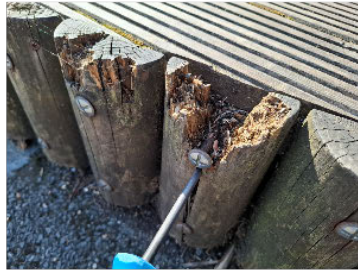
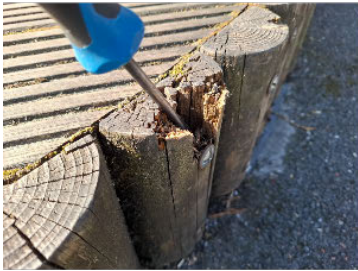
| <b>Finding One:</b> | The item is in moderate overall condition |

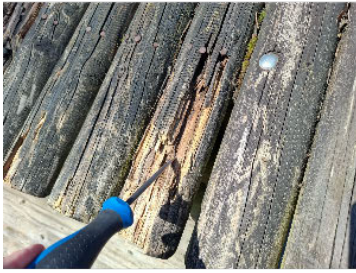
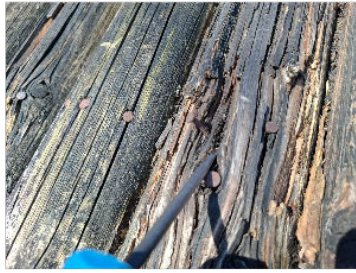
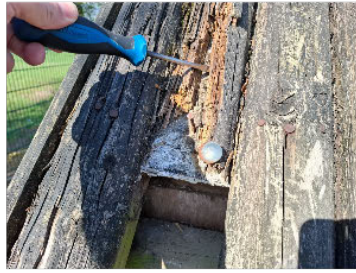
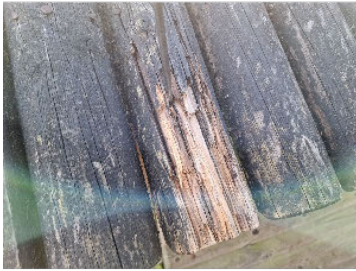
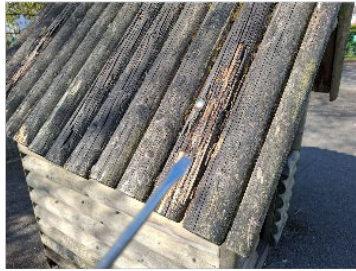
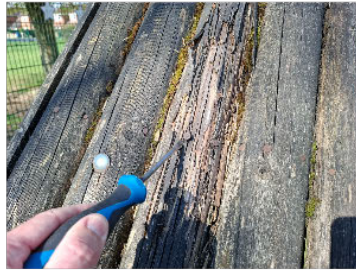
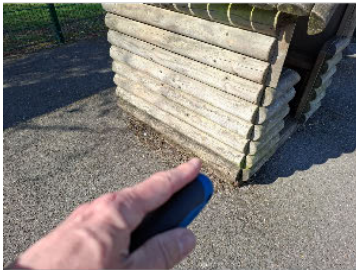
## Play Huts

| <b>Finding One:</b> | The item is in poor overall condition |

| <b>Action(s):</b> | Due to the age and deterioration of the equipment it would be uneconomical to repair., Recommend start planning for replacement equipment |

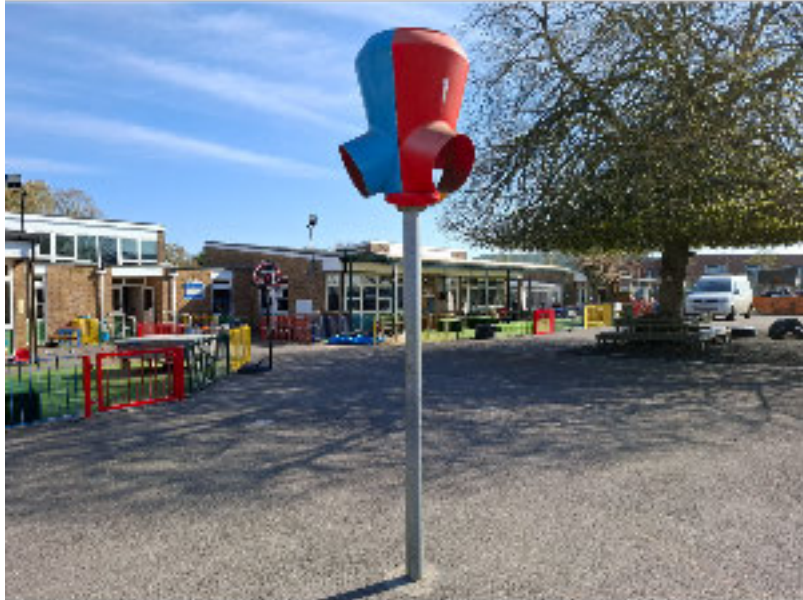
## Ball Shooter

**Finding One:** The item is in moderate overall condition

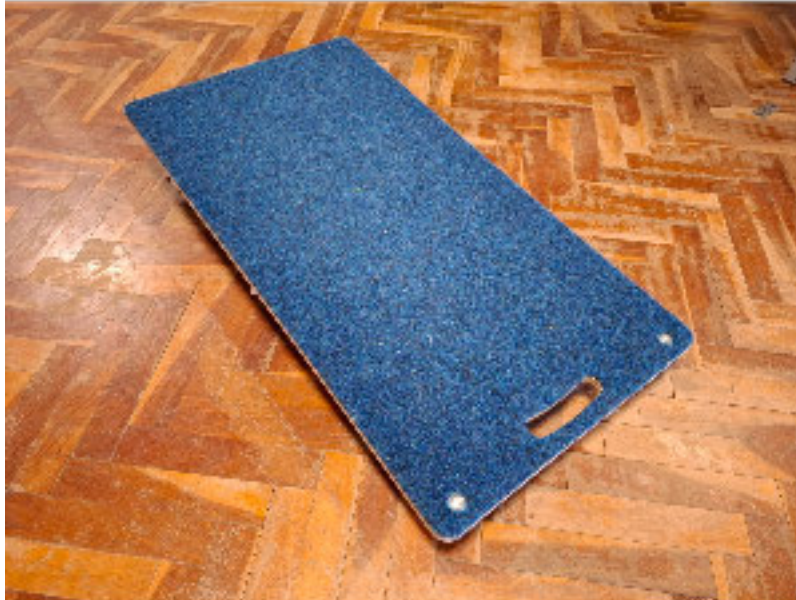
## Spring Board

**Finding One:** The item is in good overall condition

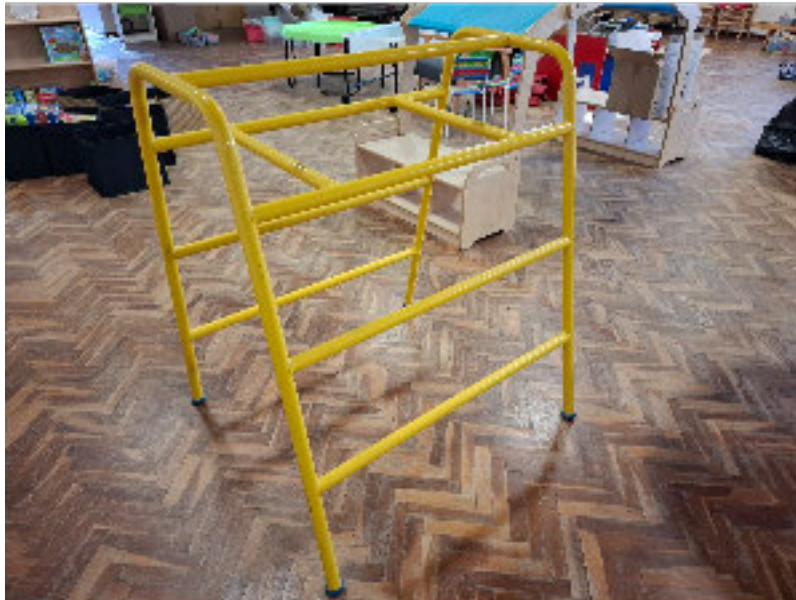
## Gym Frame

| <b>Finding One:</b> | The item is in good overall condition |

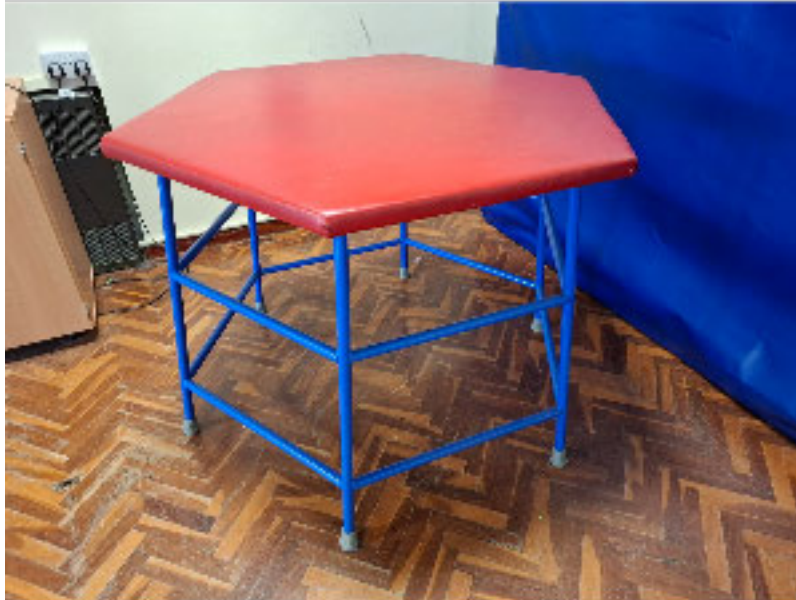
## Agility Table

**Finding One:** The item is in good overall condition
